HIGH-PERFORMANCE FIBER-REINFORCED CEMENTITIOUS COMPOSITES FOR SEISMIC DESIGN: A REVIEW OF COLUMNS

Abstract

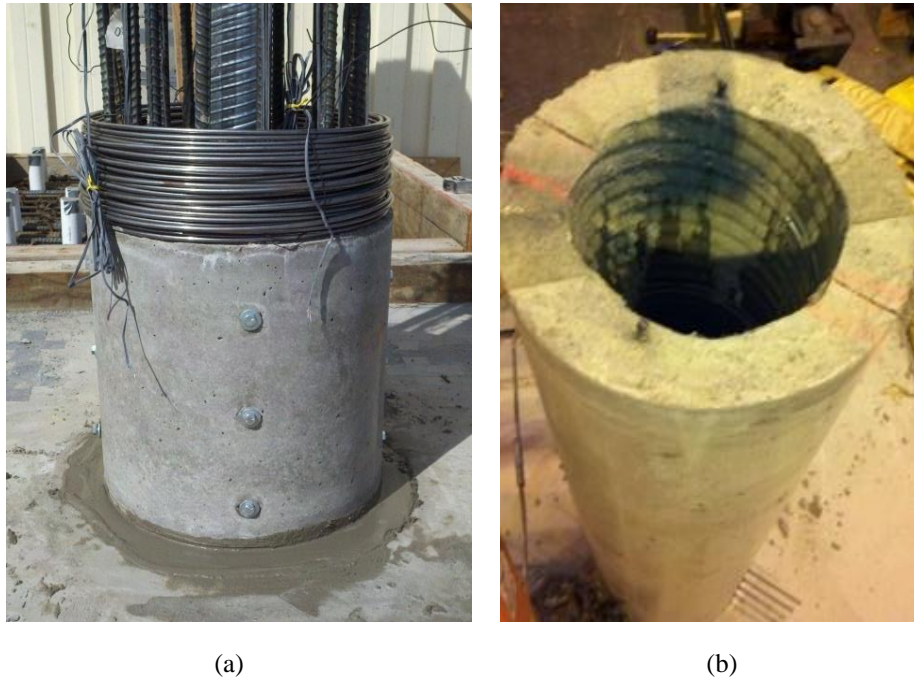
Fig. 1 – HPFRCC precast elements: (a) Solid element at column base (Trono et al. [12]);
(b) Full-height tube (Nguyen et al. [14]).

To incorporate HPFRCC material into a bridge column, precast elements are commonly specified by researchers (Fig. 1). A precast element avoids cast-in-place operations of fresh HPFRCC, which can have different workability characteristics than ordinary concrete and with which it can be difficult to ensure proper consolidation under field conditions due to congestion caused by fibers. Precast elements also conform to accelerated bridge construction (ABC) methodologies, as the precast elements can be more rapidly assembled onsite without the need to cure HPFRCC in the field, potentially reducing direct and indirect costs of bridge construction [22].

Precast HPFRCC elements have been placed at the expected plastic hinge region of a column [7, 9, 12, 15, 16], fabricated as a full-height continuous precast element [14], and fabricated as one or more precast HPFRCC segments as part of a column assembled from multiple precast segments [6, 18-21, 23, 24]. Because HPFRCC is more expensive than conventional concrete and because damage-resisting properties of HPFRCC are not fully utilized in portions of the column that deform elastically, researchers have limited the placement of HPFRCC to the expected plastic hinge region, which is where the column is most susceptible to seismic damage. For a column design consisting of multiple precast segments, the segments are typically designed with openings to allow for unbonded posttensioning strands to pass through and provide a tensile load path for the segmented column. When fabricated as an HPFRCC precast element, the cross section of the element may be solid [6, 23, 24], hollow [18-21], or hollow with concrete infilled later [18, 21].

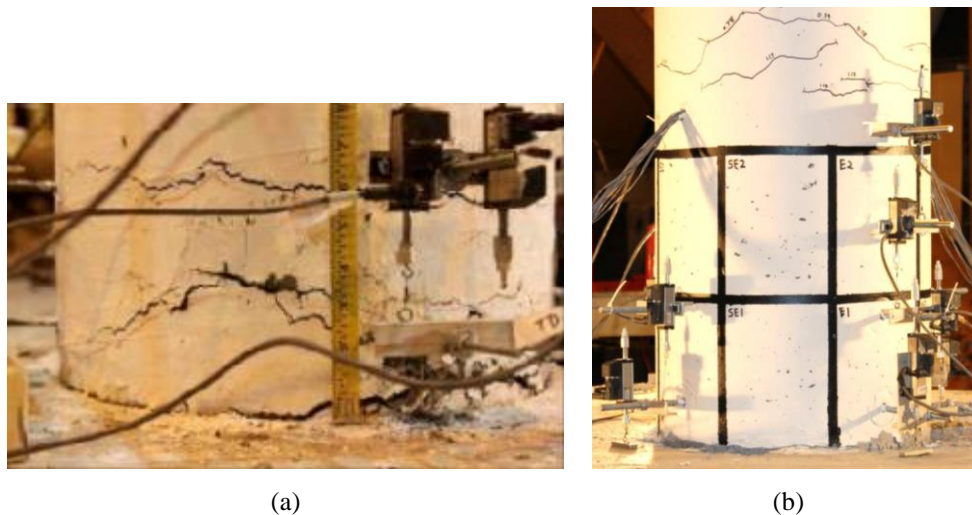
Fig. 2 – Observed cracking in HPFRCC bridge columns after reaching 3.6% drift: (a) Crack localizations (Column TS-2, Panagiotou et al. [13]); (b) Lack of flexural cracking near the column base due to unbonded longitudinal reinforcement (Nguyen et al. [14]).

Through use of novel longitudinal rebar materials, the effects of flexural crack localization and rebar strain localization can be less influential on column ductility. Panagiotou et al. [13] tested a HyFRC column designated as TS-2 that also showed crack localization, as shown in Fig. 2a. During a quasi-static load cycle that was defined by a peak drift of 3.6%, the maximum crack opening was reported to be 10 mm wide and the measured strain in the longitudinal rebar was on the order of 7%. Despite strain localization, rebar fracture did not occur until the column reached drifts greater than 9.5%, owing to the high strain capacity of stainless steel compared to low-carbon steel. Finnsson [15] tested two HyFRC columns that differed in the selection of longitudinal rebar material. Sample PreT-BS was designed with low-carbon steel, while sample PreT-SS was designed with stainless steel. Both columns showed single-crack localization. Fracture of low-carbon steel rebar first occurred at a drift of 4.0% while fracture of the stainless steel rebar occurred after a greater drift of 7.2%. The greater tensile strain capacity of stainless steel was partly limited due to bar buckling. Tazarv and Saiidi [7] tested a bridge column with a precast ECC element located at the column base. A single dominant crack in the ECC formed and had a measured width of 21 mm at 5% drift, though fracture of the nitinol longitudinal reinforcement did not occur until after the column reached a peak drift of 10%. The delay of rebar fracture to greater column drifts and the lack of bar buckling in the column was attributed to the superelasticity of nitinol, which reduces plastic deformation under cyclic loading compared to low-carbon steel.

The phenomenon of flexural crack localization in laterally loaded HPFRCC bridge columns detailed with conventional longitudinal rebar is related to the high mechanical bond between HPFRCC and rebar. The bond between the materials resists plastic deformation of the rebar, shifting rebar plasticity to cracked sections of HPFRCC where bond is degraded. This shift leads to localized deformation of both the rebar and HPFRCC at a crack. Multiple localized cracks can open depending on characteristics such as HPFRCC type and reinforcement ratio. Further information on this behavior is found in the literature [26, 27].

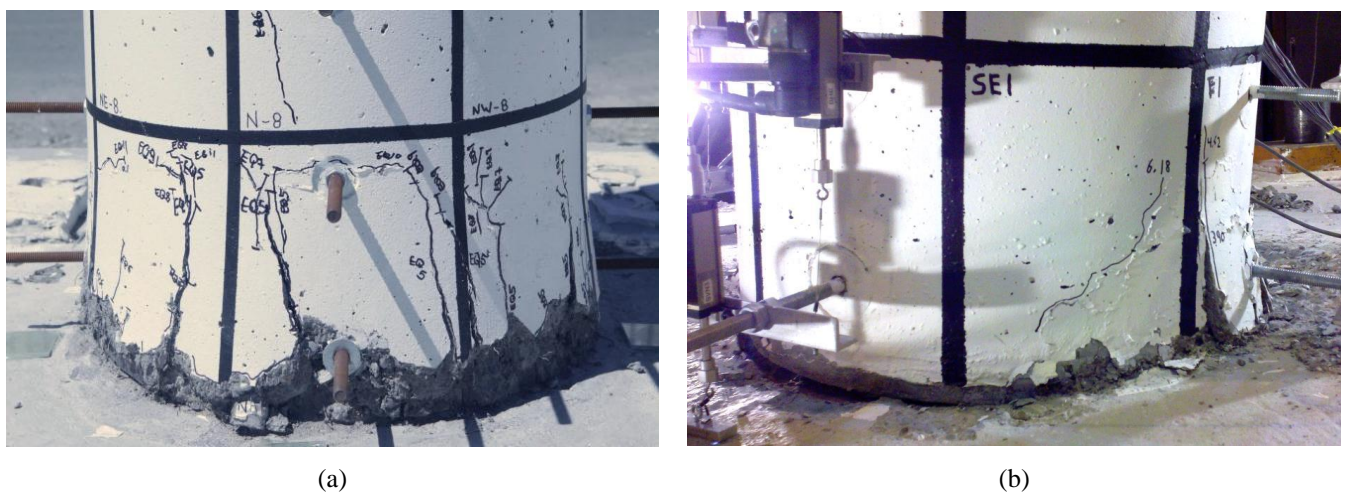
Fig. 3 – Compression damage in rocking HPRC bridge columns: (a) After 11 tested ground motions (Trono et al. [12]); (b) During loading cycle with a peak drift of 11.3% (Nguyen et al [14]).

Due to the crack-bridging effect of fibers, HPRC columns have significantly greater cover spalling resistance than reinforced concrete columns. Spalling is understood to be the physical detachment of concrete from a column. When quasi-statically tested to large drifts in excess of 10%, some HPRC column designs have shown no observable spalling [4, 14]. Shake table tests in which HPRC columns were subjected to maximum drifts of up to 8% also showed insignificant spalling [12]. Although HPRC may not spall from a column, splitting cracks and bulging of the cover can occur under high compressive strains, as shown in Fig. 3. The presented damage is relatively minor compared to widespread spalling that is typical of reinforced concrete.

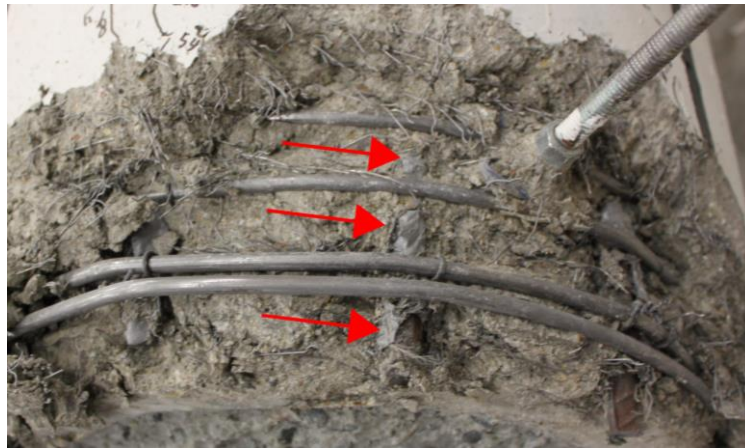
Fig. 4 – Limited longitudinal rebar buckling after test conclusion and manual HPFRCC cover removal. The column reached a peak drift of 13.1% (Nguyen et al. [14]).

fiber-reinforced concrete (SFRC) and a reference reinforced concrete column were also tested to maximum applied drifts of 4.4% and 4.2%, respectively. During testing, a hammer was used to audibly detect the separation of cover from the column core and buckling deformations of longitudinal rebar were later verified by manually removing cover after testing. All columns in the testing program developed buckled longitudinal rebar. Compared to the PFRC and SFRC columns, the average buckling lengths and average lateral displacements in the reference column, which had significantly more cover spalling, were 18% to 40% and 16% to 42% greater, respectively. The results indicate that longitudinal rebar can buckle in the presence of a cracked HPFRCC cover, though the overall buckling deformations are reduced. Nguyen et al. [14] determined that the onset of longitudinal rebar buckling and observations of initial HPFRCC cover cracking occurred within the same loading cycle during quasi-static lateral loading. With continued loading, the cracked HPFRCC cover in addition to transverse reinforcement resisted lateral deformation of longitudinal rebar, with only limited buckling deformations incurred despite testing the column to a peak applied drift of 13.1% (Fig. 4).

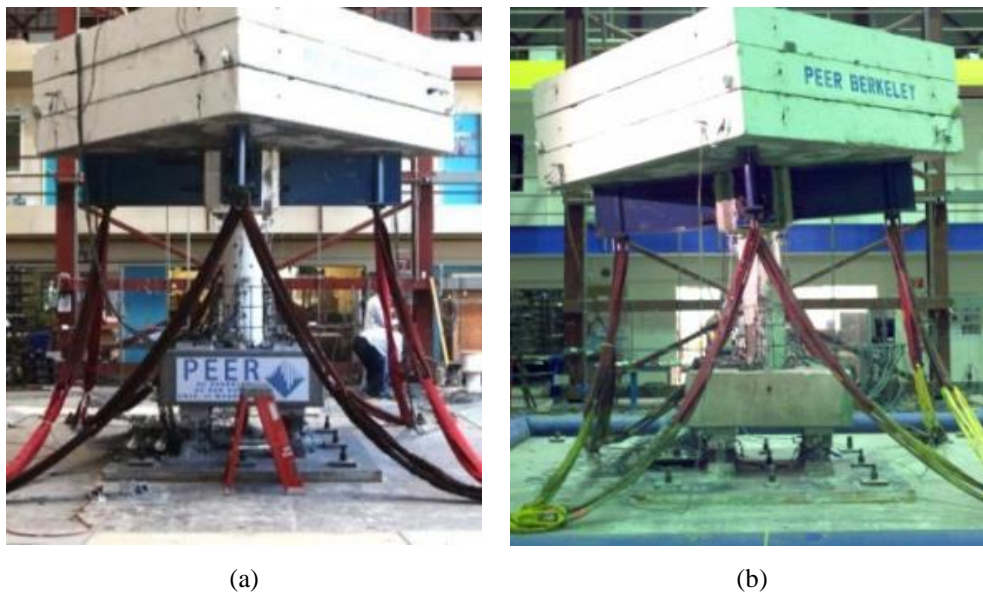
Fig. 5 – Observed state of columns after ground motion excitations, (Trono et al. [12]):
 (a) Posttensioned, rocking HPRCC column after 11 total ground motions (0.9% residual drift);
 (b) Reinforced concrete column after 7 total ground motions (6.8% residual drift).

Trono et al. [12] tested a HyFRC column detailed for controlled rocking at the column base. The column was designed with unbonded posttensioning strands, continuous longitudinal reinforcement that was unbonded from HyFRC at and near the column base, and longitudinal reinforcement that was discontinuous at the rocking plane and armored with headed plates. A conventional reinforced column of the same diameter and without posttensioning was used as a reference column for the experiment. Partial test results from the study are presented in Table 2. The HyFRC column showed significantly greater self-centering capability compared to the reference column. After 6 tested ground motions, the HyFRC column had a residual drift of 0.2% while the reference column had a residual drift of 1.6%. Although not shown in the table, the HyFRC column was tested to a total of 11 ground motions, reaching a peak drift of 8.8% and a final residual drift of 0.9%. The states of the HyFRC and reference columns after testing are shown in Fig. 5.
