NUMERICAL SIMULATION ON FAILURES OF RUBBER BEARING DUE TO THE 2016 KUMAMOTO EARTHQUAKE

Abstract

2. Overview of Okirihata bridge

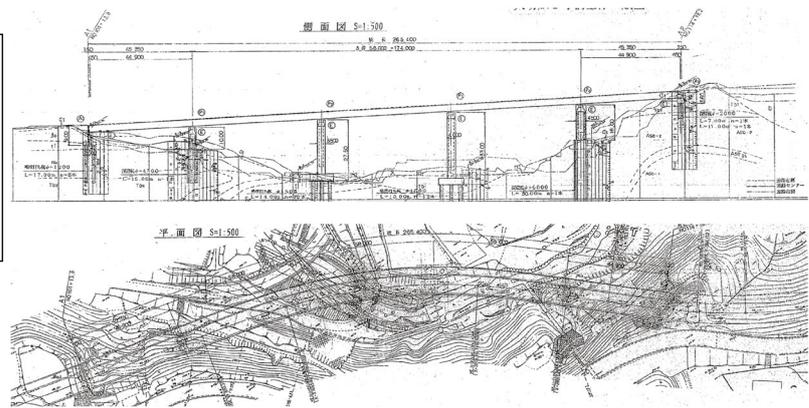
Fig. 1 – General diagram of Okirihata bridge

Okirihata bridge is laying on Prefectural Road 28 (Kumamoto-Takamori line), and 5-spans steel continuous non-synthetic girder bridge with the overall length of 265m completed in 2001. Fig.1 shows the general diagram of Okirihata bridge. And Fig.2 shows the cross section of superstructure.

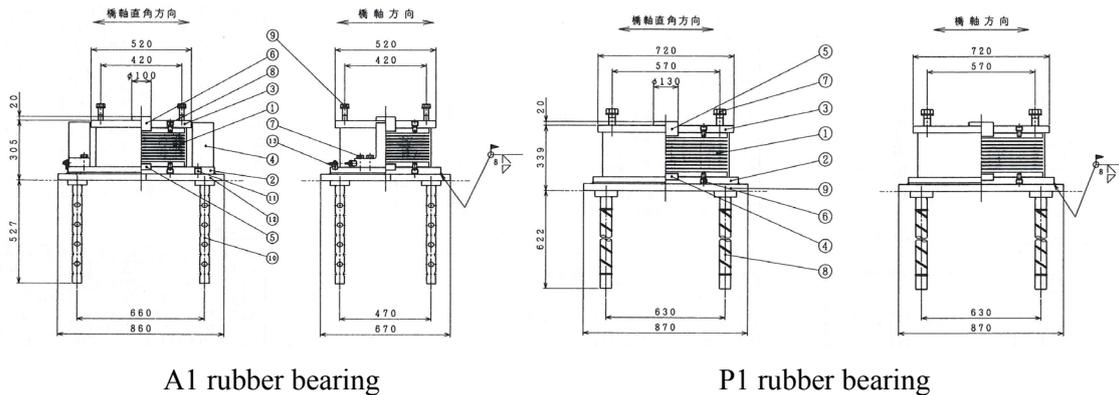
Fig. 3 – Geometry dimension of rubber bearing

In this study, A1 rubber bearing was modeled as an example of the rubber bearing at abutment, and P1 rubber bearing was modeled as an example of rubber bearing at the pier. Fig.3 shows the geometry dimension of these rubber bearing. And Table 1 shows the specifications of rubber bearing.

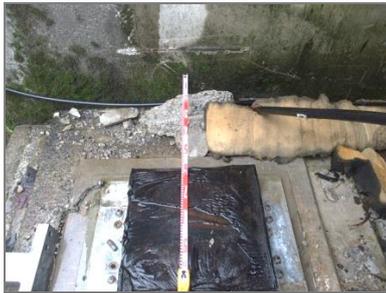
Fig. 4 – Failure of A1 abutment G5 bearing

Fig.4 shows the failure of A1 abutment G5 bearing. In the abutments, the rubber bearing was completely broken at rubber part. Since the side blocks on both sides are also broken, it is assumed that the superstructure vibrated in the direction perpendicular to the bridge axis. Observing the fracture surface of the rubber, the fracture of the rubber is occurred at not bonding surface but in the rubber material. In addition, traces of the collision of the girders were confirmed on the parapet surface.

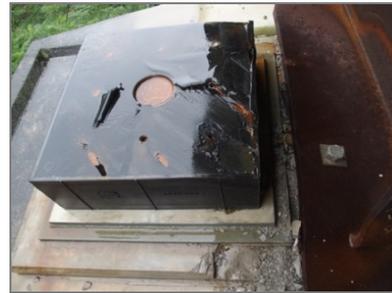
Fig. 5 – Failure of P4 pier G5 bearing

Fig.5 shows the failure of P4 pier G5 bearing. On the other hand, in the piers, the mounting bolts were broken on the P1, P3, and P4 piers, and main girder was displaced to the valley side from the original

position. In these rubber bearings, it is assumed that the rubber body did not break as the reason for upper mounting bolt was broken and the shear key was released.

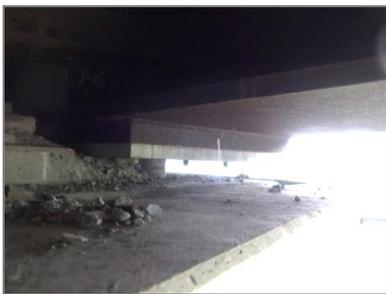
Fig. 6 – Failure of P4 pier G1 bearing

Fig.6 shows the failure of P4 pier G1 bearing (superstructure side). Since the bolt was broken at the position protruding from the lower surface of the sole plate, it can be considered that the fracture of mounting bolt was not caused by shear force but tension force.

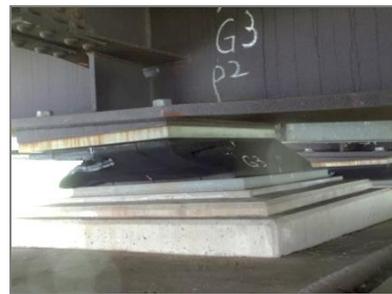
Fig. 7 – Failure of P2 pier G3 bearing

Fig.7 shows the failure of P2 pier G3 bearing. In this bridge, only P2 rubber bearing did not lose the horizontal force supporting function completely. But P2 rubber bearing was deformed toward the valley side with large shear deformation and crack on rubber part.

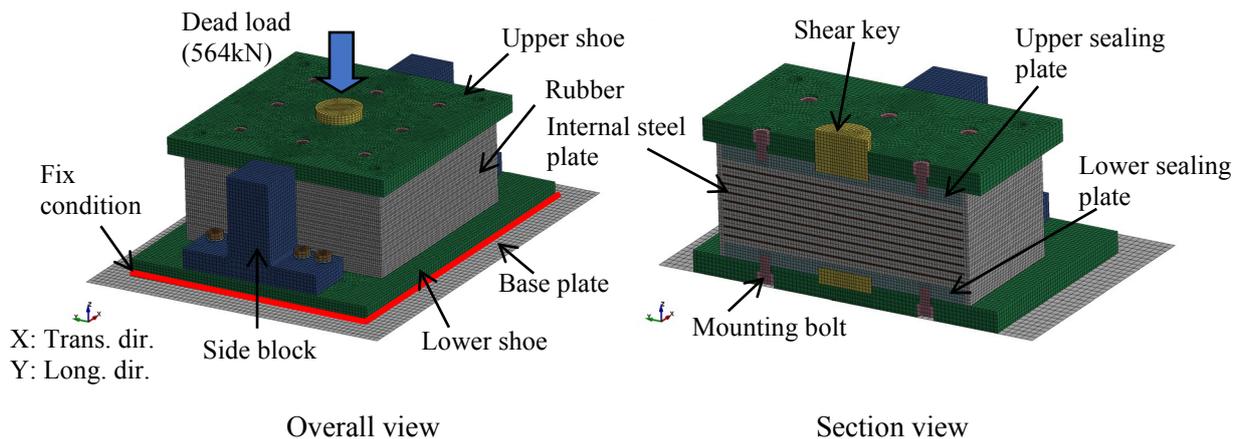
Fig. 8 –FE model for A1 rubber bearing

Fig.8 shows the FE model for A1 rubber bearing. And Fig.9 shows the FE model for P1 rubber bearing. The components of the rubber bearing such as rubber, internal steel plate, upper and lower shoe, upper and lower sealing plate, shear key and mounting bolts were modeled in detail by using FE hexahedral solid elements (506560 elements). The element size was based on a cubic element with a side length of 5 mm, which had decided by preliminary analysis for the best balance of accuracy, calculation time, and avoidance of element collapse due to large deformation.

Friction contact was modeled for between shear key and its surrounding steel plates, between mounting bolt and its surrounding steel plates, and between lower shoe and base plate. Here, the friction coefficient was assumed to 0.15, which is a general value of the static friction coefficient between steel and steel.

Fig.8 and Fig.9 also shows the load conditions and constraint conditions. The dead load of the bridge superstructure is loading to the upper shoe. After that, the horizontal displacement is loading gradually increased to the upper shoe (Pushover analysis). For the constraint conditions, after completely fixing the displacement of the base plate, and the displacement of the portion corresponding to the outer peripheral weld between the lower shoe and base plate was fixed.

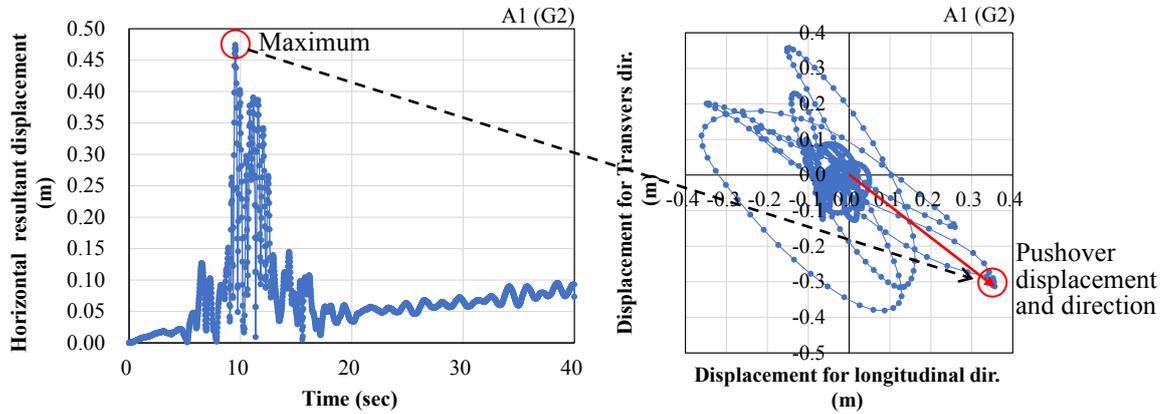
Fig. 10 – Time history of horizontal displacement and orbit (A1 abutment G2 bearing)

The direction and the quantity of the pushover displacements were decided by the results of seismic response FE analysis using the whole bridge model [1]. As an example, Fig.10 shows the time history of horizontal displacement and orbit at upper shoe for A1 abutment G2 bearing. The pushover displacement is assumed to be the displacement and direction at the time when the maximum value for horizontal resultant displacement.

Table 3 shows the analysis cases and the pushover displacement for each case. A1-Long. and P1-Long. are the cases for loading to the longitudinal direction. And A1-Diag. and P1-Diag. are the cases for loading to the diagonal direction decided by the method as shown in Fig.10.

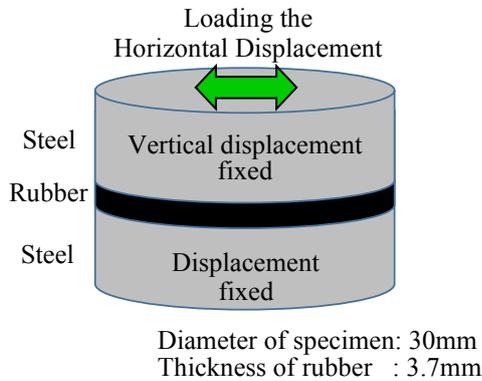
Fig. 11 – Overview of cylindrical specimen

The material constants were identified based on the results of a lap shear test using a cylindrical specimen performed at the Yoshida Laboratory of the University of Yamanashi [3]. Fig.11 shows the cylindrical specimen. And Fig.12 shows the relationship between shear stress and shear strain measured in the test.

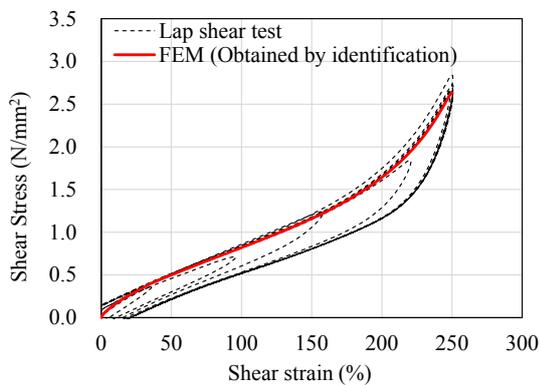
Fig. 13 – Shear stress-strain reproduced by FE analysis

The FE analysis to reproduce the lap shear test was performed. The material constants were identified by trial and error in the FE analysis. Fig.13 shows the shear stress-shear strain relationship obtained by FE analysis. Table 4 shows the material constants in Eq. (1) identified by FE analysis.

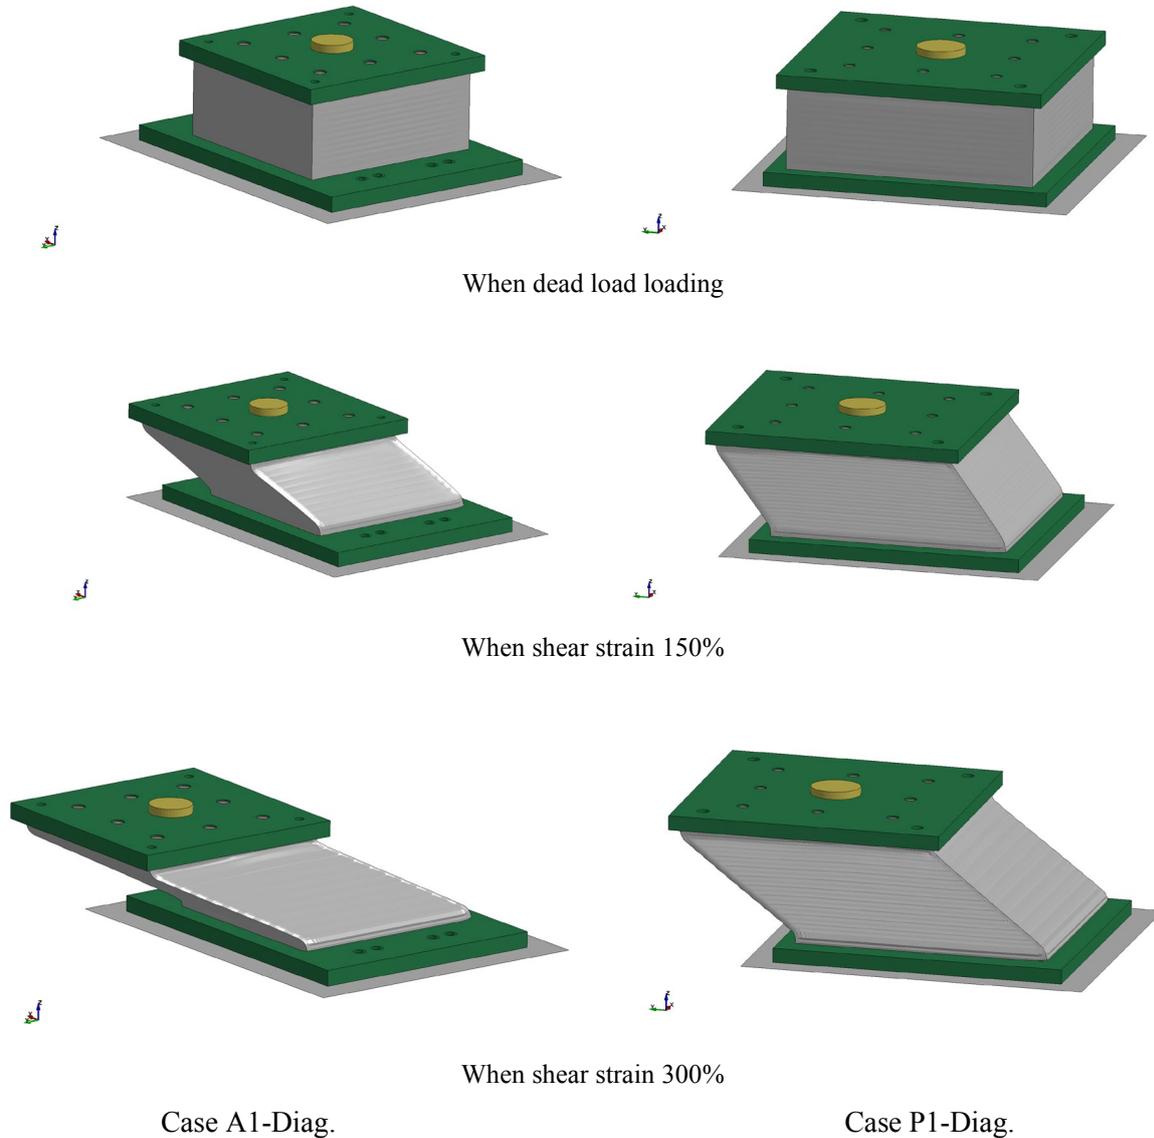
Fig. 14 – Deformation

Fig.14 shows the deformation of case A1-Diag. and case P1-Diag..

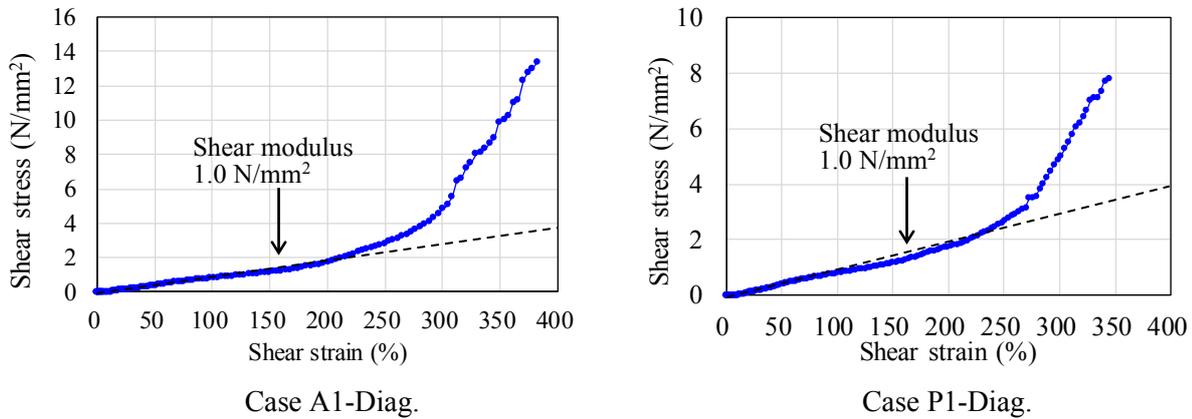
Fig. 15 – Shear stress-strain relationship

Fig.15 shows the shear stress-strain relationship of case A1-Diag. and case P1-Diag.. The shear stress-strain relationship is approximately equal to the shear modulus of elasticity 1.0N/mm^2 (Rubber material: NR-G10) in the range up to shear strain about 225%. And hardening occurs remarkably in the region where the strain exceeds 225%.

In the case of A1-Diag., the disturbance in the increase of stress occurs when the shear strain exceeds 300%. This time point corresponds to the timing at which the shear key begins to contact the surrounding steel sheet. It is considered that such a disturbance in the tendency of the increase of stress is due to local plasticization of the contact area and change in the contact surface. In other analysis cases, the disturbance of the stress occurs similarly.

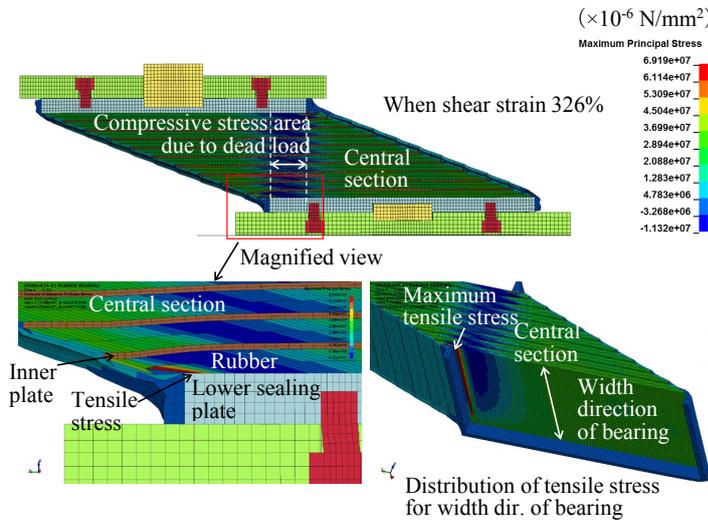
Fig. 16 – Deformation and the maximum principal stress (Case A1-Long.)

Fig.16 shows the deformation and the maximum principal stress when the shear strain 326% for case A1-Long.. The high tensile stress is generated in the rubber at the boundary between rubber part and the lower sealing steel plate (Same for upper sealing plate side). This high stress part may be the starting point of rubber breaks. This part is near the region where the compressive stress acts due to dead load. It is considered that tensile stress concentration is produced by effect of the vertical compressive restraining force due to dead load and the effect of tension field due to shear force.

- (2) In the case of A1 rubber bearing, high tensile stress is acting on the rubber part at the boundary between the rubber part and the sealing steel plate. This part may be the starting point of rubber breaks. This part is near the region where the compressive stress acts due to dead load. It is considered that tensile stress concentration is produced by effect of the vertical compressive restraining force due to dead load and the effect of tension field due to shear force.

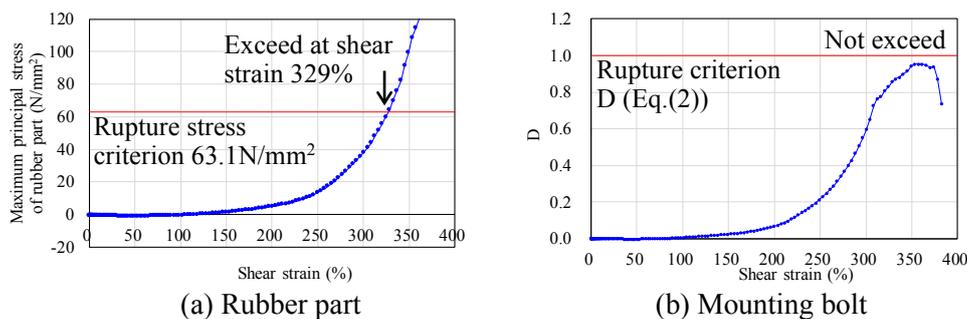
Fig. 18 – Evaluation of failure for Case A1-Diag.

Fig.18-(a) shows the relationship between the maximum value of maximum tensile stress on rubber part and the shear strain for case A1-Diag.. The tensile stress exceeds the rupture stress criterion of the rubber when the shear strain at 329%. So, the rubber may be start breaking at this timing. And, Fig.18-(b) shows the relationship between the fracture criterion D of the bolt and the shear strain. The D value did not exceed 1.0 in the range up to the shear strain 380%, where the FE analysis was performed. So, it is considered that the mounting bolt does not break.

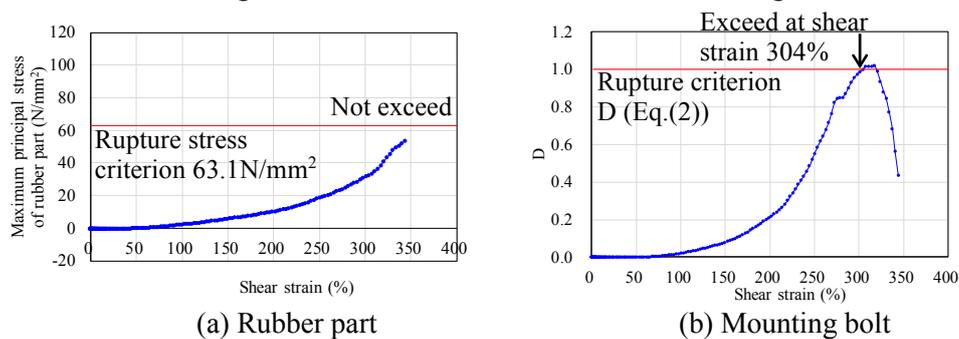
Fig. 19 – Evaluation of failure for Case P1-Diag.

Fig.19-(a) shows the relationship between the maximum value of maximum tensile stress on rubber part and the shear strain for case D1-Diag.. The tensile stress did not exceed the rupture stress criterion of the rubber in the range up to the shear strain 345% where the FE analysis was performed. So, it is considered that the rubber part does not break. And, Fig.19-(b) shows the relationship between the fracture criterion D of the bolt and the shear strain. The D value exceeds 1.0 when the shear strain at 304%. Therefore, it is considered that the mounting bolt may be start breaking at this timing.

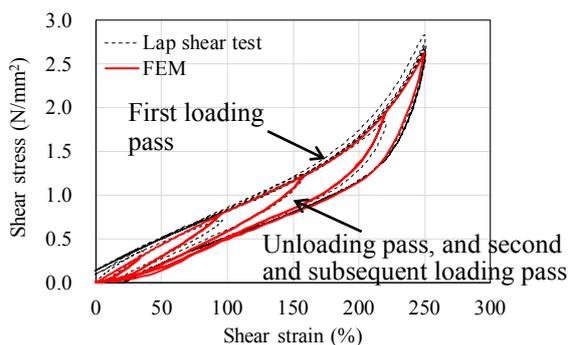
Fig. 20 – Modeling the Mullins effect

Fig. 20 shows the results of treating on Mullins effect. The relationship between the shear stress and the shear strain for the first loading process, unloading process, and in the second and subsequent loading processes can be properly reproduced.

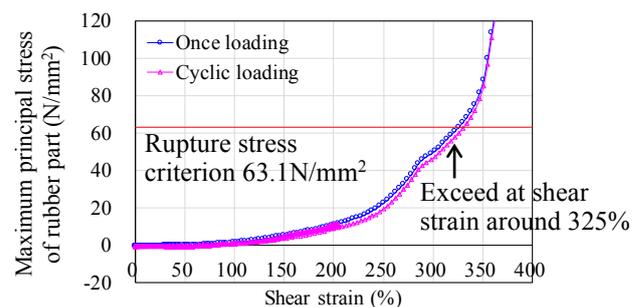
Fig. 21 – Comparison of tensile stress of rubber part

And also, the trial FE analysis on cyclic loading was performed for case A1-Long. The pushover displacement was applied to shear strain 200%, which is 0.8 times for the design shear strain 250%, then unloaded to 0%, and applied again to over 350%. Fig. 21 shows the comparison of tensile stress of rubber part between once loading condition and cyclic loading condition. Both results show that the rubber part may start to break at a shear strain around 325%. It was found that there was no significant difference on timing of failure of rubber part within the loading conditions in this study.
