Study on Damage Evaluation of Laminated Rubber Bearings using AE Method

Abstract

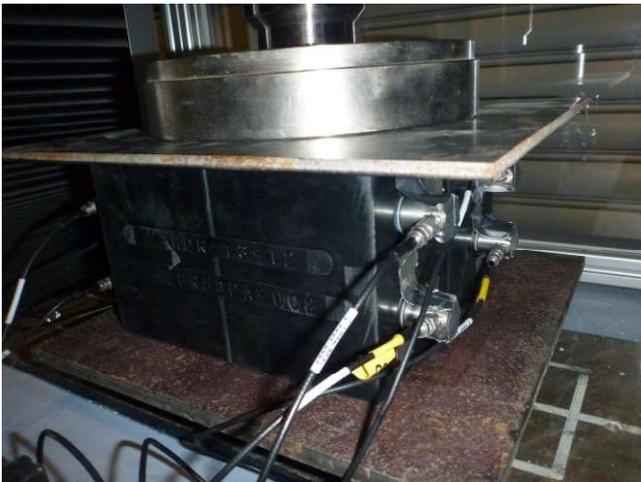
Fig. 1 – AE monitoring

The rubber bearings made of natural rubber, which conducted the shear test, were used. After the shear test, the rubber bearings conducted the cyclic compressive loading test which was assumed the traffic vibration on the bridge girder. During the test, AE monitoring performed as shown in Fig. 1. Finally, the rubber bearings cut and the cross-section observed using a microscope to compare the AE data with the microscopic observation results to determine the damage condition.

method to evaluate the rubber bearing in service on a bridge without stopping traffic, if the internal damage can be evaluated by AE measurements using cyclic compressive loading tests assuming traffic vibration. Fig.1 and Fig. 6 show the experimental conditions of the cyclic compressive loading test. The load was applied from the minimum load value to the maximum load value in 10 cyclic cycles. The minimum load value is considered a compressive force equivalent to a dead load and a live load equivalent to a surface pressure of 6MPa. Therefore, the minimum load value was set to 153.6kN (=160mm × 160mm × 6MPa) for this study. The maximum load value is calculated from the allowable maximum compressive stress, which is determined by the primary shape factor of the rubber bearing. The relationship between the primary shape factor and the allowable maximum compressive stress is shown in Table 3, and the primary shape factor of this specimen is 5.71. The specimen used in this study has a maximum allowable compressive stress of 8N/mm², so the maximum allowable load value is 259.2kN (=180 mm × 180 mm × 8MPa). The minimum load value of 153.6kN was subtracted from this value to obtain a value of 105.6kN (=259.2kN-153.6kN). 10.6kN, which is 10% of this value, was added to 153.6kN to obtain a value of 164.2kN as the maximum load value, which was named the 10% cyclic compressive load test. Similarly, the 20% and 50% portions of 105.6kN were added to 153.6kN, and the maximum load values were 174.8kN and 206.6kN, which were named the 20% cyclic compressive test and 50% cyclic compressive test, respectively. AE measurements were performed using the above 10%, 20%, and 50% cyclic compressive tests.

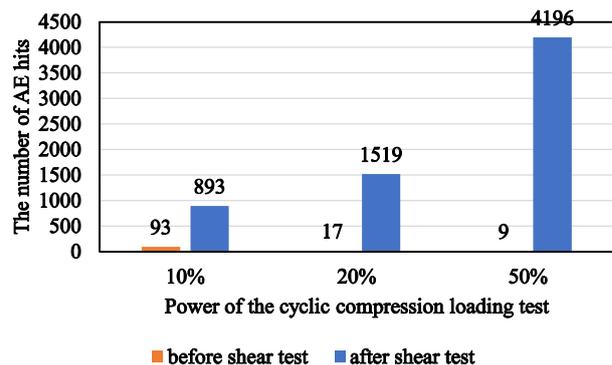
Fig. 2 – Results of AE hits

The number of AE hits was compared with before and after the shear test as shown in Fig. 2. The results showed that more AE hits were detected after the shear test. Also, several fractures, which were thought to crack due to shear test, were observed in the rubber bearings from the microscopic observation. These results indicated that the AE method could be used to evaluate the damage of the rubber bearings.

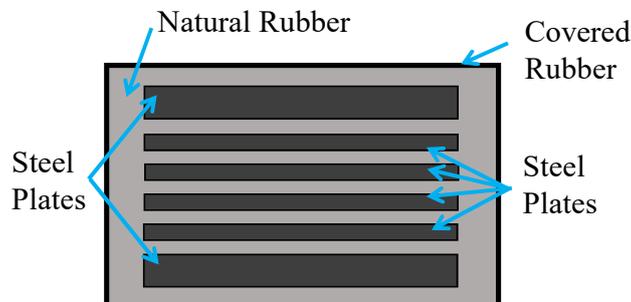
Fig. 3 – Internal structure of rubber bearing

The rubber bearing used in this study is a natural rubber-based laminated rubber bearing, and its internal structure is shown in Fig. 3. Although natural rubber has excellent elongation and tensile strength, it is not ozone-resistant and has little damping performance, which requires a damper device.

The laminated rubber bearing consists of alternating layers of rubber material and steel plates, which are vulcanized and bonded together. The vertical load is suppressed by the adhesive force between the rubber and steel plates and the tensile stiffness of the steel plates, while the steel plates do not interfere with the shear deformation of the rubber and deform by the elasticity of the rubber itself against the horizontal load. Therefore, the laminated rubber bearing is stiff in the vertical direction and soft in the horizontal direction.

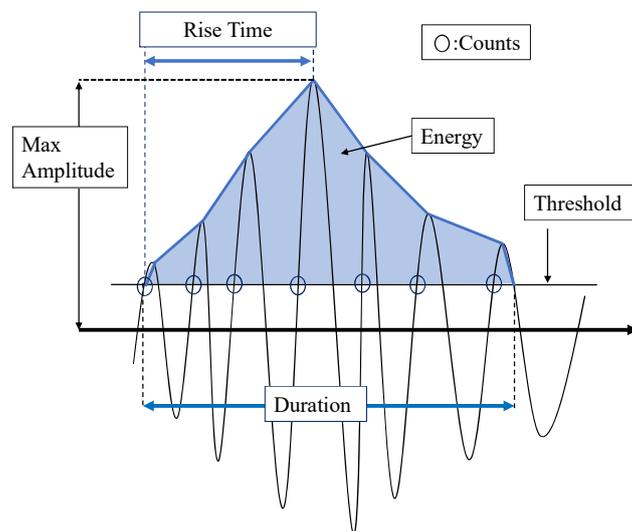
Fig. 4 – A typical AE waveform

Fig. 4 shows a typical AE waveform, and the typical AE parameters and their characteristics are shown as follows [6]:

- i. **Threshold:** This value is set to eliminate mechanical and electrical noise in AE measurement.
- ii. **The number of AE hits:** The number of AE signals detected. A larger number of AE hits indicates a larger number of wave sources, which in turn indicates a larger possibility of damage.

- iii. **Energy:** The area of the envelope detection waveform of the AE signal indicates the scale of the AE phenomenon; a larger value indicates a greater possibility of damage.

- iv. **Amplitude:** It is the magnitude of vibration caused by the event that generated the AE. The maximum amplitude value indicates the largest amplitude value of the AE signal, and a larger value indicates the possibility of a larger scale.

- v. **Rise Time:** It is the time from the start time of AE signal measurement to the maximum amplitude value for that AE signal.
- vi. **Duration:** It is the time from the start of measurement when the AE signal first crosses the threshold to the end of measurement when the AE signal last crosses the threshold.

- vii. **Counts:** Number of times the threshold value is exceeded during the duration time.

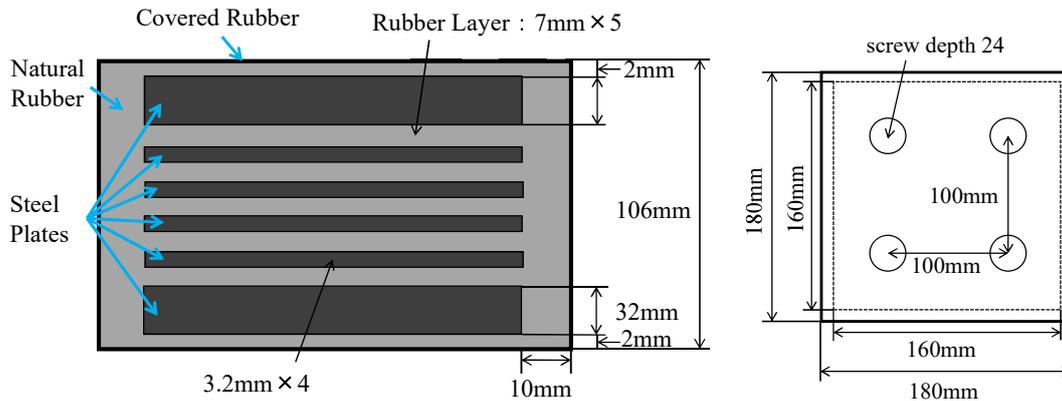
Fig. 5 – Outline of the specimen (left: cross-section view, right: top view)

The cross-section and top views of the specimen used in this study are indicated in Fig. 5, and the specimen specifications are shown in Table 1.

Dimensions (mm×mm×mm)	180×180×106
Rubber layer thickness (mm)	7
Steel plates thickness (mm)	3.2

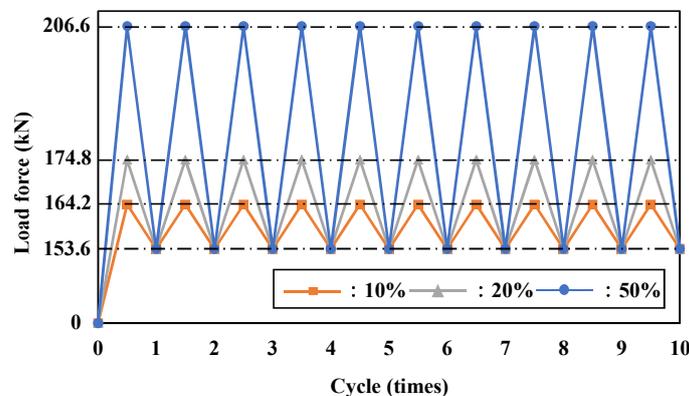
Fig. 6 – Experimental overview of cyclic compressive loading tests

Eight AE sensors with a resonant frequency of 60kHz were used for AE measurements, four at the height between the upper steel plate and the inner rubber, and four at the height between the lower steel plate and the inner rubber. The coordinates of the AE sensor locations are shown in Table 4. The threshold value for AE measurement was set at 40dB. Among the AE phenomena obtained, AE phenomena with an AE parameter count of 1 and an AE energy of 0 were eliminated as noise. In addition, AE phenomena that occurred during the time before the first exceedance of 153.6kN were also eliminated as out of the target time.

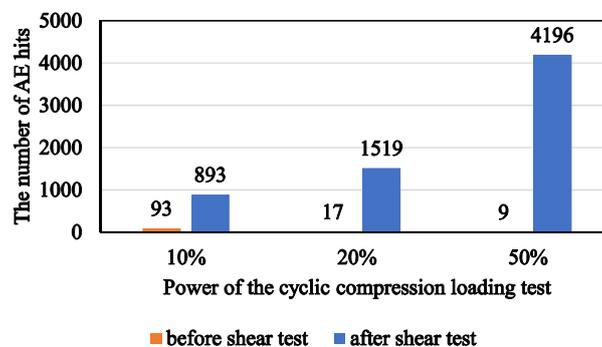
Fig. 7 – Comparison of the number of AE hits before and after the shear test

The number of AE hits in the 10%, 20%, and 50% cyclic compressive tests are compared before and after the shear tests as shown in Fig. 7. The number of AE hits after the shear test is significantly larger than that before the shear test, indicating that the AE sensor detects more AE phenomena. The higher number of AE hits indicates more AE phenomena detected by the AE sensor, thus indicating an increase in the number of AE sources, i.e., internal damage, after the shear test than before the shear test. Therefore, based on the comparison of the number of AE hits before and after the shear test, it can be concluded that the internal damage increased due to the shear test.

The above results indicate that the number of AE hits after the shear test was larger than that before the shear test, indicating that the shear test caused internal damage. Also, a comparison of the number of AE hits for each sensor shows that a large number of AE hits were detected in the sensor on the lower steel plate side, while some sensors on the upper steel plate side only detected the same number of AE hits as before the shear test, suggesting that there was little damage on the upper steel plate side and a lot of damage on the lower steel plate side.

- (1) Since the number of AE hits was significantly higher after the shear test than before the shear test, and many cracks caused by the shear test were observed in the actual cross-section, the number of AE hits was considered an increase in internal damage.

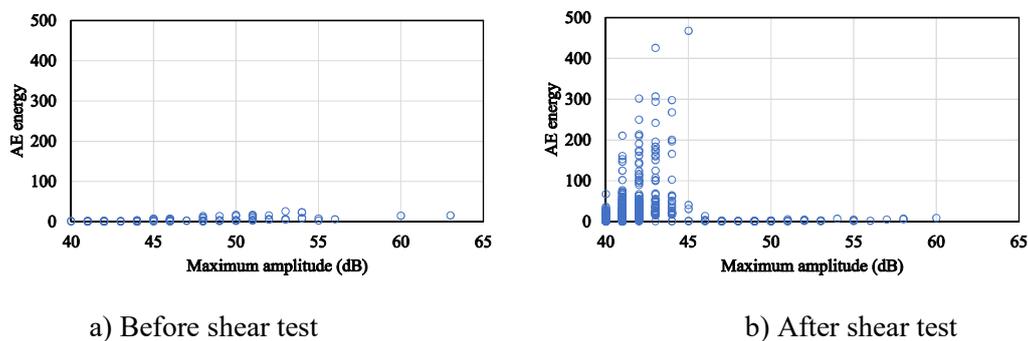
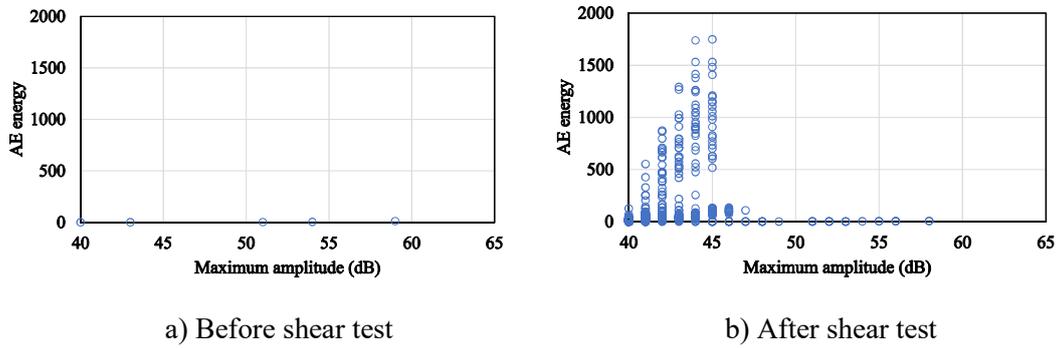
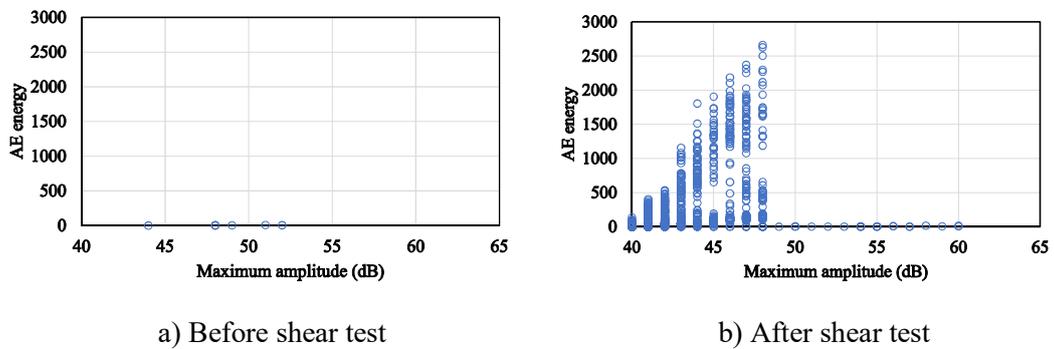
Therefore, the relationship between the maximum amplitude values and AE energy in the 10%, 20%, and 50% cyclic compressive loading tests were compared before and after the shear test. The results are shown in Fig. 8 to Fig. 10. The AE energy after the shear test is higher than that before the shear test for all the specimens under all the loading forces. For the maximum amplitude values, especially at 10% and 20%, larger values are detected before the shear test, and there is no significant difference in the distribution between before and after the shear test. In particular, after the shear test, as the maximum amplitude value increases, a significant value of AE energy is also detected, and the AE energy suddenly decreases after a specific maximum amplitude value is exceeded. Therefore, the larger the maximum amplitude value at the time of maximum AE energy value, the higher the degree of damage.

- (2) There was no difference in the distribution of the maximum amplitude values before and after the shear test, but there was a significant change in the AE energy. Therefore, the larger the maximum amplitude value at the time of the maximum AE energy value indicates, the higher the degree of damage.

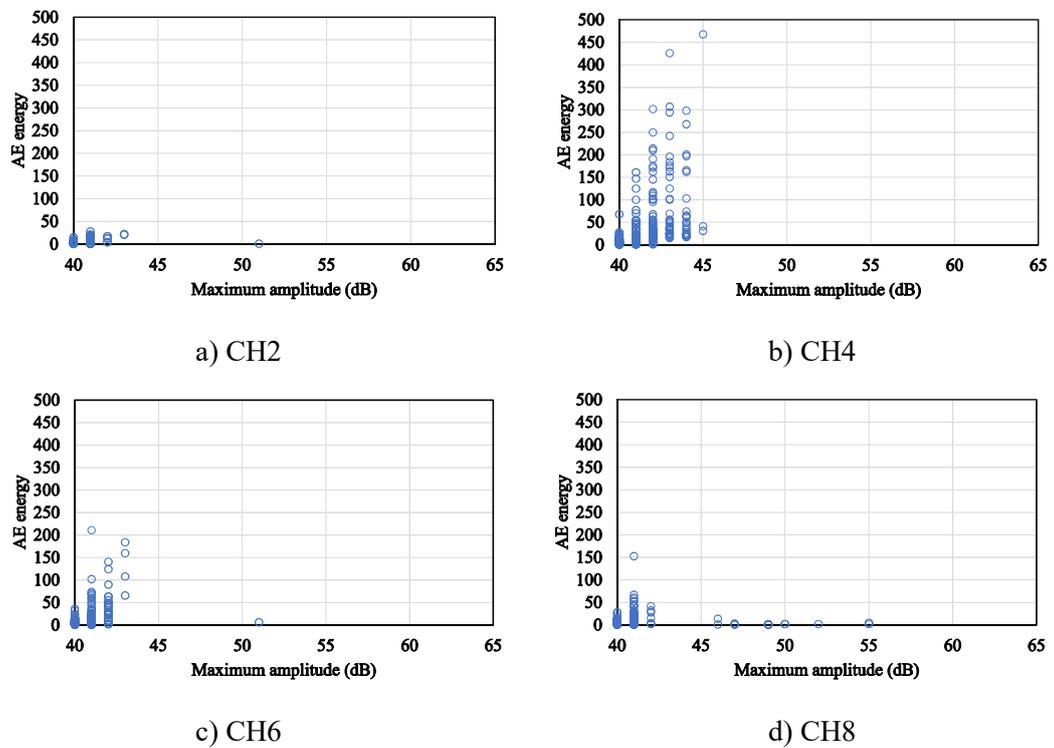
Fig. 11 – Relationship between maximum amplitude value and AE energy of sensors on the lower steel plate side

Fig. 11 shows the relationship between the maximum amplitude values and AE energy of the sensors on the lower steel plate side for the 10% cyclic compressive loading test. The maximum amplitude value at the time of the maximum AE energy is also the highest at CH4, suggesting that the area around CH4 may be more damaged than other sensors.

- (3) When the degree of damage was evaluated for each sensor, the results obtained by the relationship between the maximum amplitude value and AE energy agreed with the results observed in the actual cross-section, suggesting that the relationship between the maximum amplitude value and AE energy is effective in evaluating the degree of damage.

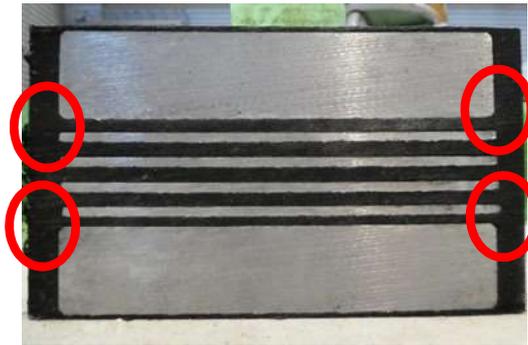
Fig. 12 – Observation points

The purpose of the microscopic observation of the rubber bearing cross-section was to compare the results of the damage evaluation by AE measurement with the actual damage level of the cross-section and to verify the reliability of the AE measurement results. After the shear test, the specimens were cut and observed with a 500x microscope. The cross-section of the specimen is shown in Fig. 12, and the observation area is the red circle, which is considered to be the most damaged area by the shear test and is also near the location of the AE sensor.

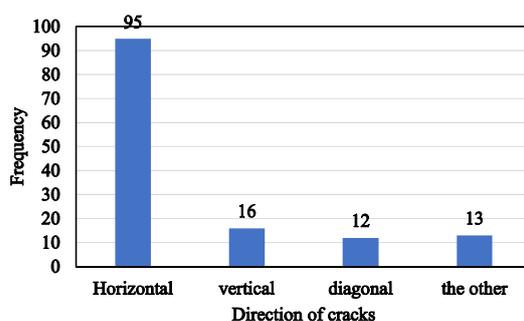
Fig. 13 – Distribution of cracks direction

This study focused on the direction and number of cracks. Horizontal cracks are considered to be caused by the shear test and cutting marks made during cutting, while vertical and diagonal cracks are considered to be caused by the shear test and the extension of horizontal cracks just before rupture. The other cracks were mostly round cracks like air bubbles that were thought to be mixed in during the manufacturing of the rubber bearings, and a few cracks that were thought to be caused by the shear test.

The results of the distribution of crack directions are shown in Fig. 13. Since horizontal cracks are caused by the shear test, vertical and oblique cracks are just before fracture, and the shear test may cause other cracks. It thought that the shear test caused internal damage. Therefore, the results shown in Chapter 5 for the number of AE hits indicate an increase in internal damage.

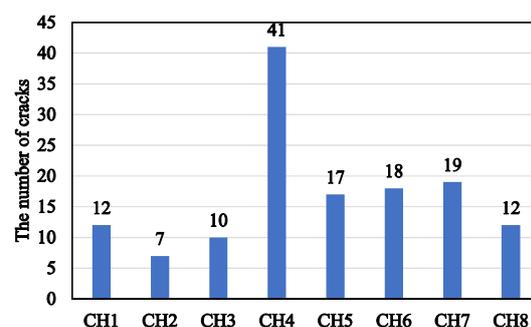
Fig. 14 – Number of cracks for each sensor

Then, the results of the number of cracks for each sensor are shown in Fig. 14. The actual cross-section of the specimen is not biased, and some sensors have fewer cracks on the lower steel plate side and some sensors have more cracks on the upper steel plate side. Also, compared with the results of the damage level in Chapter 5, similar results were obtained, and it was found that there was a large amount of damage near CH4. Therefore, it can be evaluated the degree of damage based on the relationship between the maximum amplitude value and AE energy.
