EXPERIMENTAL STUDY ON STRUCTURAL CHARACTERISTICS OF FOUNDATIONS ATTACHED TO THE LAMINATED RUBBER BEARING

This paper describes an experiment to measure the internal stresses in a reinforced concrete (RC) foundation below a laminated rubber bearing.

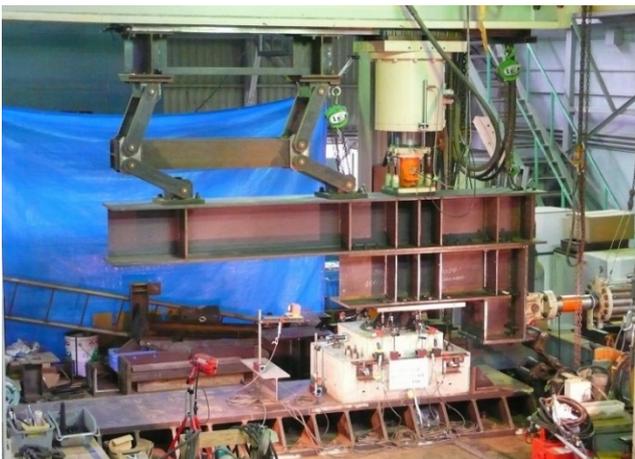
Fig.3 – Compressive shearing test machine 1

The test was performed on the compressive shearing test machine shown in Fig.3. This is a 2-axis test machine which exerts a compressive load with a jack and a shearing load with an actuator. The direction in which the actuator acts on the specimen in traction is defined as the “D-direction”. Fig.4 shows a laminated rubber bearing under compressive loading and deformed 150mm in the horizontal direction.

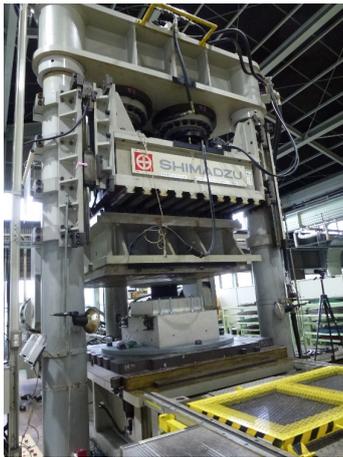
Fig.11 – Compressive shearing test machine 2

The test was conducted on the compressive shearing test machine shown in Fig.11. Fig.12 is a photograph of a test in progress. The mechanism applied a shear deformation to a laminated rubber bearing placed between the RC foundation specimen and the test machine by making the upper flange of a laminated rubber bearing move in a horizontal direction. The apparatus loaded the bearing specimens as follows: A specified horizontal deformation (offset) was applied to the bearing, followed by loading in compression; once the specified maximum loading had been applied at the given shear deformation value, the load was released and the next offset was applied for the next sequence of compressive loads. The directions of force application were those marked D-direction and S-direction as shown in Fig.12. Forces (1) to (16) in Table 4 were applied in ascending order in the D-direction. Next, forces (17) to (34) were applied in ascending order in the S-direction.
