Study on Escalator fall off behavior and structural strength during earthquake

Abstract

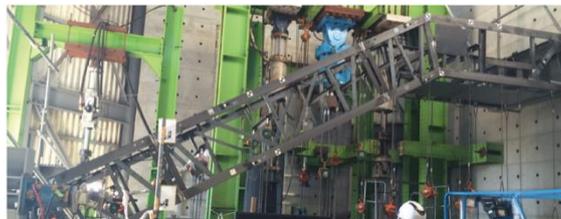
Fig. 2 – Test body

The specifications of the experiment model are shown in Table 1 and 2. The main material is Japanese Industrial Standard (JIS) SS400. The lift height of the escalator was 3 [m], further the experiment model is similar to a practical machine escalator. The experiment model is shown in Figure 2. The truss was included in the experiment model, without the escalator's internal equipment (such as step, handrail drive unit and so on). The weight of internal equipment was reproduced by hanging the dummy weights.

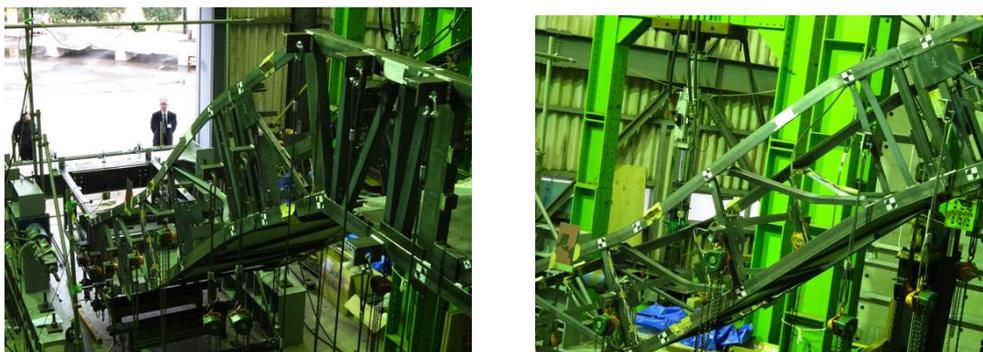
Fig. 4 – Deformation of experiment

The appearance of deformation is shown in Figure 4. The relationship between the reaction force of the truss and the enforced displacement is shown in Figure 5. Immediately after the start of compression, the relationship between reaction force and the displacement are linear. After that, the truss member buckled, further the load suddenly decreased. The effect of repetition is negligible at the displacement 40 [mm] and 80 [mm]. The trusses were standing by themselves without falling at the enforced displacement 200mm.
