RETROFITTING OF A BRIDGE FORM HISTORICAL STATION USING SEISMIC ISOLATION

D. Kubin⁽¹⁾, J. Kubin⁽¹⁾, G. Feroglu⁽²⁾, H. Sucuoglu⁽³⁾, İ.A. Ilis⁽⁴⁾, U. Ozcamur⁽⁵⁾, I. Ozdem⁽²⁾, S. Yalcin⁽⁶⁾

Keywords: Göztepe Station, Masonry Structure, Historical Building, Retrofit, Seismic Isolation

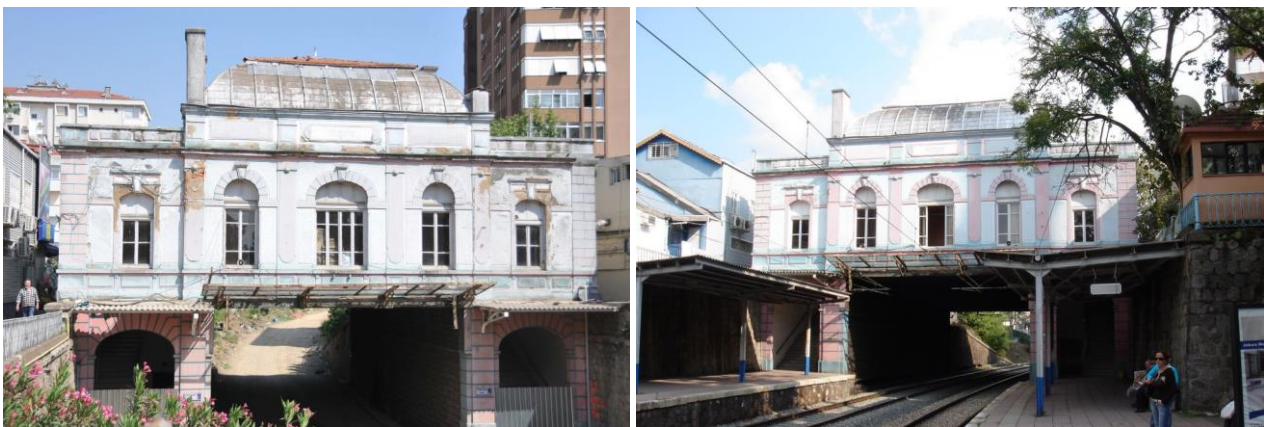
Fig. 8 – Recent Photographs of the Station Before Strengthening

Göztepe railway station has been constructed as a 20 x 12 m rectangular block shaped bridge. Height of the building is approximately 15 m. The station consists of a platform level and a ground floor which is used as a ticket office and launch. The structural system of station is composite stone and brick masonry.

The primary load-bearing piers of the structure are the stone masonry stairs blocks leading to the platform at both sides of the building. Slab system of the building was constructed using one-way I-shape steel ribs with approximately 800 mm centres. Spaces between the steel ribs were filled using hollow bricks to create a slab system called Volta.

The ground level walls are brick masonry spanning from floor to the roof. All of the walls have been plastered. Walls thickness is around 700 mm at platform level and 400 mm at ground floor. All interior walls are also brick masonry with 300 mm thickness. These masonry walls carry the grey vault having a raised section at the middle of the structure. At both sides of the vault, gable roofs are constructed. During the assessment works conducted to determine the as built state of the building, no reinforced concrete elements were observed.

Observations revealed that some sections of the flooring system have experienced some revisions in time, since different timber cover sizes were measured in office areas. Original floor covers having thicknesses around 75 to 150 mm were used in these areas, whereas 200 x 200 mm square mosaic tiles were employed in the ground floor. It was also determined that the building did not experience any significant structural or architectural revision since it was constructed, with the exception of the canopies at the platform level that were added at a later date.
