A STUDY ON AGED DETERIORATION OF RUBBER BEARINGS INSTALLED IN THE ISOLATED BUILDING AFTER 30 YEARS IN USE

Abstract

Keywords: Isolated building; Natural rubber bearing; Aged deterioration; Free vibration test; Static loading test

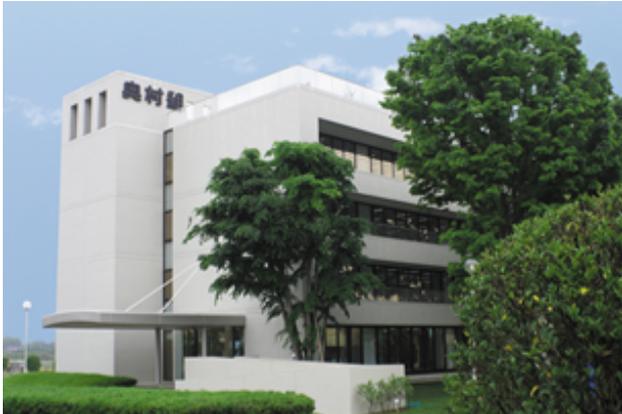
Photo 1 – Target building

The base-isolated structure tested in this study was built in September 1986 (Photo 1). The seismic isolation device consists of 25 natural laminated rubber bearings (NRB) and 12 sets of steel dampers. Table 1 provides the specifications of the target building and the seismic isolation devices. Fig. 1 shows the configuration of the seismic isolation devices.

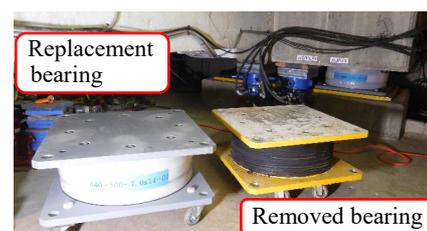
Photo 3 – Replacement of bearings

We removed two bearings from the building (Photo 3) to examine the limit deformability in a compression shear test machine. Fig. 13 is a schematic drawing of the loading system. This system is equipped with two and four actuator units in the horizontal and vertical directions, with a loading capacity of 6 MN and 25 MN, respectively. The sum of the values of the load cells for each direction is considered to be the load; the mean value of the values measured by displacement sensors in each direction is regarded as displacement. The direction of load application is set to coincide with the direction of displacement of the building in the loading test. Table 2 shows the loading history. A bearing stress of 6.0 N/mm² corresponding to a design load of 1,176kN on the building is regarded as the vertical load; displacement corresponding to shear strain of $\gamma = \pm 100\%$ – $\pm 400\%$ relative to the total thickness of rubber is regarded.
