## SHAKE TABLE TESTING OF FIRE SPRINKLER PIPING SYSTEMS TYPICAL OF NEW ZEALAND PRACTICES

This paper describes the test setup and piping configuration. An initial set of results from the ongoing experimental program are presented and their implications for the design of sprinkler piping systems in New Zealand are discussed.

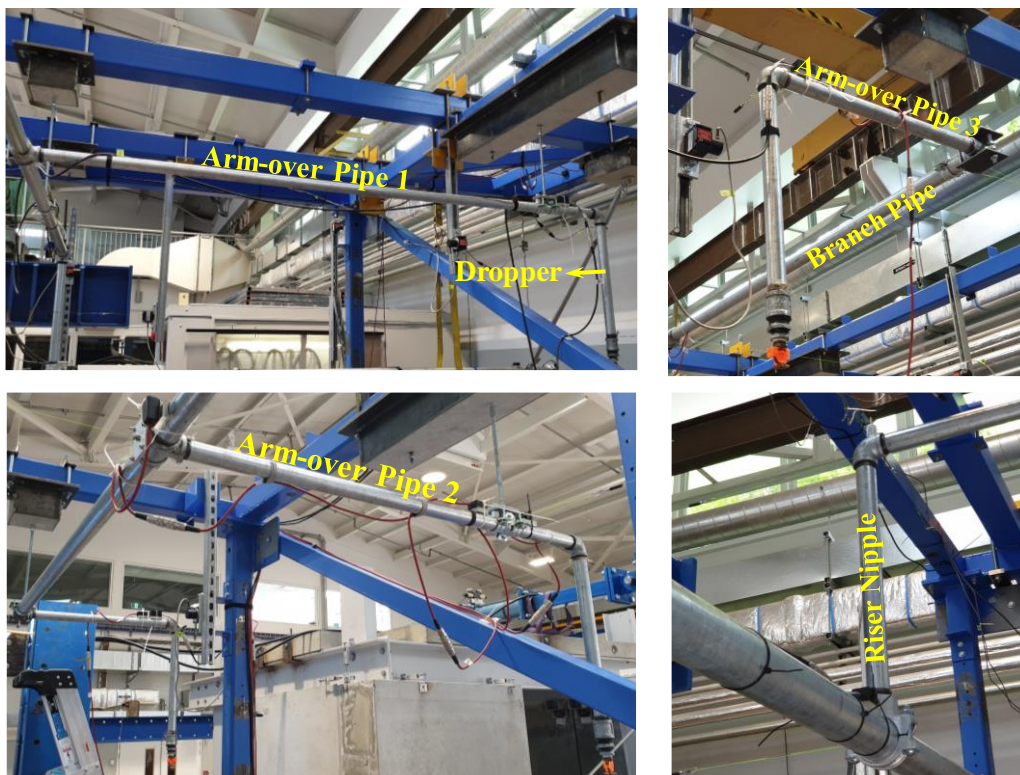
Fig. 4 – Different piping segments

The piping specimen consisted of a 6.5m distribution pipe connected to a branch pipe through a riser nipple and was 600mm below the branch pipe (Fig. 3). The branch pipe was further connected along its length to three arm-over pipes of different lengths: i) arm-over pipe 1 – 1950mm, ii) arm-over pipe 2 – 1150mm, and iii) arm-over pipe 3 – 600m (Fig. 4). 500mm long dropper pipes (rigid) were installed on all arm-over pipes. The reason for including three arm-over pipes and of different lengths is that the dropper extending from an arm-over pipe is the only component of the horizontal piping which is in direct contact with other elements such as ceiling panels and were observed to be of different lengths during surveys. Given that the current standard in New Zealand does not give sufficient guidance regarding the seismic

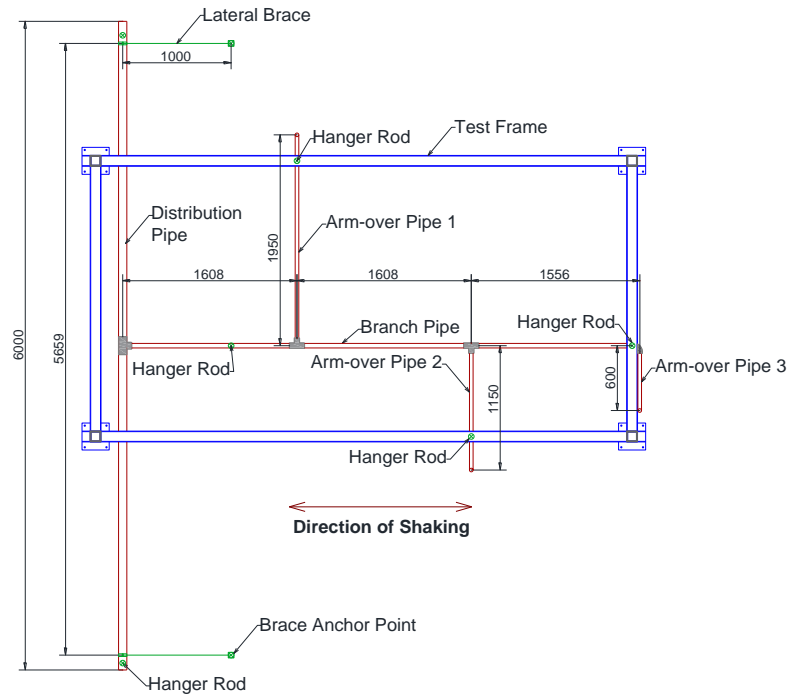
Fig. 5 – Test setup plan view

bracing of arm-overs, it was considered important to quantify the seismic demand on these pipes of typical lengths. The plan view of the specimen is shown in Fig. 5 below.

The distribution pipe was braced and provided with hanger rods for gravity support on both ends. The branch pipe had no lateral or longitudinal bracing and only had two hanger rods (Fig. 5). No arm-over pipe was braced in order to measure the maximum displacement demands on them. Arm-overs, 1 and 2, had hanger rods near their ends, while arm-over pipe 3 was left unsupported without any gravity support (commonly done in practice and is permitted by NZS 4541 [8]). The brace and hanger rod attachments used are shown in Fig. 6.

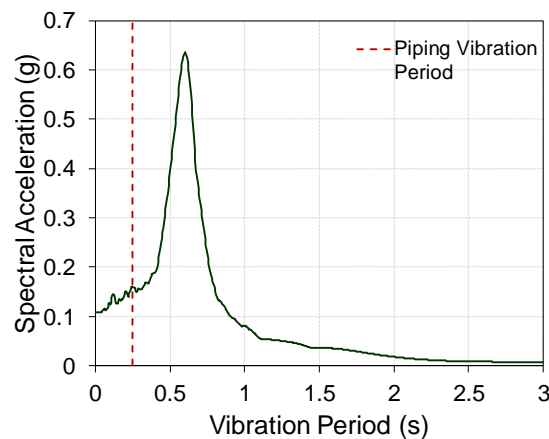
Fig. 7 – Response spectrum of input motion

The test specimen was subjected to a recorded floor acceleration response history of an instrumented eight story reinforced concrete shear wall building in New Zealand. The response spectrum of the input motion is shown in Fig. 7.

It is important to note here that the vibration period of the piping (0.25s) was not in proximity to the dominant period of the input motion (0.6s) as shown in Fig. 7. Therefore, the amplification results are only representative of cases where the piping system is not in resonance with the input floor excitation. This motion was chosen intentionally to study the response of the system under non-resonant conditions. Further testing involves subjecting the specimen to a motion where the piping system is in resonance with the input motion to study the response of the system under different possible excitations.

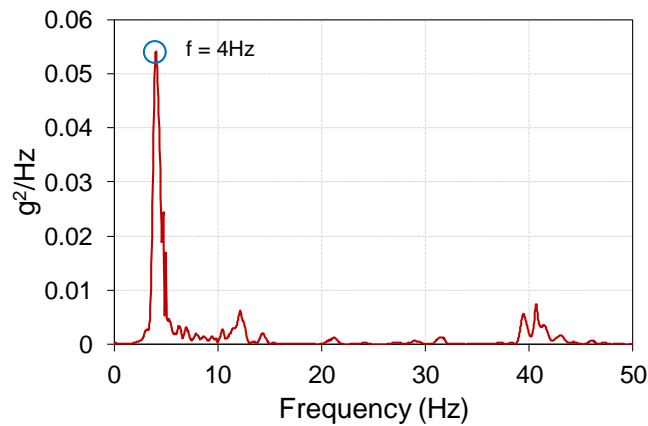
Fig. 8 – Power spectrum of distribution pipe acceleration

The piping natural frequency and damping were calculated using snap-back and white noise tests. The snap-back tests consisted of pulling the specimen from one end and then releasing it in order to set the specimen in free vibration. The lateral mode of vibration (along direction of shaking) has a natural frequency of 4.0Hz as shown by the power spectra (Fourier amplitude squared) in Fig. 8. The associated damping was calculated using the logarithmic decrement method and lied in the range between 4-5%.
