## OPTIMIZED SEISMIC STRENGTHENING STRATEGIES FOR A TYPICAL SPRINKLER-PIPING SYSTEM IN A HOSPITAL

Taking a sample sprinkler piping system in a medium-scale hospital as an example, this research aims to verify seismic strengthening strategies based on NFPA 13 to improve seismic performance of the fire protection sprinkler system in critical buildings. The design concepts, which include numerical analysis simulating original piping, design of input motion and test specimen, and strengthening strategy established based on the consideration of improving seismic performance of specific damage states were introduced. Meanwhile, preliminary results of shaking table tests for four strengthening strategies are discussed as well to propose a more applicable seismic design guideline for sprinkler piping system in Taiwan.

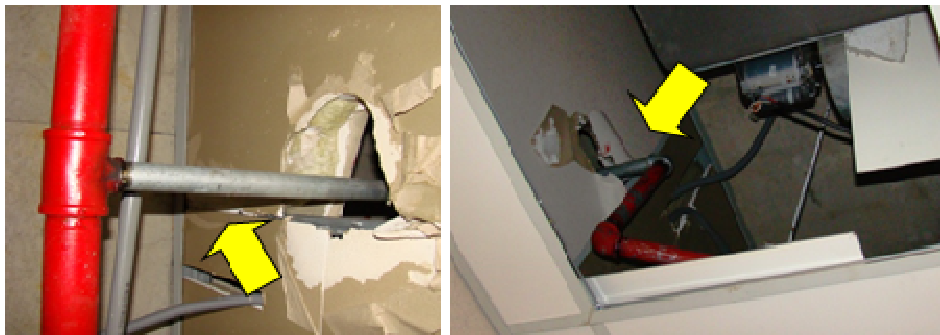
In recent years, the major disasters and economic losses in critical buildings in Taiwan caused by the earthquake have changed from structural to non-structural systems, which include piping systems. For instance, the leakage of the fire protection sprinkler systems in hospitals during small earthquakes could result in shortage of medical function and fire protection, and malfunction and repairs of medical equipment. The break of sprinkler systems caused by strong earthquakes could even harm the life safety. On 4 March 2010, a moderate-scale earthquake with magnitude  $M_L$  6.4 occurred at Jiaxian in Kaohsiung city, namely Jiaxian earthquake, and shook the southern Taiwan. A middle-scale hospital (hereinafter called the sample hospital), located at the Douliou City in Yunlin County, encountered strong ground motion with the peak acceleration between 80 gal and 250 gal. On the six floor in one of the buildings belonging to the sample hospital, almost half area is flooded after Jiaxian earthquake due to the leakage of suspended sprinkler piping system. As shown in Fig. 1, one-inch drop above a sickroom has been replaced after Jiaxian earthquake immediately due to the pressurized water aggravate the flood problem. Besides, it can be seen that the wall penetration was enlarged by the impact between sprinkler piping and the partition panel. Tears in partition walls and suspended ceiling panels adjacent to piping and sprinkler heads respectively were observed as well. In 2014, The damaged sprinkler piping system in the range of the sickroom in the sample hospital mentioned above was duplicated on the shaking table to identify the failure modes of piping [4]. From the results of the tests, the main cause of leakage was found to be the poor moment capacity of the screwed fitting of the one-inch drop. The movement of the one-inch pipe cannot be consistent with two-inch branch due to the constraint of the adjacent partition wall.

Fig. 1 – The damaged sprinkler drop in the sample hospital

Based on the shaking table test results, a screwed fitting of a 1" drop at the tee branch was the most vulnerable part of the damaged sprinkler piping system with the original configuration of the hospital during the 2010 Jiashian earthquake. Brittle failure associated with a screwed fitting and couplings was observed in the shaking table tests. The effectiveness of three types of seismic restraint devices for a sprinkler piping system, namely braces with well-designed attachments for main pipe, steel wires for branch lines, and flexible hoses for penetrations, were also tested. Although a seismic bracing can reduce the damage of adjacent architectural components, the optimum strategy to avoid leakages is to strengthen the main pipe with braces and to use flexible hoses near the tee branch to decrease both the shear and displacement demands on screwed fittings, or use braces and steel wires to limit the movement of main pipe and branch lines respectively. Based on the results of finite element analysis and component tests, simulate parameters of prototype and modified types of attachments under different loading directions are proposed for the application on seismic design of piping systems as well.

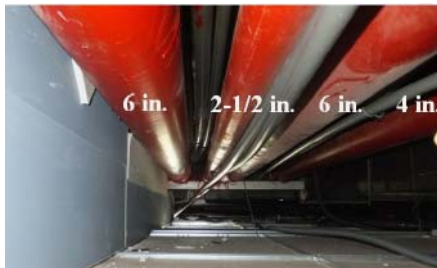
In the sample hospital, the main pipe of the southern part of the fire suppression system is T-shaped distributed along the corridor and the central elevator hall. Fig. 2 depicts the layout of the main pipe above the corridor ceiling. The four galvanized steel pipes size from left to right in the Fig. 2 are 6", 2-1/2", 6" and 4" are placed on the same trapezes. As shown in Fig. 3, although only 6" pipe belongs to the sample sprinkler system, another three ones are still counted into the numerical analysis to reflect the real mass and stiffness of piping. Boundary conditions of the piping system are also corresponding to in-situ observation, such as the location marked with a red circle in Fig. 3 is regarded as a fixed end of main pipe in the numerical model. Numerical model of the sprinkler-piping system in the example hospital was established for fragility analysis using SAP2000 v.20 software. . Fig. 3 depict the modal shape at the fundamental frequency in transverse

Fig. 2 – Piping layout in the corridor

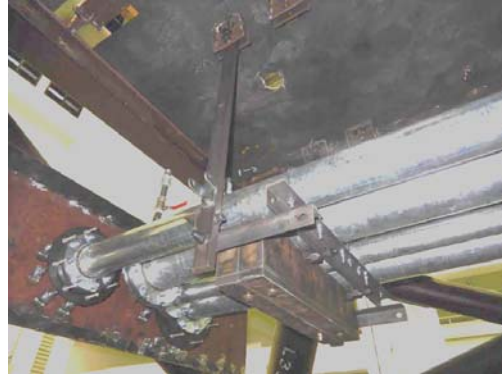
Fig. 8 – Boundary of test specimen
