## THE 2019 TOKYO METROPOLITAN RESILIENCE PROJECT E-DEFENSE TEST OF A 3-STORY DISASTER MANAGEMENT CENTER

### Abstract

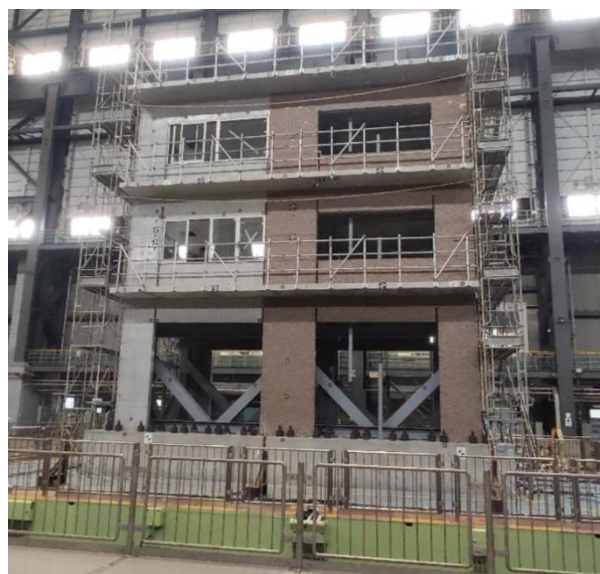
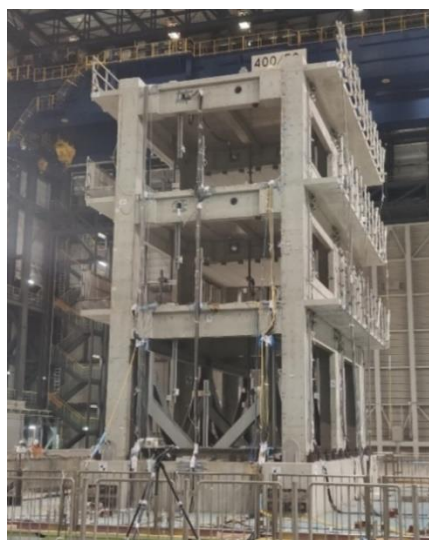
The RC specimen layout and dimensions are shown in Fig. 1. Spandrel wall elements were casted to be monolithic with the frame elements with 50 mm wide gaps present at hanging/standing wall ends on 2F and 3F (Fig. 2a) to ensure that plastic hinges form at intended locations and to prevent bar buckling failure. Similar detail was used for RF hanging-walls and 1F wing-wall bases, except that the gaps were filled with concrete to allow the walls to act in compression. The gap detailing had been tested previously [6,7], while the concrete filled-gap detailing was new. Reinforcing details of frame elements parallel to the loading direction are shown in Fig. 3. Note that reinforcing in the RF hanging-wall and 1F wing-wall base was terminated 50 mm before its ends, and that the lower reinforcing layer for B1 beams was also terminated before intersecting G2 and G3 beams. Details for other frame elements are available from Fukai et al [8].

Fig. 1 – Specimen layout; (a) in-plane elevation dimensions, (b) in-plane elevation photo, (c) out-of-plane elevation dimensions, (d) out-of-plane elevation photo, and (e) location and ID of components

- i) Windows on south-west bay on 2F and 3F (Fig. 1e);
- ii) Ceilings on west bay on 2F and 3F (Fig. 1e);
- iii) Exterior tiles on south-east bay over entire height (Fig. 1e); and
- iv) Piping on roof.

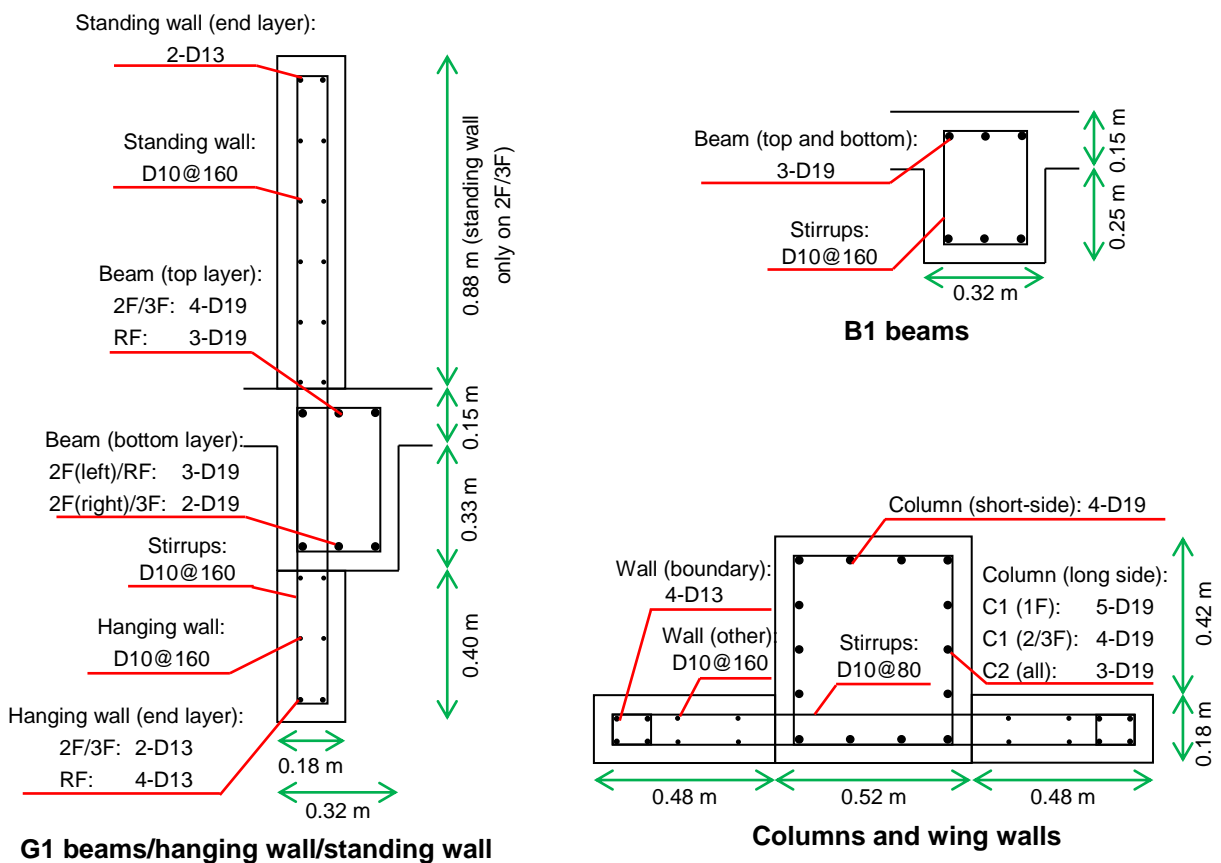
Fig. 3 – Cross section details

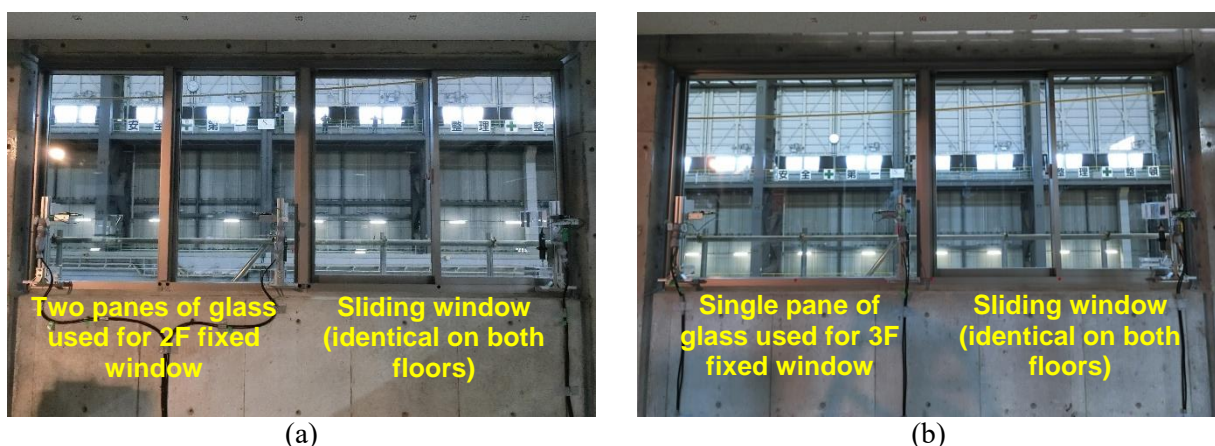
Two types of windows were installed in the building; fixed and sliding. The 2F fixed window used two panes of glass (Fig. 4a) while the 3F fixed window used a single pane (Fig. 4b). As the window sash used for both fixed windows were identical, the edge clearance is larger for the 2F fixed window and thus the drift capacity of the fixed window with two glass panes should be greater. The sliding windows were identical on both floors to observe the influence of drift demands on the seismic performance of sliding windows.

Fig. 4 – Window detailing; (a) two panes of glass used for 2F fixed window and (b) single pane of glass used for 3F fixed window

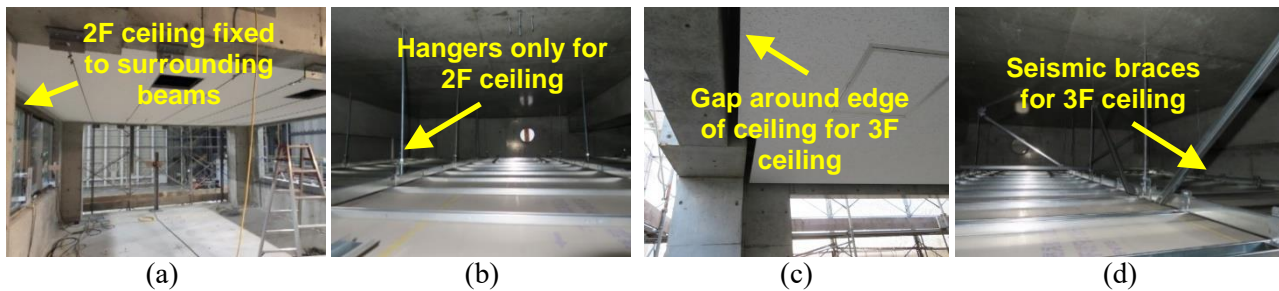
Two detailing variants were used for each non-structural component type; one being more seismically resilient than the other. With regards to ceilings, the one located on 2F (attached to 3F slabs) was fixed to the surrounding beams (Fig. 5a) without seismic bracing (Fig. 5b). The ceiling on 3F (attached to roof slab) had gaps around its edge (Fig. 5c) and was seismically braced (Fig. 5d). The latter ceiling was thought to be more seismically resistant and thus was installed where the acceleration demand was expected to be greater.

Fig. 5 – Ceiling detailing; (a) no gaps for 2F ceiling, (b) no seismic braces for 2F ceiling, (c) edge gaps for 3F ceiling, and (d) seismic braces for 3F ceiling

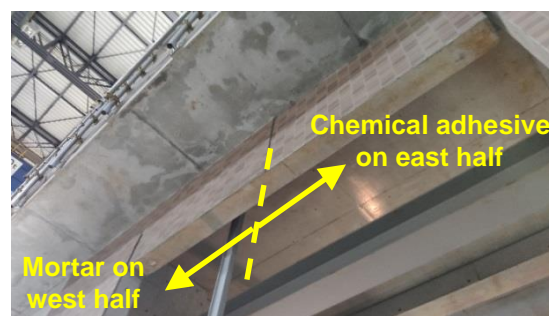
Two different materials were used to attach tiles to the south-east exterior bay; (a) mortar and (b) chemical adhesive. The mortar was applied over the western half of the bay, while the chemical adhesive was applied over the eastern half. The mortar layer was approximately 10 mm thicker, and thus a discontinuity of the tile surface could be observed as shown in Fig. 6. The chemical adhesive was more flexible than the mortar layer, and therefore the exterior tiles attached using the chemical adhesive were expected to remain attached to the frame at higher drift demands.

Fig. 6 – Tile detailing

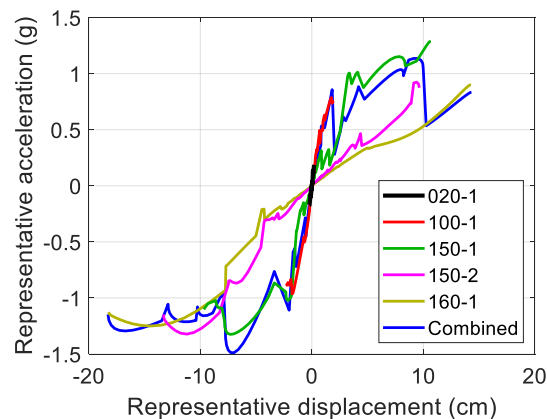
using modal analysis methods considering the displaced shape at each time-step, (iii) applying the Wavelet Transform Method and selecting ranks representing the predominant response, and (iv) obtaining the resultant “skeleton curve” from the representative acceleration-displacement response. The skeleton curve obtained from preliminary application of this approach using the experimental data is shown in Fig. 11.

The skeleton curves are useful in several ways. Firstly, the change in the “initial” period could be estimated based on the change of the initial slope with each excitation. Secondly, the overall building ductility demand could be estimated based on the ratio of peak representative displacement to estimated yield displacement. Thirdly, if a “safety limit” is known, one could assess how close the building is to reaching this safety limit, essentially providing an alternative to the damage evaluation procedure [10] followed previously. One important advantage is that this system can be applied in real-time, meaning that the safety of the building could be evaluated almost immediately. This can reduce the time and effort required to evaluate a building’s level of safety.

Fig. 11 – Derived capacity curves using WTM
