## Experimental Study on Separated Low Yield Point Steel Plate Wall with Slits

### Abstract

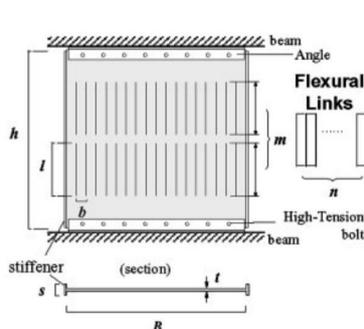
Fig.1 Steel plate wall with slits<sup>[1,2]</sup>

A steel plate shear wall with slits was proposed by Hitaka et al.(2003,2007) (see fig.1)[1-2].The basic concept of these walls is for the steel plate segments between the slits to behave as a series of flexural links,which undergo large flexural deformations relative to their shear deformations,to provide a fairly ductile response without the need for heavy stiffening of the wall.In this system,these walls are earthquake-resisting elements that are connected to moment frames by high-strength tension friction bolts.Strength and stiffness can be adjusted independently by changing the slit configuration such as interval,length and number of layers of slits.The wall is need not occupy the full beam span,thus accommodating door or window opening adjacent to the wall.Three buildings incorporating steel plate shear wall with slits have been constructed in Japan.However, the stiffness and bearing capacity of the wall are weakened by the slits.As in the two applications,the steel plate shear wall is designed to carry approximately 10% to 25% of the seismic base shear, with the balance being carried by the moment frames.

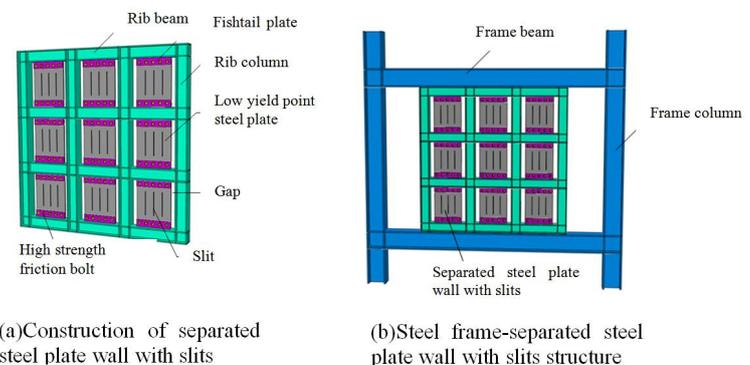
Fig.2 Separated low yield point steel plate wall with slits system

Based on the study of the above steel plate shear wall, the author proposes a new type of separated low yield point steel plate wall with slits[14],which is composed of steel frame lattice and embedded low yield point steel plate with slits(see fig.2).The steel frame lattice is composed of small ribbed beams and ribbed columns, and the embedded steel plate is scattered in several small steel lattices.Because of the small size of the steel plate, it is easy to meet the requirements of the steel plate to prevent buckling. Being different from the reinforced rib of the conventional stiffened steel plate shear wall, the ribbed beam and the ribbed column of the new steel plate walls are the main load-bearing components, and the function of the steel frame lattice effectively improves the lateral stiffness and horizontal bearing capacity of the steel plate wall, and can provide a certain vertical bearing capacity.The stiffness,bearing capacity and vibration characteristics of the walls can be adjusted by changing the configuration of the steel frame lattice.The objectives and scope of this paper is to verify the seismic performance of this new earthquake-resisting element through the quasi-static test.

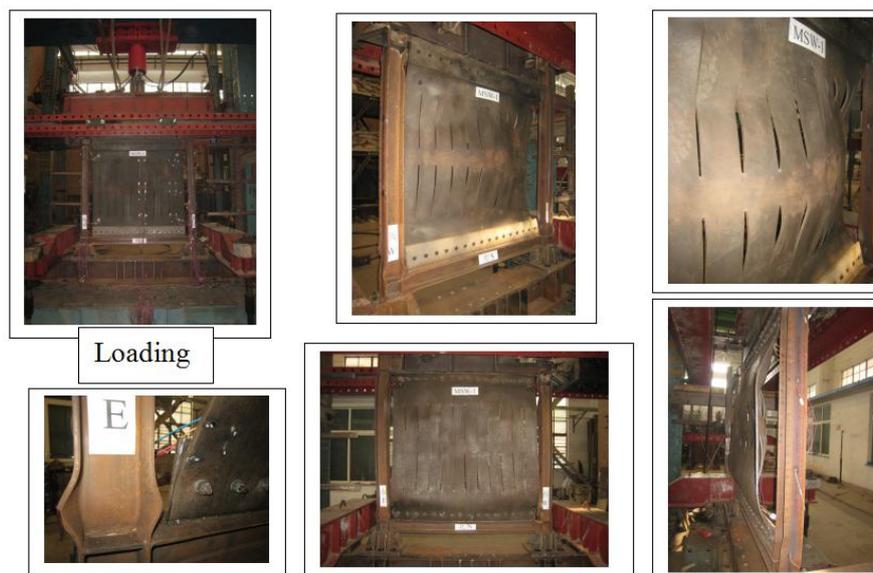
Fig.3 Failure state of specimen MSW-1

Firstly, the vertical load was applied to the top of the ribbed column with the axial compression ratio of 0.1. Secondly, the horizontal load was applied according to each stage 40kN, and each stage load was cycled once. When loaded to 240kN, the embedded steel plate yielded, the column foot of the ribbed column yielded, and the load displacement curve of the tracking record began to be nonlinear, which was determined that the deformation of the steel plate wall had entered the elastic-plastic stage, at this time, the displacement of the specimen was defined as the yield displacement of  $\delta_y=12\text{mm}$ . Subsequently, the loading was controlled by a multiple of the yield displacement, three cycles per stage. When loaded to 24mm, the embedded steel plate produced slight shear and bending deformation; when loaded to 36mm, the steel plate had obvious bending deformation, and the out-of-plane buckling appeared, and the strips of steel plate bulged out of the plane in a basin shape; when loaded to 48mm, the steel plate has appeared large out-of-plane buckling, and the basin-like deformation has been further developed, at this time, the specimen has reached the maximum ultimate bearing capacity of 275kN. With the further increase of the load, when loaded to 60mm, the external buckling of the steel plate was serious, but the whole frame lattice of the specimen remained deformed in the plane; when loaded to 72mm, the basin-like deformation of the steel plate continued to develop, and a certain buckling occurred at the flange of the rib column; when loaded to 80mm, the steel plate basin-like deformation was further developed, and the buckling of the flange of the rib column foot was further increased; when loaded to 96mm, the steel plate basin-like deformation was larger, and the rib column foot formed a plastic hinge, it was considered that the specimen has reached the failure loading and the test stopped, and the top storey draft angle of the specimen has reached 6.0%, the ductility coefficient was  $\delta / \delta_y=8$ . The failure state of the specimen MSW-1 is shown in fig.3.

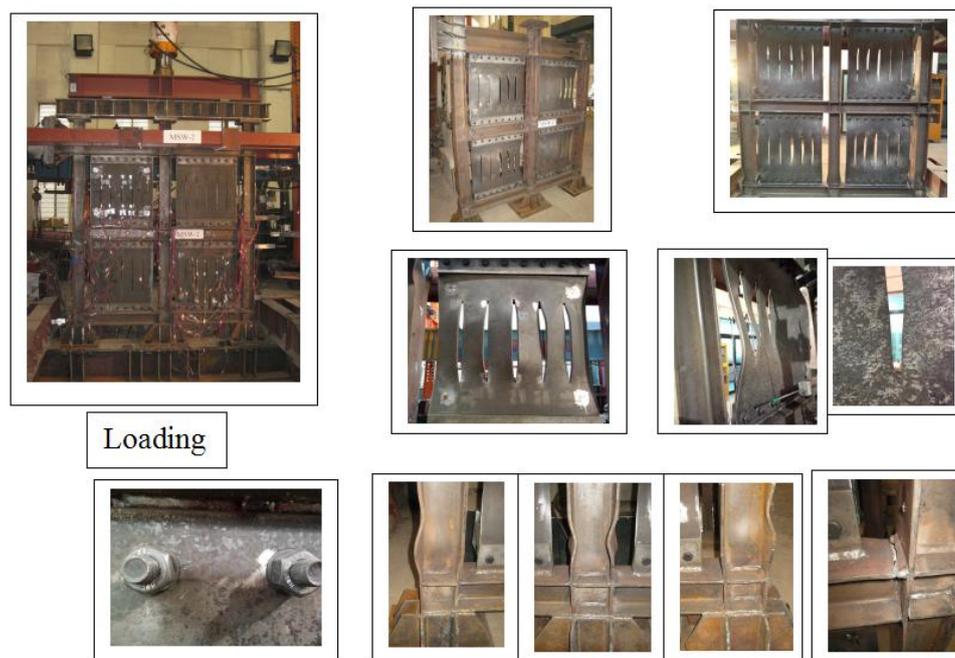
Fig.4 Failure state of specimen MSW-2

Firstly, the vertical load was applied to the top of the ribbed column with the axial compression ratio of 0.07. Secondly, the horizontal load was applied according to each stage 20kN, one cycle per stage. When loaded to

300kN, the embedded steel plate yielded entirely, the end of ribbed beam and the bottom of ribbed column yielded, and the load displacement curve of the tracking record began to be nonlinear, at which time the displacement of the specimen was defined as the yield displacement being  $\delta_y = 12\text{mm}$ . Subsequently, the loading was controlled by a multiple of the yield displacement, three cycles per stage. When loaded to 24mm, the embedded steel plate had slight shear and bending deformation; when loaded to 36mm, the steel plate had obvious shear and bending deformation; when loaded to 48mm, steel plate presented a series of bending deformation of the strips and a certain out-of-plane deformation occurred, at which time the specimen has reached the maximum ultimate bearing capacity of about 450kN. When loaded to 60mm, the out-of-plane deformation of the steel plate was further increased, and the edge rib column had a certain bending deformation; when loaded to 72mm, the out-of-plane deformation of the steel plate was more severe and bulged out of the plane, showing a basin shape. A crack appeared at the weld seam of the middle rib beam and the edge rib column, and the tear gradually occurred during the subsequent loading process. When loaded to 84mm, the basin-like deformation of the steel plate further developed and the vertical slits opened; when loaded to 96mm, the shear failure occurred at the weld of the middle rib beam and the side rib column, and the plastic angle appeared at the foot and the top of the rib column, it was considered that the specimen has reached the failure load and stopped the test, and the top storey draft angle of the specimen has reached 6.0%, the ductility coefficient was  $\delta / \delta_y = 8$ . The failure state of the specimen MSW-2 is shown in fig.4.

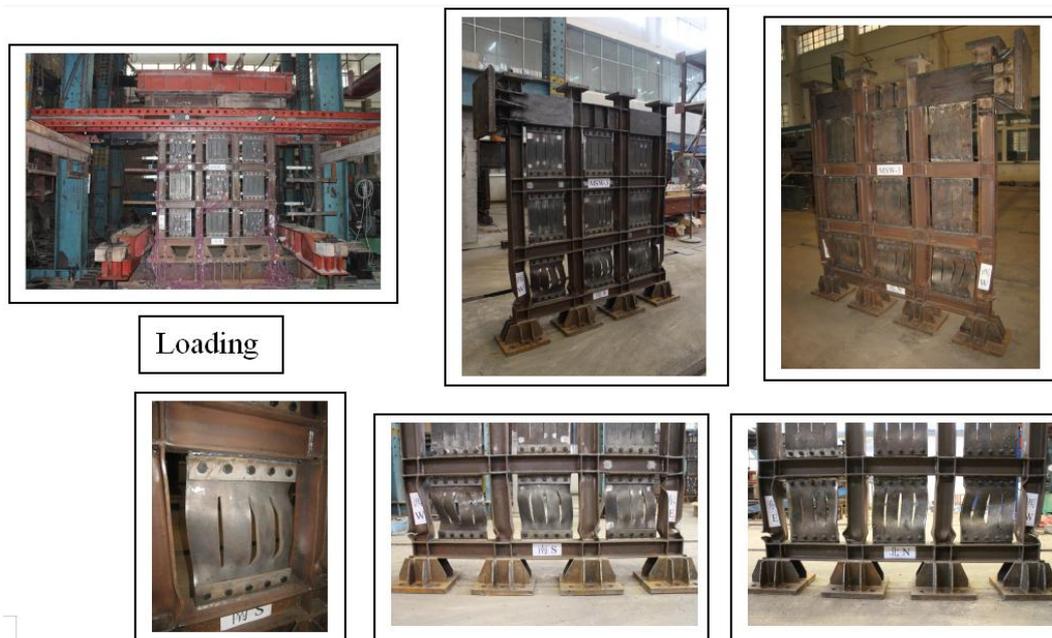
Fig.5 Failure state of specimen MSW-3

Firstly, the vertical load was applied to the top of the ribbed column with the axial compression ratio of 0.05. Secondly, the horizontal load was applied according to each stage 80kN, one cycle per stage. When loaded to 400kN, the embedded steel plate yielded, the end of the bottom ribbed beam and the foot of the bottom ribbed column yielded, and the load displacement curve of the tracking record began to be nonlinear, at which time the displacement of the specimen was defined as the yield displacement, being of  $\delta_y = 12\text{mm}$ . Subsequently, the loading was controlled by a multiple of the yield displacement, three cycles per stage. When loaded to 24mm, the embedded steel plate has no obvious deformation; when loaded to 36mm, the steel plate produced a slight shear deformation; when loaded to 48mm, the steel plate in the bottom frame lattice presented a certain bending deformation, and there was no obvious out-of-plane buckling; when loaded to 60mm, the

steel plate of the bottom frame lattice showed obvious bending deformation, the embedded steel plate of the upper frame lattice had obvious shear deformation, and the slip phenomenon appeared between the embedded steel plate and the bolt. When loaded to 72mm, the steel plate of the bottom frame lattice showed a certain out-of-plane buckling, but the steel plate of the upper frame lattice had no out-of-plane buckling, the flange of the middle rib beam as well as the flange of the rib column foot had certain buckling deformation; when loaded to 84mm, the strip of the steel plate of the bottom frame lattice bulged out of the plane and was basin-like, while the steel plate of the upper frame lattice had only slight out-of-plane buckling; at this time the specimen reached the maximum ultimate bearing capacity of about 670kN. When loaded to 96 mm, the basin-like deformation of the steel plate in the bottom frame lattice was further developed, while the steel plate in the upper frame lattice had only a certain out-of-plane buckling, the column foot of the bottom ribbed column formed a plastic hinge, and the overall frame of the specimen remained as in-plane deformation without buckling instability. When loaded to 108mm, the bottom frame lattice of the specimen was deformed seriously, and the flange of the column foot of the edge ribbed column appeared to tear as pulling direction, it was considered that the specimen has reached the failure load, and the test was stopped, and the top storey draft angle of the specimen reached 6.75%, the ductility coefficient was  $\delta / \delta_y = 9$ . The failure state of the specimen MSW-3 is shown in fig.5.

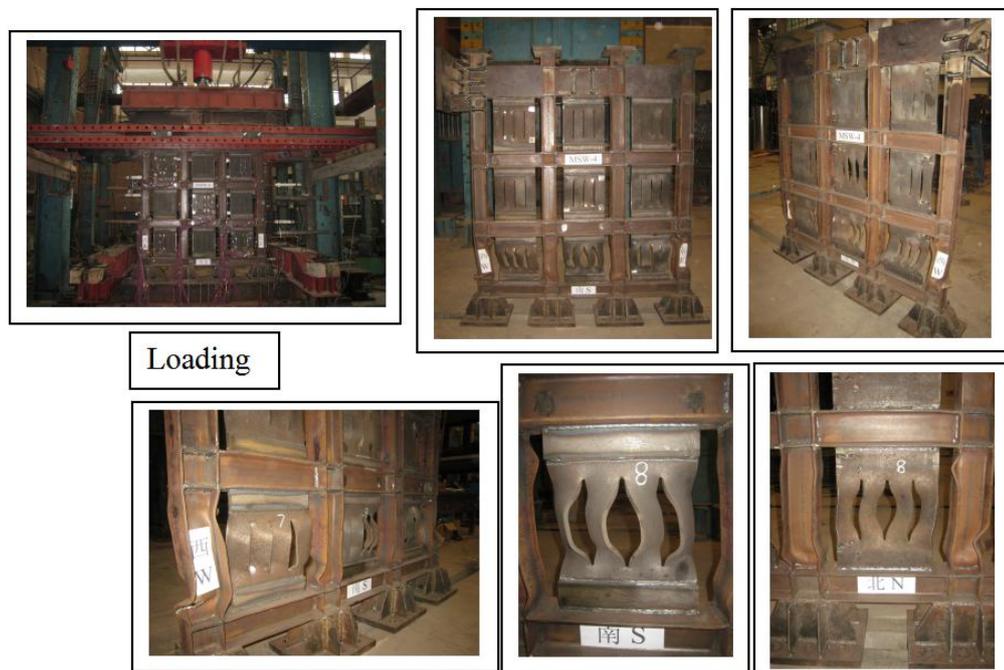
Fig.6 Failure state of specimen MSW-4

Firstly, the vertical load was applied to the top of the ribbed column with the axial compression ratio of 0.05. Secondly, the horizontal load was applied according to each stage 80kN, one cycle per stage. When loaded to 400kN, the embedded steel plate yielded, the end of the bottom ribbed beam and the foot of the bottom ribbed column yielded, and the load displacement curve of the tracking record began to be nonlinear, at which time the displacement of the specimen was defined as the yield displacement, being of  $\delta_y = 10$ mm. Subsequently, the loading was controlled by a multiple of the yield displacement, three cycles per stage. When loaded to 20mm, the embedded steel plate had no obvious deformation; when loaded to 30mm, the steel plate presented a certain shear and bending deformation; when loaded to 40mm, the band bending deformation of the steel plate of the bottom frame lattice increased, but the steel plate in the second and third frame layers was still dominated by shear deformation; when loaded to 50mm, the strip of the steel plate inside the bottom frame lattice presented large bending deformation and obvious out-of-plane buckling, while the

steel plate of the upper frame lattice did not see obvious out-of-plane buckling, at this time, the specimen reached the maximum ultimate bearing capacity of about 680kN; when loaded to 60mm, the bending deformation and out-of-plane buckling of the steel plate strip in the bottom frame lattice were further increased; when loaded to 70 mm, the steel plate in the upper frame lattice also produced a certain bending deformation and out-of-plane buckling, and plastic buckling deformation appeared at the flange of the upper and lower ends of the bottom ribbed column; when loaded to 80mm, the bottom frame lattice embedded steel plate appeared a large basin-like out-of-plane buckling, and the flange and web at the upper and lower ends of the bottom frame lattice ribbed column were torn, to prevent the specimen from collapsing and protect the instrument, the loading was stopped, and the top storey draft angle was 5%, the ductility coefficient was  $\delta / \delta_y = 8$ . The failure state of the specimen MSW-4 is shown in fig.6.

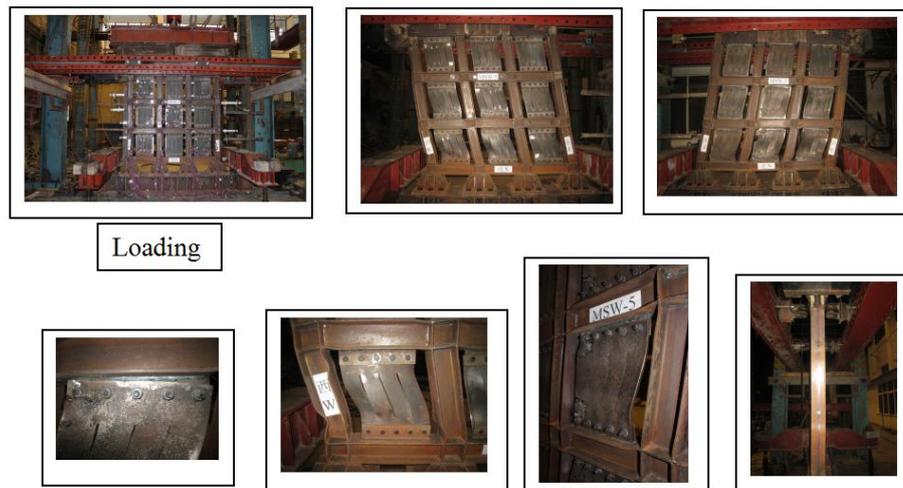
Fig.7 Failure state of specimen MSW-5

Firstly, the vertical load was applied to the top of the ribbed column with the axial compression ratio of 0.05. Secondly, the horizontal single-pull load was applied according to each stage 80kN, and each stage load was applied once. When loaded to 400kN, the embedded steel plate yielded, the end of the bottom ribbed beam and the foot of the bottom ribbed column yielded, and the load displacement curve of the tracking record began to be nonlinear, at which time the displacement of the specimen was defined as the yield displacement, being of  $\delta_y = 12\text{mm}$ . Subsequently, the single-pull loading was controlled by a multiple of the yield displacement, one time per stage. With the increasing of horizontal single-pull loading, the embedded steel plate was gradually transformed from shear deformation to bending deformation of strips, and the bolts appeared a certain slip phenomenon. When pulled to 240mm, limited by the equipment, stopped the test. In the end, the top storey draft angle of the specimen reached 15.0%, the ductility coefficient was  $\delta / \delta_y = 20$ , while the ultimate bearing capacity reached 734kN, and the whole frame of the specimen was still maintained in the plane deformation without instability, showing good ductility. The failure state of the specimen MSW-5 is shown in fig.7.

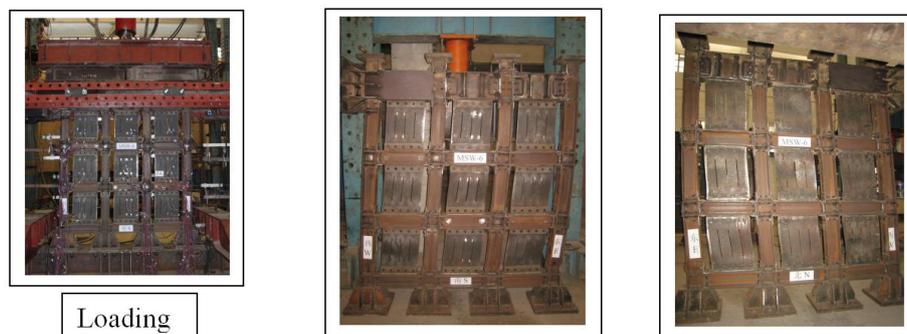
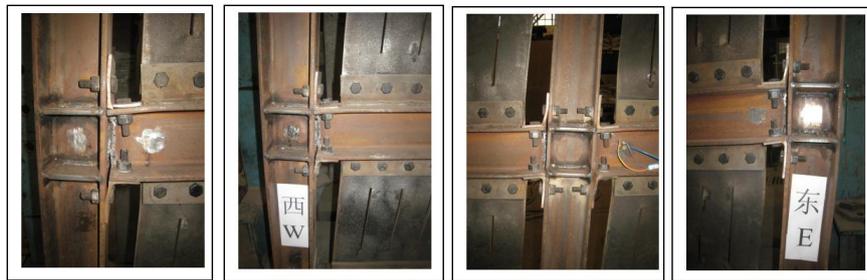
Fig.8 Failure state of specimen MSW-6

Firstly, a vertical load with an axial compression ratio of 0.05 was applied to the top of the ribbed column. Secondly, the horizontal load was applied at each stage of 80kN, one cycle per stage. When loaded to 400kN, the embedded steel plate yielded, the end of the bottom ribbed beam and the foot of the bottom ribbed column yielded, and the load displacement curve of the tracking record began to be nonlinear, at which time the displacement of the specimen was defined as the yield displacement, being of  $\delta_y = 15\text{mm}$ . Subsequently, the loading was controlled by a multiple of the yield displacement. When cyclic loading to 30mm, the embedded steel plate had no obvious deformation; when cyclic loading to 45mm, the steel plate produced a slight shear deformation. When cyclic loading to 60mm, the steel plate had obvious shear and bending deformation; when cyclic loading to 75mm, the bending deformation of the steel plate was further increased, and after one cycle of the 75mm, the angle steel at the connection between the rib beam and the rib column was broken and then changed to single-push loading. When pushed to 120mm, the embedded steel plate presented the larger bending deformation of the strips, the column foot of the bottom ribbed column formed the plastic hinge, and the test stopped. Finally, the ultimate bearing capacity of the specimen was 585kN, and the top storey draft angle of the specimen reached 7.5%, the ductility coefficient was  $\delta / \delta_y = 8$ . During the whole loading process, the bolt did not appear obvious slip, and the fishtail plate and bolt were basically intact. Except for one bolt connection fracture failure, the other bolts connection between the ribbed beam and the ribbed column were well, and the deformation coordination performance between the embedded steel plate and the frame lattice was good. The failure state of the specimen MSW-6 is shown in fig.8.

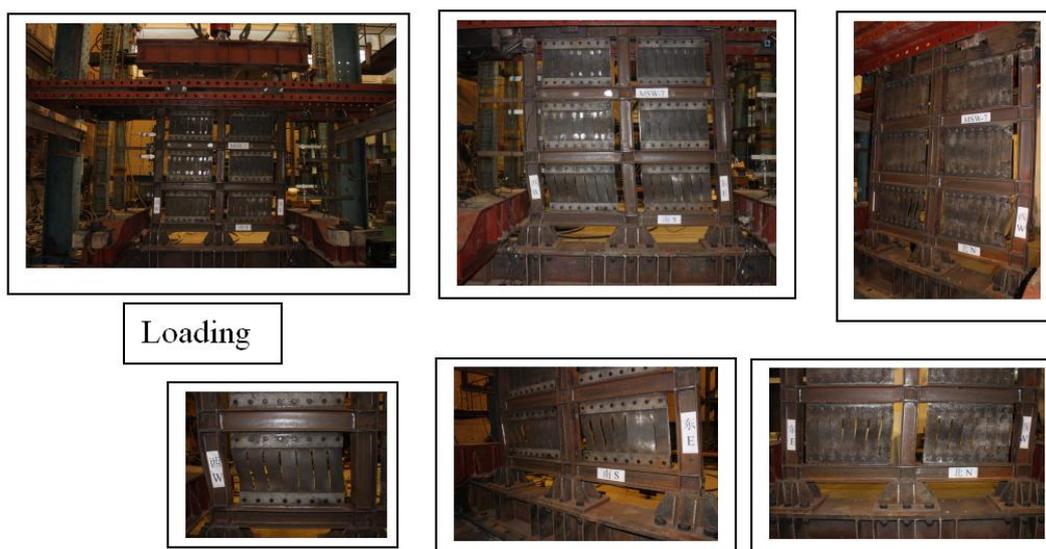
Fig.9 Failure state of specimen MSW-7

Firstly, a vertical load with an axial compression ratio of 0.07 was applied to the top of the ribbed column. Secondly, the horizontal load was applied according to each stage 80kN, one cycle per stage. When loaded to 400kN, the embedded steel plate yielded, the end of the bottom ribbed beam and the foot of the bottom ribbed column yielded, at which time the displacement of the specimen was defined as the yield displacement, being of  $\delta_y = 10\text{mm}$ . Subsequently, the loading was controlled by a multiple of the yield displacement. When cyclic loading to 20mm, the embedded steel plate had no obvious deformation; when cyclic loading to 20mm, the steel plate inside the bottom frame lattice produced a slight shear deformation; when cyclic loading to 30mm, the bottom steel plate had obvious shear deformation; when cyclic loading to 40 mm, the bottom steel plate showed a certain bending deformation; when cyclic loading to 50mm, as the positive direction (push direction) was loaded, the web of the top beam underwent local buckling instability, and then loading was changed to a single pull. When pulled to 112mm, the bottom frame lattice was seriously deformed, the bottom steel plate strip presented a large bending deformation, and the column foot produced plastic buckling deformation, which was considered that the specimen was destroyed and the test was stopped. In the end, the ultimate bearing capacity of the specimen was about 670kN, the top storey draft angle of the specimen reached 7.0%, the ductility coefficient was  $\delta / \delta_y = 11$ , and the steel plate wall did not appear obvious out-of-plane buckling. The failure state of the specimen MSW-7 is shown in fig.9.

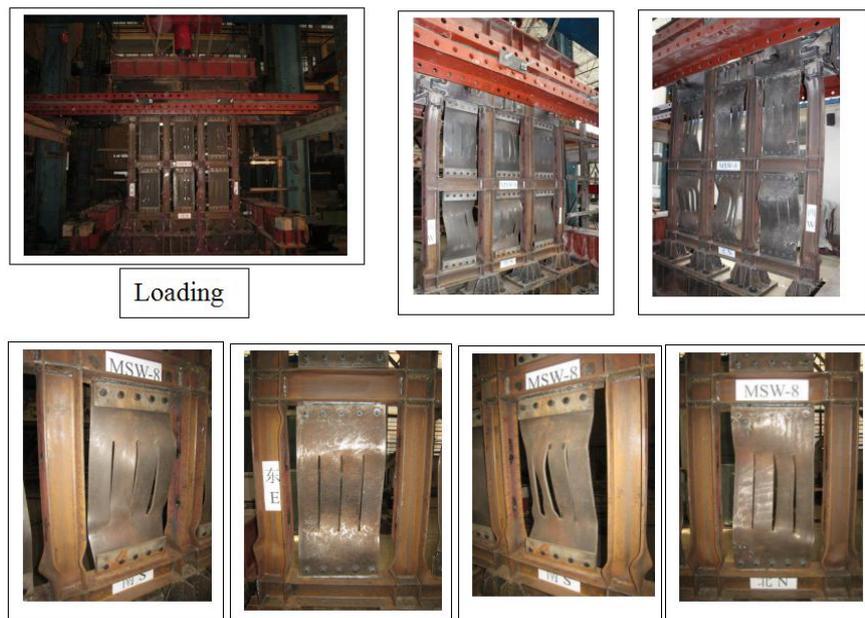
Fig.10 Failure state of specimen MSW-8

Firstly, the vertical load with the axial compression ratio of 0.05 was applied to the top of the ribbed column. Secondly, the horizontal load was applied according to each stage 80kN, one cycle per stage. When loaded to 320kN, the embedded steel plate yielded, the end of the bottom ribbed beam and the foot of the bottom ribbed column yielded, and the load displacement curve of the tracking record began to be nonlinear, at which time the displacement of the specimen was defined as the yield displacement, being of  $\delta_y = 15\text{mm}$ . Subsequently, the loading was controlled by a multiple of the yield displacement, three cycles per stage. When loaded to 30mm, the embedded steel plate has no obvious deformation; when loaded to 45mm, the steel plate had obvious shear and bending deformation; when loaded to 60mm, the strip of the steel plate presented a large bending deformation, and the specimen has reached the ultimate bearing capacity of 493kN; when loaded to 75mm, the bending deformation of the steel plate was further developed; when loaded to 90mm, the steel plate showed a certain out-of-plane buckling; when loaded to 105mm, there was a large plastic deformation at the column foot of the rib column, and the fracture failure occurred at the weld between the middle rib beam and the edge rib column, but the whole frame of the specimen was still maintained in the plane; when loaded to 120mm, the column foot of the ribbed column formed a plastic angle, and the bending deformation of the steel plate strips developed fully, and there were certain out-of-plane buckling of the steel plate. At this time, the top storey draft angle of the specimen reached 7.5%, the ductility coefficient was  $\delta / \delta_y = 8$ , which is considered that the specimen had reached the failure load and stopped the test. The failure state of the specimen MSW-8 is shown in Fig. 10.

As above, the failure order of each specimen, first was the embedded steel plate, then was the rib beam, the rib column, the last was the column foot of the rib column to form the plastic angle, which could be graded to destroy, graded to release energy, showing a reasonable energy dissipation mechanism and failure mode. During the whole loading process, the deformation coordination performance between the embedded steel plate and the frame lattice was good. The function of frame lattice effectively prevented or delayed the out-of-plane buckling of the embedded low yield point steel plate, and greatly improved the ultimate bearing capacity of steel plate wall. Despite the local out-of-plane buckling of the steel plate during the large displacement control loading, the overall frame of the specimen has always been kept deformed in the plane, and there was no obvious degradation of strength and stiffness of the specimen as well as sudden collapse phenomenon, showing

good stability. Since shear steel plate was transformed into a series of bending strips due to the slits, providing a large ductility, coupled with the steel frame lattice, the plate steel wall has good ductility, which the top storey draft angle of the specimen has reached more than 5%, and the ductility coefficient has reached more than 8.

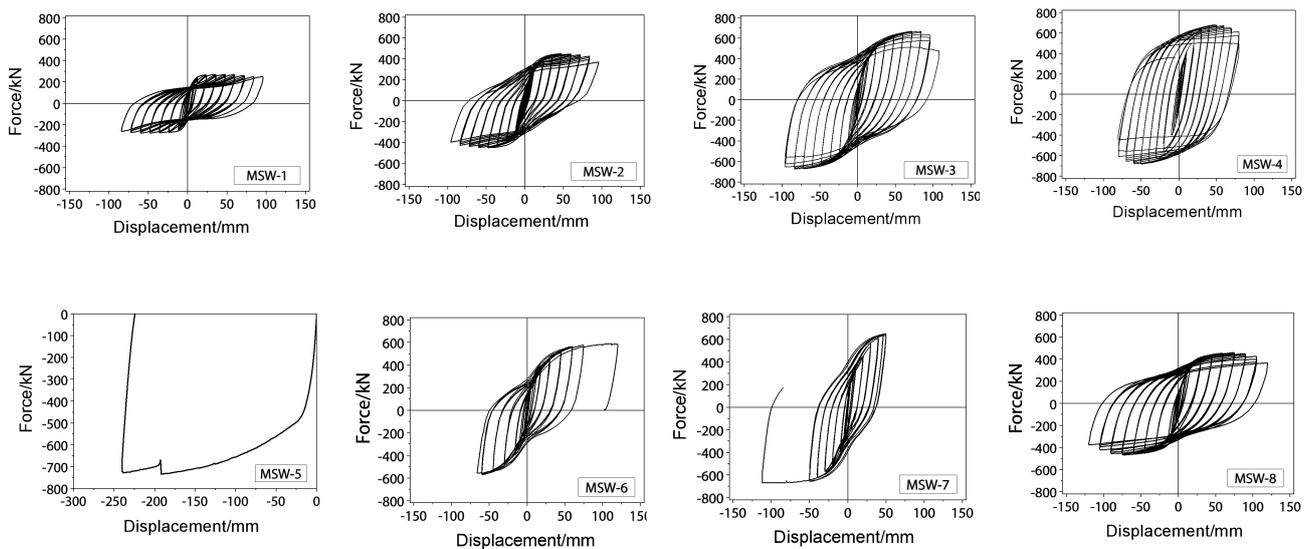
Fig.11 Hysteresis curves of specimens

Figure 11 shows that the shape of the hysteresis curve of specimens is full, indicating that the separated low yield point steel plate wall with slits has a strong energy dissipation capacity. For the specimens MSW-1, MSW-2, MSW-3, MSW-6, MSW-7 and MSW-8, the connection of the embedded steel plate with the ribbed beam was bolted, during the control loading process, the bolt would slip somewhat, resulting in a certain pinch slip phenomenon in the hysteresis curve. However, with the increasing of the number of ribbed beams and ribbed columns, the pinch slip phenomenon of the specimen was reduced. Since the embedded steel plate in the specimen MSW-4 was welded with the fishtail plate, there was no slip, which the hysteresis curve was more full. The load-displacement skeleton curves of specimens are shown in figure 12, the existence of the frame lattice, and the increasing in the number of ribbed beams and ribbed columns, which greatly improved the initial stiffness and ultimate bearing capacity of the specimens. Figure 13 is the energy dissipation value of the specimens, the frame lattice effectively prevented or delayed the out-of-plane buckling of the embedded steel plate, which made the embedded low yield point steel plate energy dissipation sufficient, and greatly improved the energy dissipation capacity of the steel plate wall.
