LARGE SCALE EXPERIMENTAL INVESTIGATION OF SPECIAL MOMENT RESISTING CONNECTIONS IN STEEL PLATE SHEAR WALLS

R. Purba⁽¹⁾, M. Moestopo⁽²⁾

Abstract

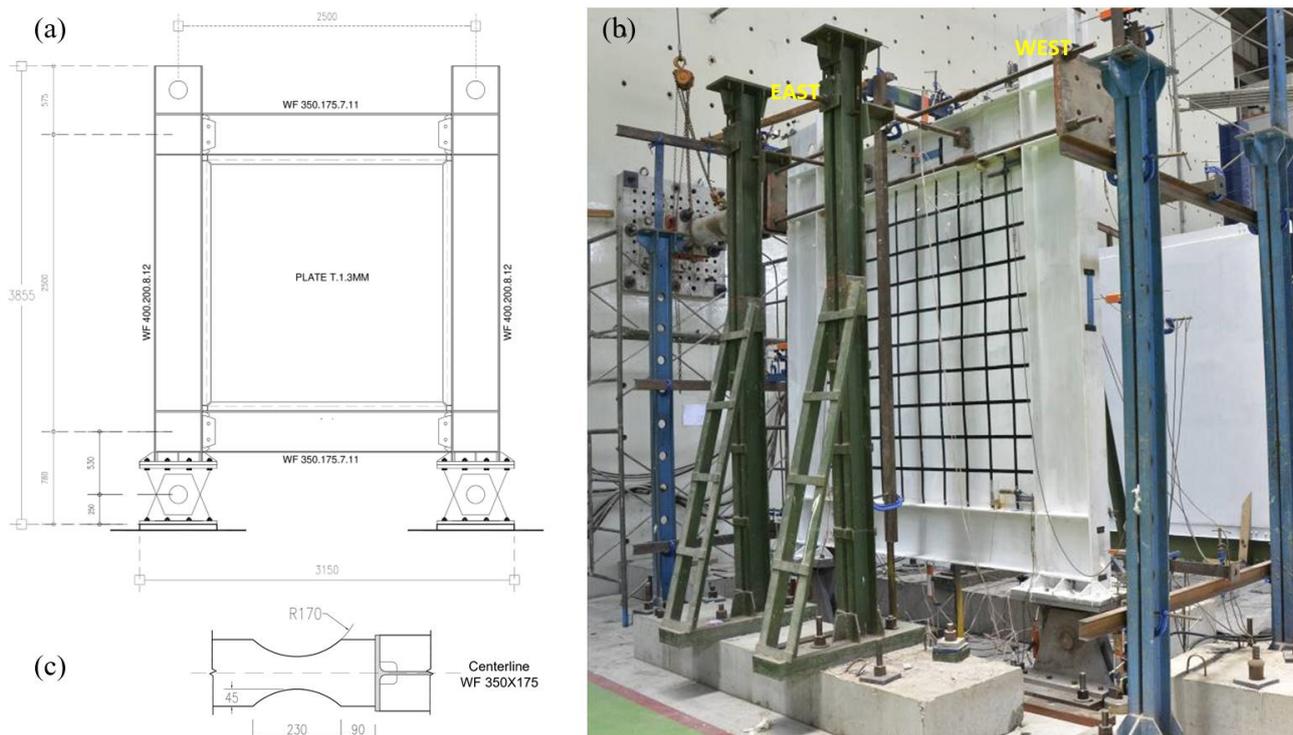
Fig. 1 – SPSW Specimen: (a) Elevation View; (b) Experimental Setup; (c) RBS Detail

special moment resisting connections specified in the AISC 358-16 documents [13] were considered. The WUF-W type connection was designed for all four HBE-to-VBE connections in the first SPSW specimen (WUF-W Specimen), while that in the second specimen, the RBS type connection was used (RBS Specimen). Detail dimensions of RBS is shown in Fig. 1(c).

Fig. 1(b) shows a photograph of experimental setup in the PUSKIM facility. The specimen was positioned in the East to West direction, supported by two hinges at the base of columns similar to that in [7], fastened to a 650×650×50 mm base plate using eight 19 mm diameter bolts on each column, and then anchored to the 1 m thick concrete strong floor using 4 high strength tension rods at each column. The clevis hinge center point was 530 mm from the centerline of the bottom beam.

An existing “belt” consists of four high strength tension rods and a connecting plate at each end of the rods was utilized for each experimental program. When the rods fastened, the belt clamped the specimen at the level of top beam to simulate simultaneous lateral displacement between East and West columns as in the case of a rigid floor. One static hydraulic actuator was then attached to the East connecting plate to laterally load the specimen. Two existing framings on each side of the specimen were used to provide lateral supports to the specimen with rollers touched the top beam at two locations, as shown in Fig. 1(b).

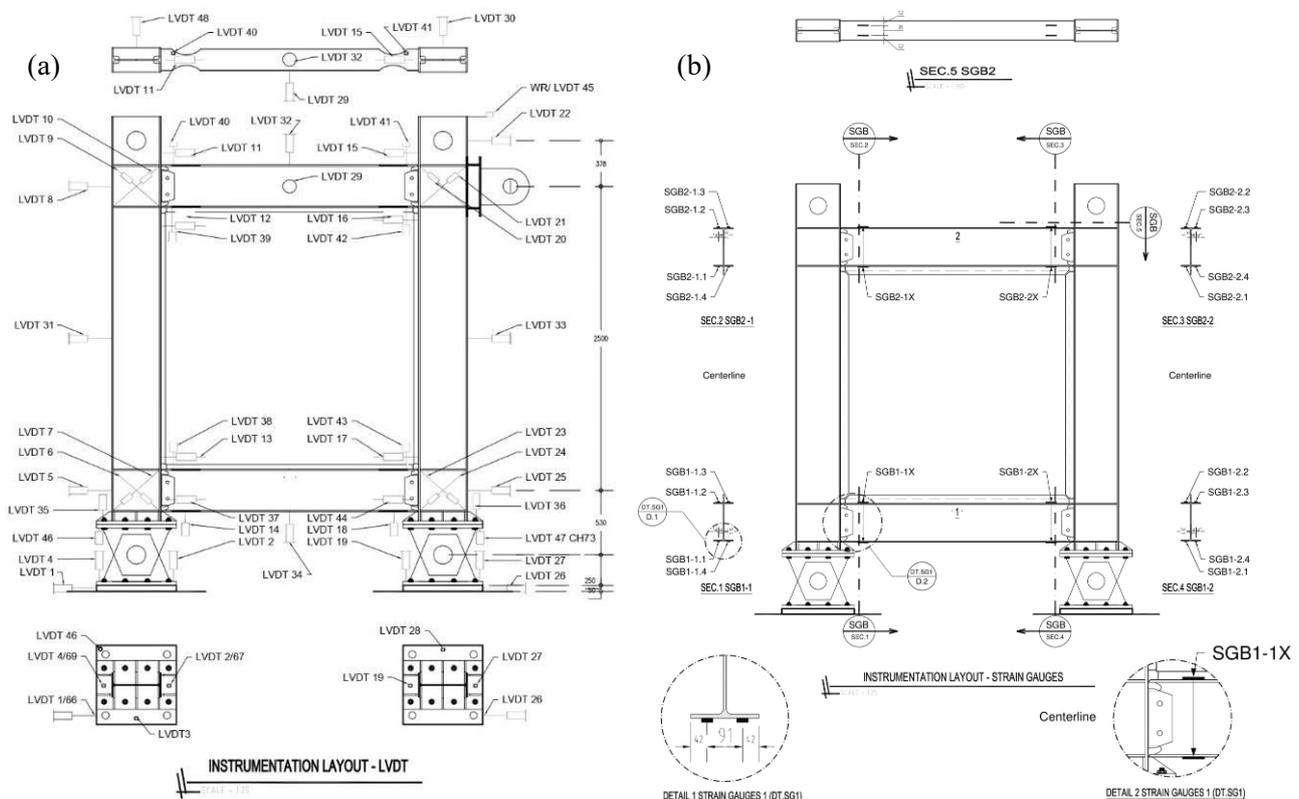
Fig. 2 – Instrumentation Layout: (a) Displacement Transducers; (b) Uniaxial Strain Gauges

Fig. 2(a) shows instrumentation layout for the displacement transducers. The transducers provided various measurements including lateral displacements at the centerline of the top and bottom beams as well as at the mid-high of the left and right columns, panel zone deformations, beam-to-column joint rotations, out-of-plane displacement, and uplifts at the pin supports. Instrumentation layout for uniaxial strain gauges is shown in Fig. 2(b). A group of four strain gauges measured strains at expected plastic hinge locations, 205 mm from the face of columns.

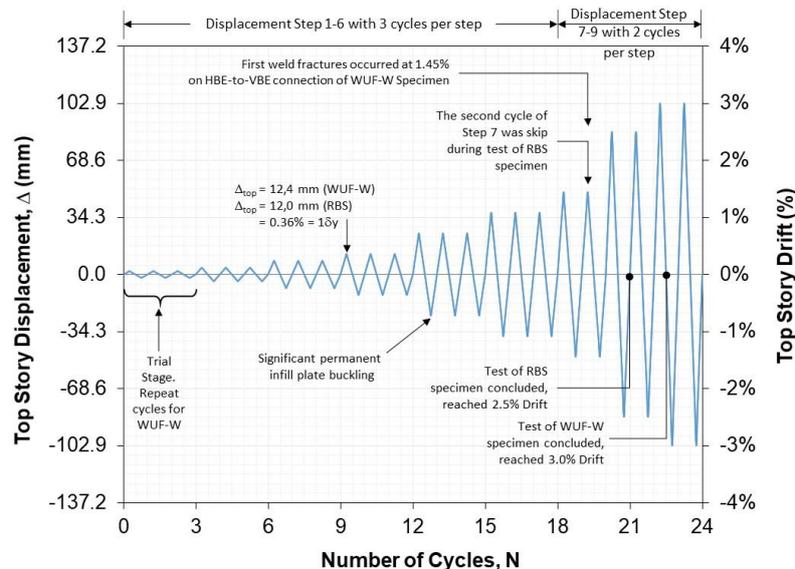
Fig. 3 – Cyclic Displacement Loading History

The tests were carried out in a displacement-control quasi-static cyclic loading. The initial three displacement steps were $1/6$, $1/3$, and $2/3$ of the estimated effective yield displacement. The specimens were

cycled three times for each displacement step. After this point, the maximum target displacements were increased by multiples of δ_y until reaching an estimated ductility of three. Afterward, the target displacements continued to increase by an estimated ductility of four, but the number of cycles was decreased to two cycles. Beyond this point, the target amplitudes were increased by drift increments until reaching 2.5% and 3.0%, consecutively. Fig. 3 shows a typical loading protocol for these experimental programs, with a total of 9 displacement steps and a cumulative 24 cycles to be applied to the specimen.

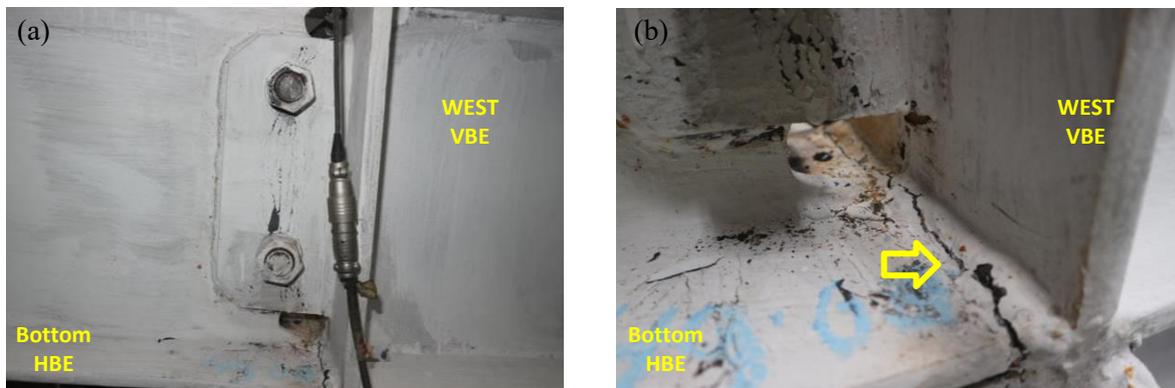
Fig. 4 – Specimen Condition During Step 7 (1.45% drift $= 4\delta_y$): (a) Shear Tab Yielding; (b) Weld fractures

The experimental program continued to a higher displacement target of 49.7 mm ($= 1.45\%$ drift $= 4\delta_y$) for 2 cycles. During the first cycle of this displacement Step 7, flange local buckling and yielding of shear tabs (Fig. 4a) were observed at the WUF-W connections. At the end of the second cycle, however, fracture was observed at the West connection of the bottom beam (Fig. 4b). While flaking of whitewash was noted on the infill plate, no plate tearing was observed up to this point. The resulting peak base shears when cycling at 1.45% drift amplitude were 527 and 749 kN for the pushing (West) and pulling (East) excursions, respectively. Yielding around the shear tabs and flaking of whitewash on the infill plate spread to a larger area when the specimen was pushed to a higher displacement target of 85.8 ($= 2.5\%$ drift $= 6.9\delta_y$) in Step 8. In addition, flange local buckling increased (Fig. 5a) and fractures of moment connections were observed at continuity plates on panel zones (Fig. 5b) and at shear tabs (Fig. 5c) The hysteretic curve showed minor strength degradation when pushed in the West direction with recorded base shear of 498 kN. For the East excursion, however, the recorded base shear was 772 kN, slightly increased from that in the previous step.

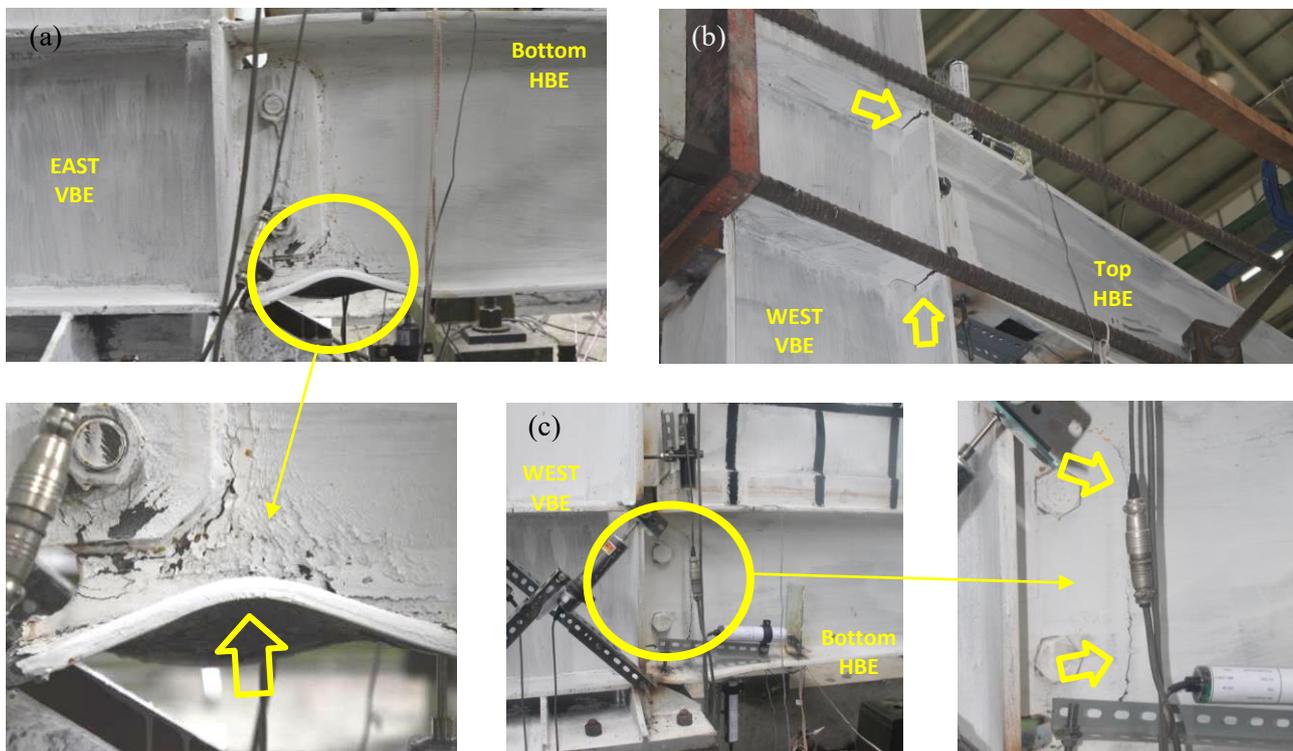
Fig. 5 – Specimen Condition During Step 8 (2.5% drift $= 6.9\delta_y$): (a) Flange Local Buckling; (b) Fractures of Continuity Plate; (c) Fractures of Shear Tabs

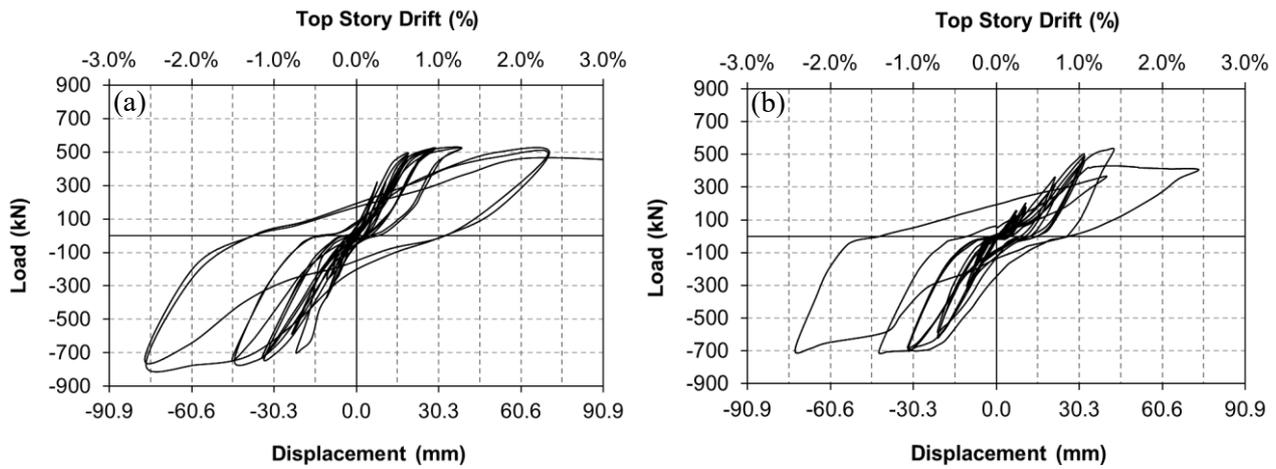
Fig. 6 – Base Shear versus Interstory Displacement: (a) WUF-W Specimen; (b) RBS Specimen

After tightened all bolts at the lateral supports and while closely monitoring it, the experimental program then continued one more cycle to a higher displacement target of 85 mm ($= 2.5\%$ drift) in displacement Step 8, with an expectation whether new events such as damages at RBS locations would have been observed. However, no damage was occurred at RBS locations, other than significant plastification at the cutouts and panel zone locations (Fig. 9). Due to twisting of columns, as shown in Fig. 10, testing was concluded to prevent damage to the lateral supports that may have occurred. Fig. 6(b) presents a complete

hysteretic curve recorded for the RBS specimen. Incidentally, due to some instrumentation issues, displacement records of the last cycle were inferred from three LVDTs that measured specimen lateral displacements at the top beam level.

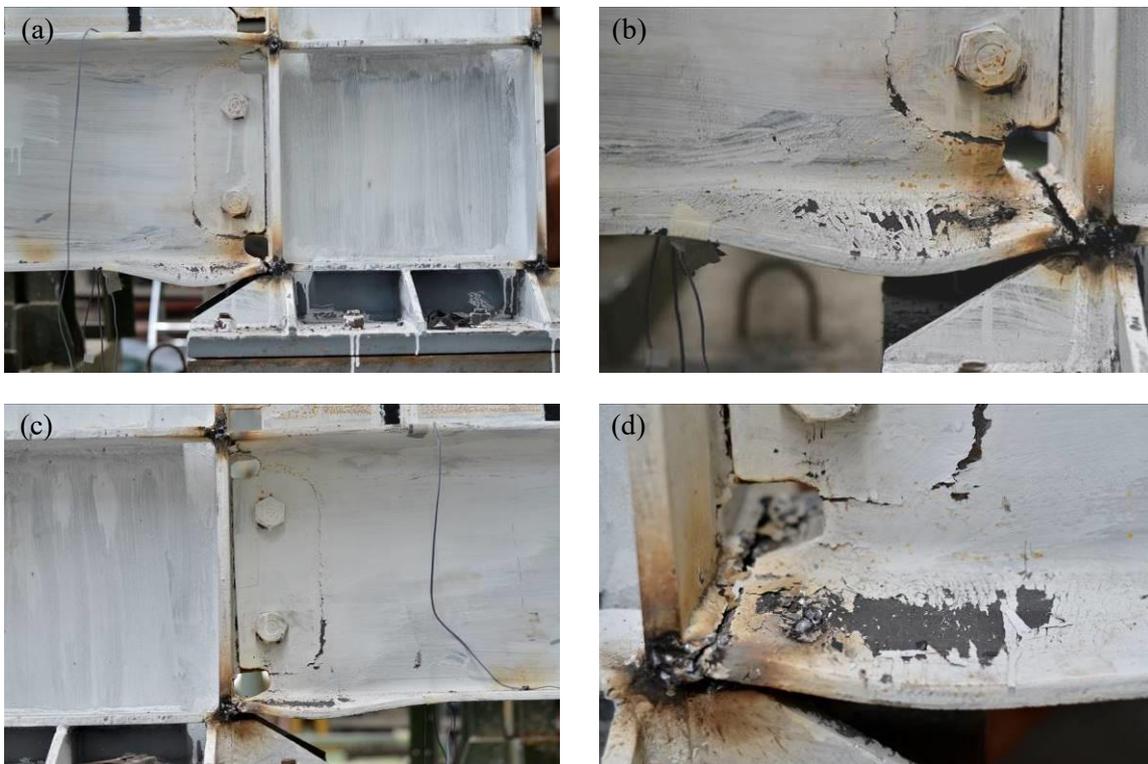
Fig. 7 – Final Condition of WUF-W Specimen at the Bottom HBE-to-VBE Connections: (a) East Connection, South View; (b) Detail of (a); (c) West Connection, South View; (d) Detail of (c)

After half-way through the first cycle of the displacement Step 9 at 102.9 mm displacement target ($= 3.0\%$ drift $= 8.29\delta_y$), the test was stopped because lateral supports were inadequate any longer to prevent the specimen to move out-of-plane. The specimen experienced a 47 mm out-of-plane movement when the target displacement reached. Fig. 6(a) presents a complete hysteretic curve recorded for the WUF-W specimen, plotting the base shear versus top story displacement. Incidentally, the amount of slips occurred at the base have deducted from the top story displacement. The hysteretic curve exhibits a typical pinching behavior reported in past experimental research (e.g., [5, 7, 18]), stable and ductile behavior when undergoing large lateral drifts, and relatively small strength degradation between cycles at the same displacement step. Final condition of the WUF-W specimen is shown in Figs. 7 and 8. Large flange local buckling, significant plastification, or fractures were observed at the WUF-W connections.

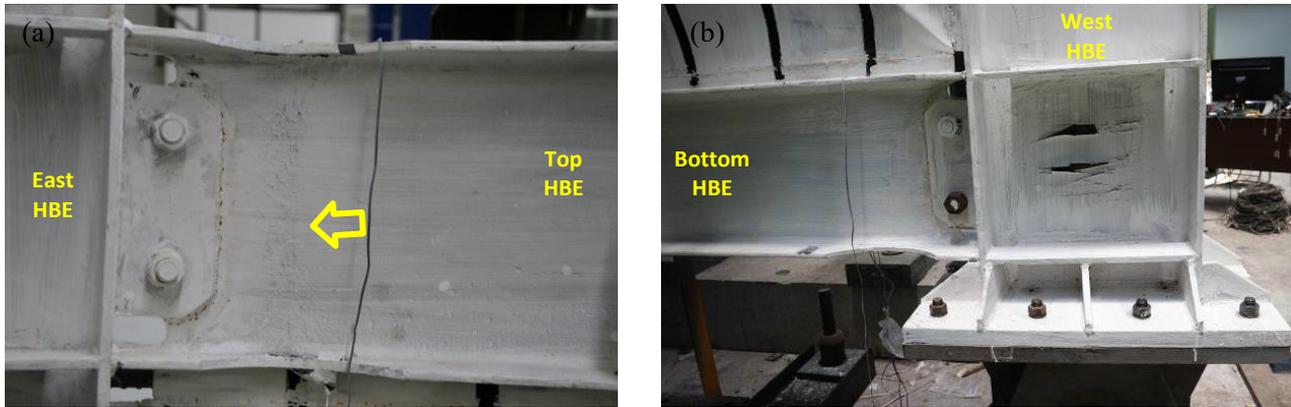
Fig. 9 – Signs of Plastification of RBS Specimen Step 8 (2.5% drift): (a) at Cutouts; (b) at Panel Zone

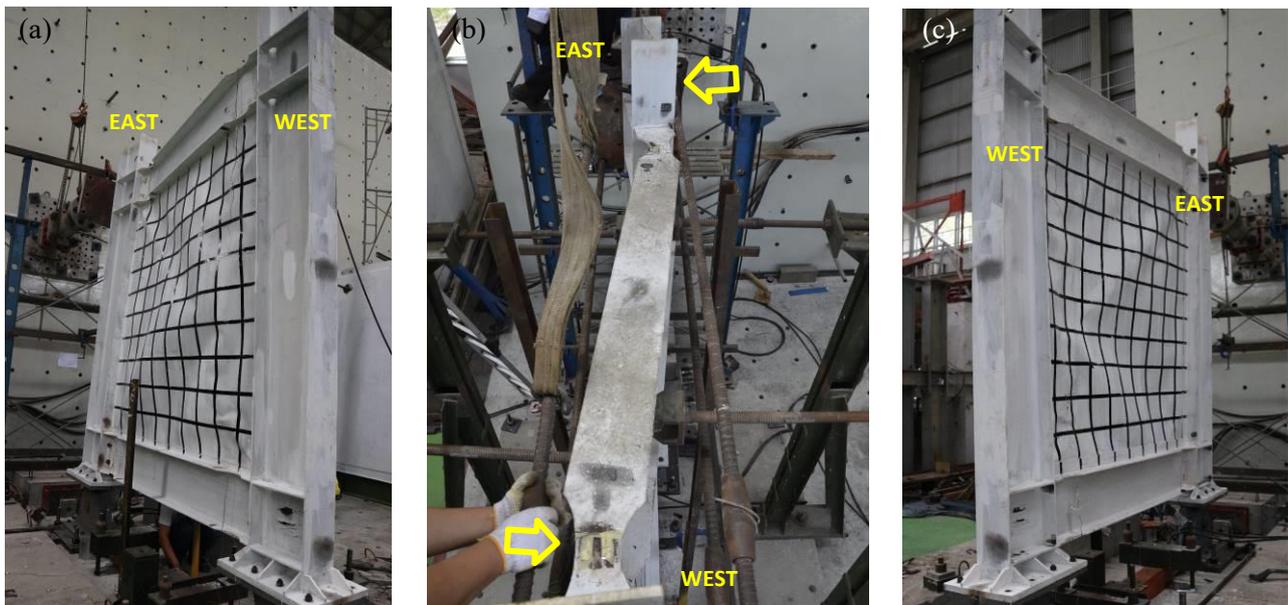
Fig. 10 – Final Condition of RBS Specimen: (a) North View; (b) Top View Showing Twisting of Columns; (c) South View

During displacement Step 6, at 36.0 mm target displacement ($= 1.06\%$ drift $= 3\delta_y$), out of plane movements of 22.4 and 11.6 mm were recorded at the top of West and East column, respectively. This twisting of columns increased to 51.0 and 53.2 mm at the respective locations, when the specimen was cycled at 48.0 mm target displacement ($= 1.41\%$ drift $= 4\delta_y$) in displacement Step 7. As a consequence of this significant out of plane movements, testing was performed only once cycle in this step. Several LVDTs were removed to prevent unexpected damage to them. However, no major damage was occurred on the infill plate, other than minor cracks at its corners. Yielding at the RBS locations and panel zones spread to a larger area. In addition, the resulting peak base shears when cycling at 1.41% drift amplitude were 527 and 705 kN for the West and East excursions, respectively.
