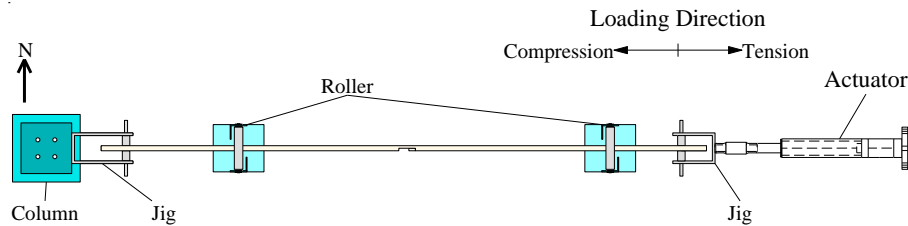
Fig. 2 – Loading system (Plan)

The loading system is shown in Fig. 2. One end of the bracing is pin-joined to the column and the other end is pin-joined to the actuator. Rollers are installed at two places on the bracing to prevent vertical deflection during the application of force. The front side of the diagram (of Fig. 2) is called the S-side, the back side is called the N-side, the left side is called the W-side, and the right side is called the E-side. The bracing is installed with the notch facing the S-side.

The applied force, a positive and negative alternating repetition of compression and tension, is performed within a range in which the buckled brace can be accommodated in the apparatus. On the compression side, the compression of the bracing corresponds to the amplitude of the story deformation angle of about 1/250, 1/200, 1/180, 1/150, 1/120, 1/100, 1/75, and 1/50 rad, respectively; a displacement of 6.0 mm, 7.5 mm, 8.4 mm, 10.1 mm, 12.6 mm, 15.1 mm, 20.2 mm, and 30.4 mm is applied, respectively; and on the tension side, a force is applied until the load reaches 10 kN.

In order to measure the influence in the in-plane direction and out-of-plane direction, strain gauges are attached 200 mm from the bracing fulcrum and on the four sides around the center.

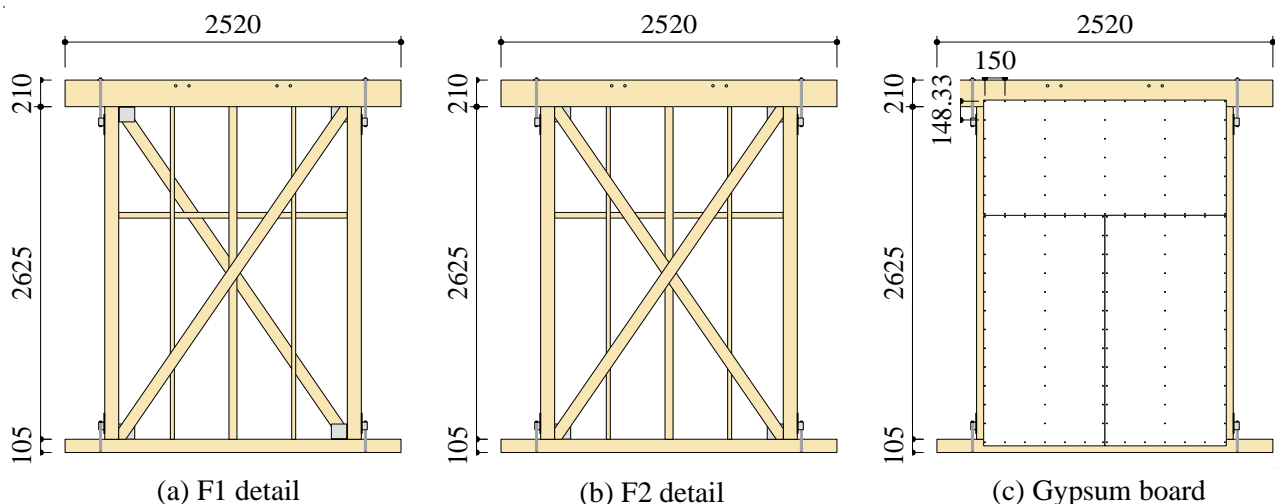
Fig. 5 – Overview of test specimens

Fig. 5 shows the outlines of the frame specimens, which consist of columns, girders, bases, studs, and bracings, all of which are made of cedar. The basic frame is 1,820 mm × 2,730 mm.

The bracing is assumed to be a two-sided bracing, and there are two specimens, a specimen F1 (without a notch), and a specimen F2 (with a notch). The bracing is 30 mm × 90 mm, and the notch depth is 15 mm, which is the same as that of the element specimens described in Section 2. The ends of the bracing are joined using double braced hardware.

The Gypsum board is 12.5 mm thick, of dimensions 910 mm × 1,820 mm, with 3 pieces pasted on each side. The body edge is placed in the seam, and screws are positioned at intervals of approximately 150 mm. Hole-down hardware specced at 25 kN is installed on the capital and 35 kN is installed on the pedestal, respectively.

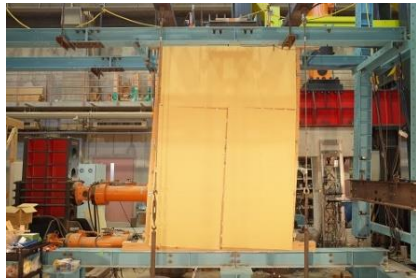
(a) Before reaching (-1/50 rad)

(A) Specimen - F1

Fig. 7 – Typical damage of specimens

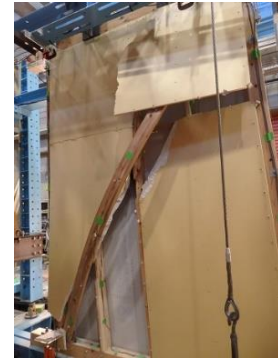
(c) N-side damage

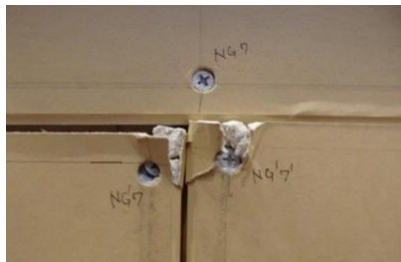
(d) Gypsum board joint damage (1/50 rad)

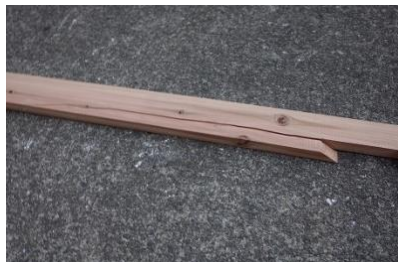
(e) W-side stud splitting when dismantling

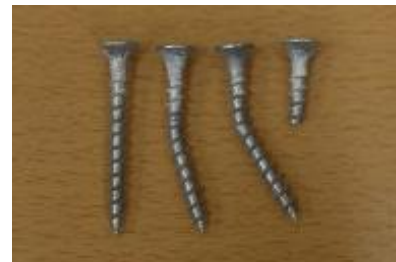
(f) Screw break

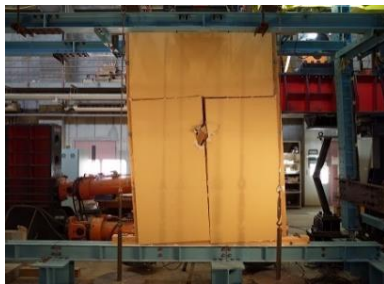
(a) Reaching (+1/50 rad)

(B) Specimen - F2

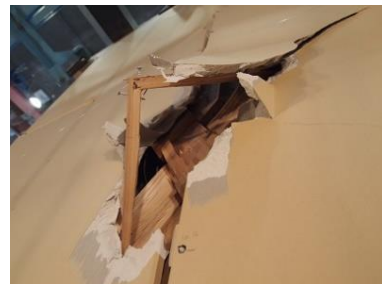
(c) Bracing damage (1/50 rad)

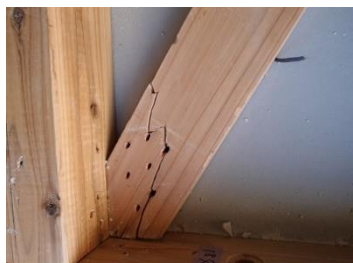
(d) Lower end of N side bracing when dismantling
