## CYCLIC LOAD TESTING OF FULL-SCALE ASSAM-TYPE WOODEN HOUSE FOR EVALUATION OF LATERAL CAPACITY

### **Abstract**

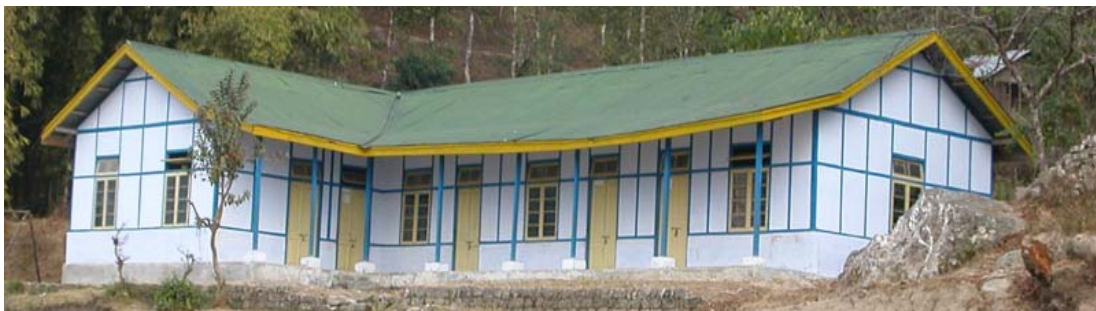
Fig. 1 – A typical Assam-type house [2]

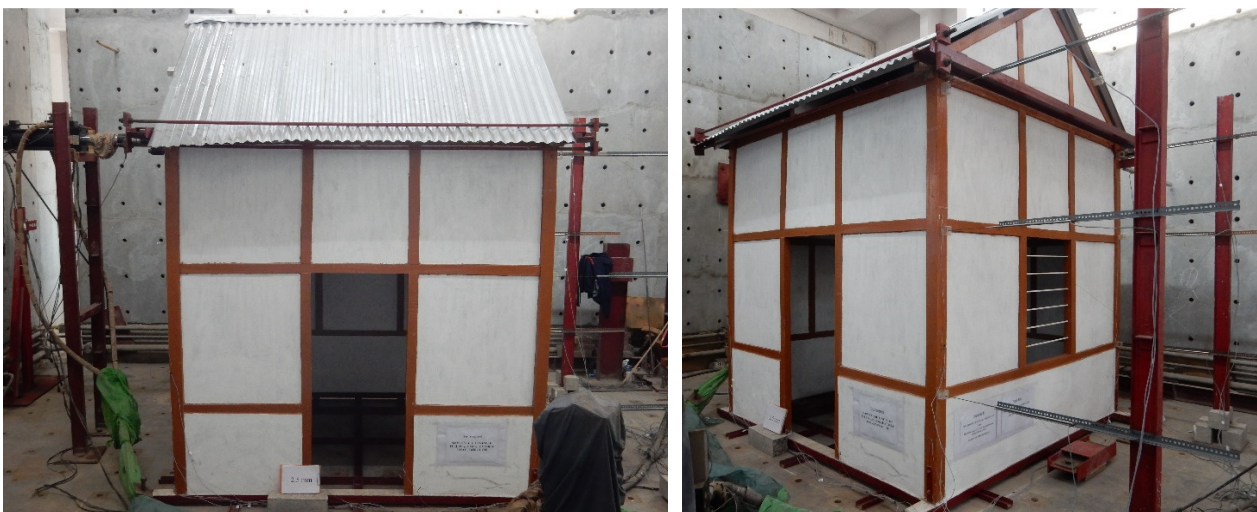
A full-scale single room house specimen of a typical Assam-type house was tested under quasi-static cyclic loading as shown in Fig. 2. The house specimen (main posts and walls) was constructed on rigid steel frame consisting of channel sections after filling concrete in the web of the channels. The main posts of the specimen were supported over the concrete using steel L-clamps, which were inserted into the concrete and welded with the channel sections. A detail description of the construction methodology of the house specimen will be discussed here. Various members and connections used in the house and their locations are shown in Fig. 3 and Fig. 4. Joints A and B (bottom of the main posts) were mutually provided such that Joint A resists the rotation of the main post along the plane of the wall (along the loading direction), while Joint B allows the rotation as shown in Fig. 4 (a and b). In this type of construction, main posts are first erected and connected to the top wall plate beam through open mortise-tenon connection reinforced with the help of steel flats and bolts to prevent the lateral sway in the joints (Fig. 4c). The main posts and top wall plate beam are then joined with horizontal and vertical framing members with the help of different connections as shown in Fig. 3. One end of the horizontal studs is connected to the main post (Joint D) using mortise and tenon joint (Fig. 4d), and the other end is connected using a shear key type of arrangement (Joint E) as shown in Fig. 4(e). The vertical studs are toothed on both the ends to facilitate insertion into the grooves (5 mm wide and 15 mm deep) cut along the length of the horizontal studs or the beams (Joint F), and nails are driven in these connections to secure the joints and to reduce the sway (Fig. 4f). The timber frame (main posts and wall plate beam) of the specimen is made of *Sal* wood (*Shorea robusta*) and secondary horizontal and vertical studs are made up of *Jam* wood (*Syzygium cumini*).

Fig. 2 – Full-scale Assam-type house specimen tested under quasi-static cyclic loading

The specimen had a central window opening in one of the walls above the sill level, and a central door opening in an adjacent wall of the house specimen (Fig. 2). As per the prevalent construction practice, the connections of window panels and top connections of door posts with the frame are mortise and tenon type (Joint D'), whereas, bottom connections of doorposts are slightly inserted into the plaster of the floor without any connection. However, in the present study, the doorposts were inserted into the foundation of the specimen (concrete) in order to improve the lateral load behavior of the door posts. The house specimen was a single story, single room Assam-type house with a room size of about 2.83 m × 2.83 m and height of about 3.6 m. The main posts were made of about 100 mm square sections and the wall plate beams had section of about 75 mm × 100 mm. The intermediate stud frame sections had about 75 mm square section. The rafter sections were about 75 mm × 65 mm and purlins were about 75 mm × 50 mm in section. The roof of the specimen was

Quasi-static cyclic testing was performed on the house specimen along the weaker direction, since the purpose of the study was to evaluate the load carrying capacity of these houses. The house specimen had a wall with central door opening and a fully infill wall in the loading direction. In the direction perpendicular to the loading (transverse direction), the specimen had a central window opening and a fully infill wall (Fig. 2). The experimental arrangement for lateral load testing of the specimen is shown in Fig. 5.

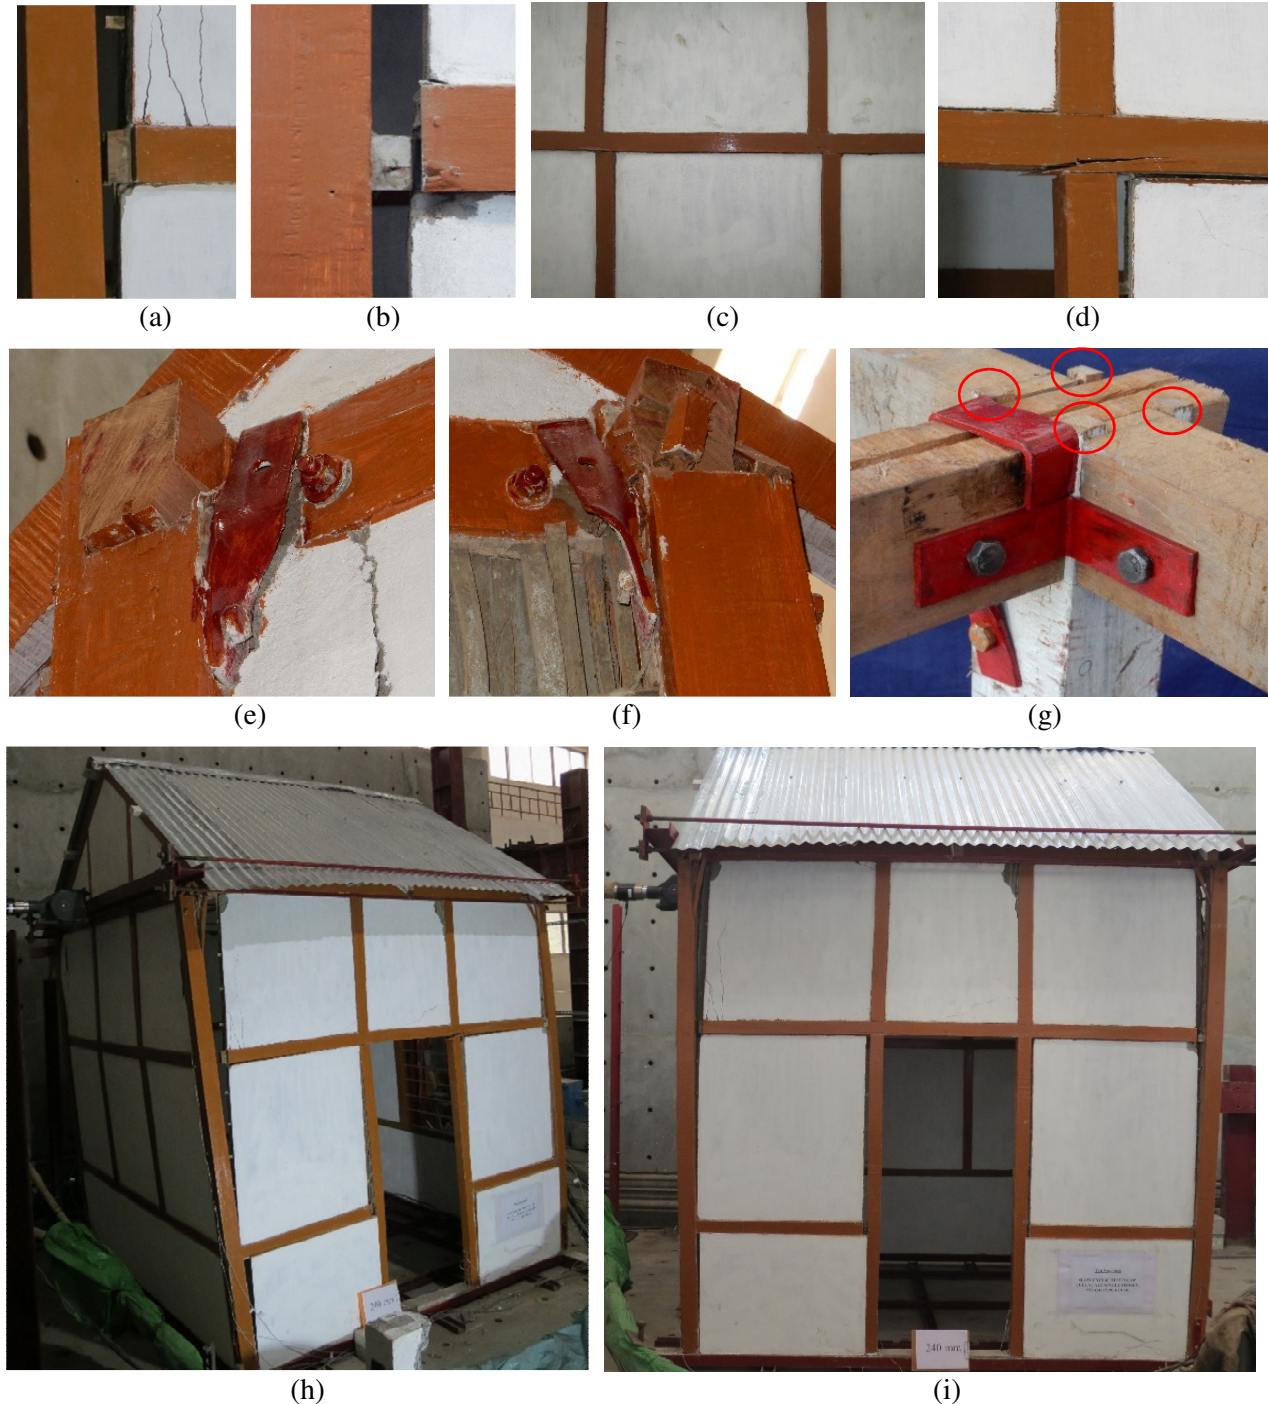
The house specimens exhibited a large lateral deformation without much damage under the action of the applied lateral loading as one of the main post-foundation connections (Joint B) in each of the frames allowed rotation at the bottom, whereas the other (Joint A) resisted it. Even after being subjected to large deformation, Joints A and B of the main framing members remained intact during the entire cyclic testing unlike the damage observed in the main joints of other traditional houses, like *Dhajji-Dewari* or *Pombalino* construction [15-18]. This is because the main posts of the house were neither inserted into the foundation nor fixed with any wooden member. Because these connections govern the overall lateral load behavior of the house, flexible connections of the main framing members (Joints A and B) resulted in an excellent lateral load behavior. The connections of the horizontal studs with the main posts (Joints D and E) behaved quite flexibly with the loosening of the

nails in the joints, allowing large deformation without noticeable damage in the joints (Figs. 7a, 7b). Similarly, at a higher lateral drift, the tooth and groove joint between the vertical and horizontal studs (Joint F) assisted in sliding of the vertical studs in the groove of the horizontal studs (Fig. 7c).

Fig. 7 – Damage observed in various components of the house during quasi-static testing: (a) Pullout of Joint D, (b) Pullout of Joint E, (c) Sliding movement of vertical stud and *Ikra* panels, (d) Tearing of top joint of doorpost, (e) Damage to top main post joint (Joint C'), (f) Hook-type steel flat in Joint C', (g) Small thickness of main post unable to prevent damage at Joint C', (h) Out-of-plane movement of transverse wall under lateral loads, and (i) Damage in the wall with door opening after 240 mm displacement

Due to the flexible connection of the *Ikra* panels with both the studs, sliding movement of the *Ikra* panels was observed in the walls of the house without any visible damage to the *Ikra* panels (Fig. 7c). However, *Ikra* panels did not slide or fall from the transverse walls of the house specimen. The sliding of *Ikra* panels caused formation of the interface crack between the panels and the surrounding studs along the periphery of the *Ikra* panels. With the increase in the applied lateral displacement, the gap between the vertical interfaces between the *Ikra* panel and the main posts increased near the corners, and on further increase in the lateral displacement, the horizontal studs were detached from the vertical main posts. Though the horizontal studs were detached, the lateral load resistance was still provided by the *Ikra* panels, masonry infill, and to a certain extent, by the interaction of the *Ikra* panels with the timber frame as ascertained from the hysteresis response. The masonry infill (below sill level) did not suffer any significant damage. Under the lateral loading, the behavior of the in-plane wall with door opening and the in-plane wall with full infill was found to be quite different. Noticeable damage was observed only in the wall with door opening, whereas no significant damage was observed in the fully infill wall. At 65 mm lateral displacement, tearing of doorpost connections by the nails present in the connection was observed (Fig. 7d), and an interface crack developed between the masonry wall and the concrete foundation in the transverse wall. At 115 mm displacement the bottom of doorpost pulled out from the concrete foundation. At 145 mm displacement, sound of wood crack was heard from the top of the main post joint, and a crack was observed in the *Ikra* panel above the door opening at 160 mm displacement.

The connection of top of the main post with the wall plate beam (Joint C') was found to have severely damaged in the in-plane wall with door opening, and out-of-plane movement of the transverse walls was observed at 165 mm displacement (Figs. 7e, 7f, and 7h). The joints were not disintegrated completely due to the presence of hook-type and L-type steel flats in Joint C' (Fig. 7g) as shown in Figs. 7e, and 7f. Three members meet at the top of the main posts. Due to which very small thickness of timber is left at the top of the main post (Fig. 7g), damaging the top of the main post joints during the lateral loading. Therefore, to improve the lateral load behavior of these houses, the size of the main post should be increased. Major damage in the joints occurred in the doorposts, which acted as intermediate vertical posts and restricted the sliding movement of the *Ikra* panels which in turn damaged the joints. Interestingly, the top joints of the main posts in the in-plane wall with full infill did not suffer any damage due to absence of any rigid connection. The doorposts started rocking with further increase in the lateral displacement. At 215 mm displacement cycle, the cement plaster got damaged near the top of the main post joint due to out-of-plane movement of the steel flats in the transverse walls. The fully infill wall, two out-of-plane walls and the ceiling did not suffer any significant damage up to 240 mm displacement level. Overall, most of the damage in the house specimen occurred only in the wall with door opening at connections of main posts as shown Fig. 7(i). The excellent lateral load performance of the framing system can be attributed to the simple and flexible connections in the frame members, light weight *Ikra* panel and its flexible connections with the surrounding framing members.

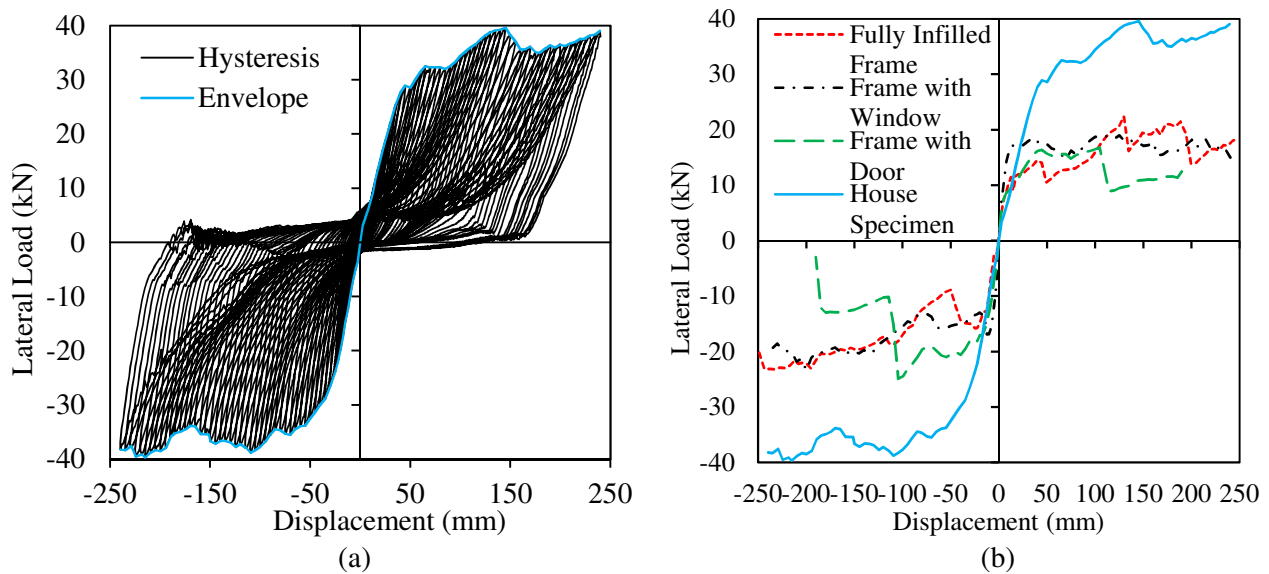
The hysteresis response for the first cycle of every displacement level applied on the house specimen is shown in Fig. 8(a). The hysteresis behavior of the test specimen was symmetrical in push and pull directions and demonstrated extremely good ductile behavior without significant reduction in the lateral load carrying capacity even when subjected up to 240 mm displacement level. However, the hysteresis loops of the house specimen showed several kinks with increasing lateral displacement levels due to readjustment of *Ikra* panels and interface joints with the surrounding frame. The house specimen sustained the lateral load without any significant drop because of the resistance provided by the *Ikra* panels without suffering much damage, thus imparting significant strength and stiffness to the specimen under the action of lateral loading [14]. Pinching

effect was observed in the hysteresis loops due to the separation of joints in the form of sliding movement of *Ikra* panel and opening and closing of horizontal stud connections with the main posts.

Fig. 8 – (a) Hysteresis response of the full-scale house specimen, and (b) Comparison of envelope curves of full-scale house specimen with individual frame specimens

The envelope of the lateral load response of the house specimen was compared with the envelope response of three individual frame specimens tested earlier by the authors [14] as shown in Fig. 8(b). The individual frame specimens were frame with fully infill wall, frame with a window opening, and frame with a door opening. The frame specimens were constructed with same materials, sizes and tested under same testing conditions. The lateral load carrying capacity of house specimen was found to be nearly twice of the combined strength of the in-plane walls. The house specimen was found to have lesser initial stiffness compared to the individual frame specimens due to loosening of interface connections of infill panels (masonry wall and *Ikra* panels) with framing members during the shake table testing of the house specimen.

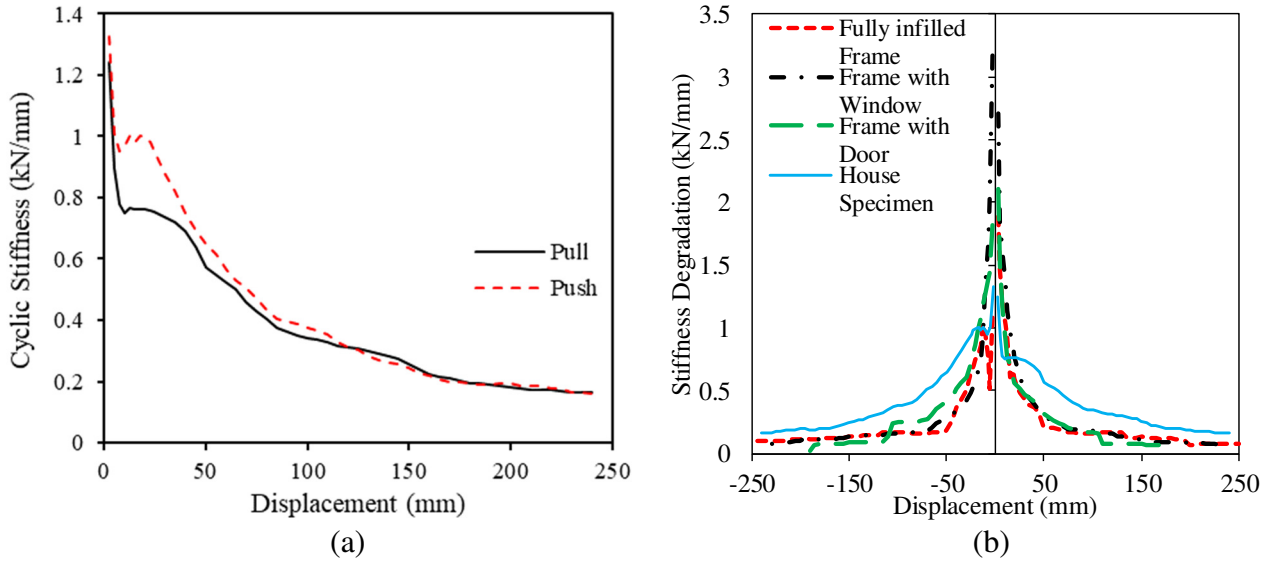
Fig. 9(a) shows a comparison of the cyclic stiffness of the full-scale house specimen in pull and push directions calculated as the maximum lateral load divided by the corresponding displacement observed in various cycles of loading. It is observed that the difference in stiffness in the push and pull direction of house specimen was comparatively more in initial displacement levels and the difference reduced with increase in displacement level and became equal at about 120 mm displacement. The difference is attributed to the separation of the horizontal studs from the main posts in the push direction. Fig. 9(b) compares the stiffness degradation observed in the full-scale house specimen with that observed in the individual frame specimens. It is noticed that the cyclic stiffness degradation in case of frame specimen was similar in both push and pull directions, and as already discussed the stiffness of the individual frame specimens was found to be higher than the house specimen in initial displacement levels. This was due to the initial damage incurred in the house specimen during shake table testing, which was carried out on the same house specimen before conducting quasi-static testing. As expected, the cyclic stiffness became higher in case of the house specimen in both pull and push directions than the individual frame specimens after 25 mm displacement level, i.e., after the house specimen was subjected to the lateral displacement level (during quasi-static testing) that was higher than the relative displacement achieved during the shake table testing.

Fig. 9 – Comparison of stiffness degradation observed in the full-scale house specimen: (a) in pull and push directions, and (b) with frame specimens

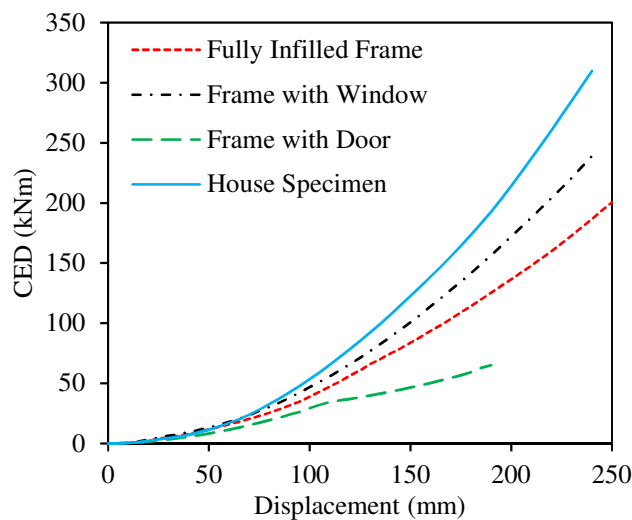
The cumulative energy dissipation (CED) was calculated by adding the area enclosed by the three hysteresis loops at every displacement level. The comparison of energy dissipated by the house specimen with individual frame specimens is shown in Fig. 10. Because of the reasons already discussed, the energy dissipated by the house specimen was found to be less than the frame specimens in initial displacement cycles, and after about 25 mm displacement cycle the energy dissipation of house specimen became highest among all the specimens. The energy dissipation was largely attributed to the sliding of the *Ikra* panels, and the interaction of different connections with the framing members.

Fig. 10 – Comparison of cumulative energy dissipation of Frame specimens with full-scale house specimen
