EXPERIMENTAL STUDY ON THE MECHANICAL PERFORMANCE OF DOUGONG IN MAHAVIRA HALL OF HUIZHAN TEMPLE

Keywords: Mahavira Hall of Huishan Temple, Dougong, vertical loading, cyclic test, mechanical performance

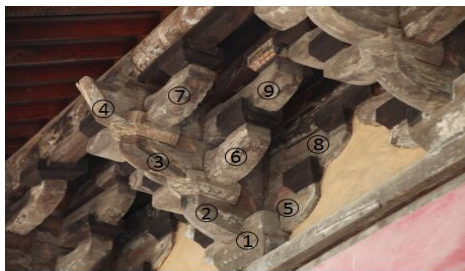
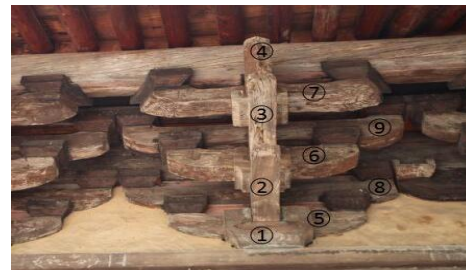
Fig. 1 – Dougong in Mahavira Hall of Huishan Temple

(a) Side photo of the Dougong

(b) Front photo of the Dougong

The example of Dougong in Huishan temple is shown in Figure 1. ①Ludou, ②Touang, ③Erang, ④Mazhatou, ⑤Nidaogong, ⑥Guazigong, ⑦Linggong, ⑧⑨Mangong. The detailed construction of Dougong is shown in Figure 2. The sizes of main components are shown in Table 1.

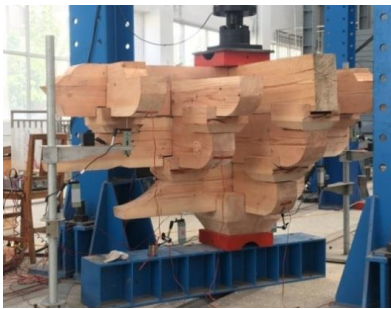
Fig. 3 –Vertical loading setup

During the vertical loading, the Dougong was placed on the steel structure grade beam and the load was applied in the way of displacement control (Fig. 3). The preloading was carried out first in order to reduce the system error. The experiment adopted continuous uniform loading mode. The displacement increment speed was 2mm/min. Until the Dougong appeared obvious damage to stop loading, the force was unloaded to 0, and the experiment was over. The load-displacement curve of the test piece was measured by the pressure sensor (connected to the jack) and the thimble displacement meter (set at the Mazhatou).

The experiment was conducted in the structural laboratory of Henan University of Technology. Vertical loading was carried out with a hydraulic servo jack with a range of 500kN, and horizontal loading was carried out by MTS loading system. The design thrust of the actuator was ± 250 kN and the displacement range was ± 375 mm.

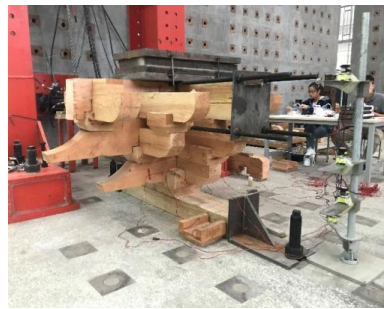
Fig. 4 –Horizontal loading setup

The horizontal loading contained the longitudinal and transverse directions. A steel tie rod system was set to realize the application of cyclic load (Fig. 4) when loading. When thrust was applied by the actuator, the force was transmitted directly to the specimen through a steel plate on the side close to the actuator. When the tension was applied, the force was first transferred to the steel plate on the other side through the steel tie rod, and then the force was transferred from the steel plate to the specimen, so as to avoid local tension of the specimen joints. According to the actual structure of Dougong in Mahavira Hall of Huishan Temple, The bottom of the beam was provided with a wooden beam. The middle of the beam extended the mortise and passed through the bottom of the Ludou to connect with the Dougong, and the wooden beam was firmly fixed with the laboratory cement pedestal. Displacement loading was used under low cyclic reversed loading, and the loading protocol referred to method B (ISO16670 standard) in ASTM E2126-11 standard [12]. As shown in Figure 5, the displacement amplitude Δ_m of low cyclic reversed loading was taken as 50 mm. The test was terminated when the carrying capacity dropped to 80% of the limit load or

when the Dougong was visibly damaged. The load of the specimen was directly output by MTS loading system and the displacement was measured by a displacement meter connected with the top steel plate.

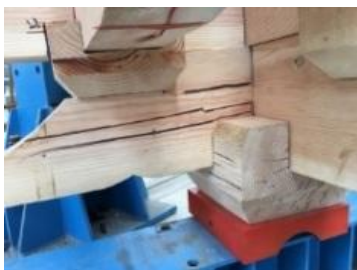
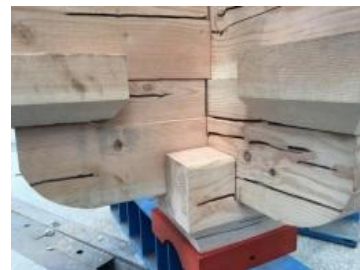
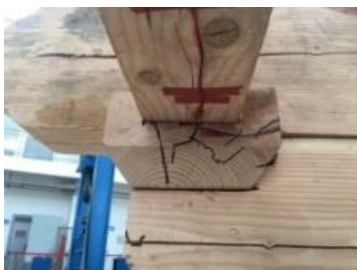
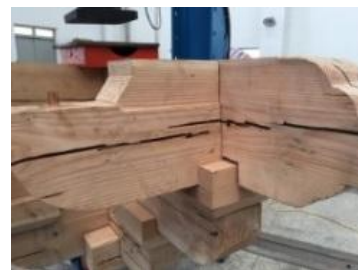
Fig.6 – Failure mode of Dougong under vertical loading

At the initial stage of loading, with the increase of load, the components of the Dougong were gradually squeezed, and there were frequent "squeaking" noises. When the Dougong was loaded to 8mm of vertical displacement, micro cracks were formed along the bottom of the Ludou Ear at the intersection of the Nidaogong and the bottom of Ludou. The cracks continued to develop with the loading. Horizontal cracks appeared on the Touang while the load displacement increased to 12mm (Fig. 6a). In this process, Micro-cracks began to form at the intersection of the Mangong and Fang in the upper part; the two ends of the Guazigong were slightly up and the rests of the test piece did not show the phenomenon of destruction.

During the loading to 24mm of vertical displacement, the specimen frequently made the sound of wood cracking. Horizontal cracks appeared at the Ludou, Nidaogong and Touang in the flat, and the gap gradually increased (Fig. 6b). The loose battle at the intersection of the upper Erang and the Linggong appeared oblique cracks (Fig. 6c); horizontal cracks formed at the intersection of the Linggong and Mazhatou, and gradually extended outwards (Fig. 6d). With the loading, horizontal cracks appeared in the tail of the Erang, the cracks in the Nidaogong increased, and the sound of wood cracking appeared low frequency and high sound. When the displacement was loaded to 34mm, horizontal cracks in each layer gradually formed a common seam. Then the Erang and the Touang had obvious warping; Sandous on both sides of Manggong were formed horizontal seam on the outer side of the Ear, and the intersection between Mangong and Mazhatou also began to appear cracks. The test was terminated at 42mm of vertical displacement, and most of the cracks in the Dougong were formed through the seams, which was regarded as the failure of the specimen.

(a) Horizontal crack of the Touang

(b) Development of horizontal cracks at the bottom

(c) Oblique cracks of the Sandou

(d) Development of upper horizontal cracks

Under the action of vertical load, the middle part of the Dougong passed through the force, so the specimen also showed high bearing capacity. The Gong, Fang and other components bore the bending moment, showing the warping at both ends. Components such as the Sandou and Jiaohudou were tilted under eccentric pressure.

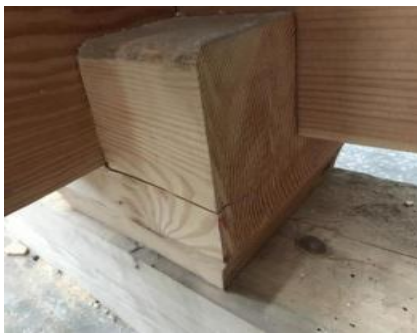
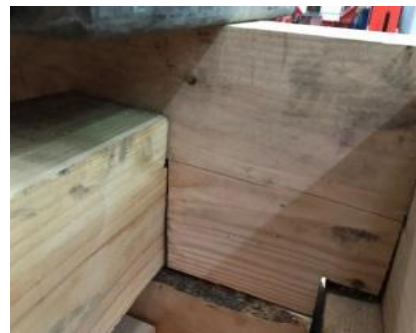
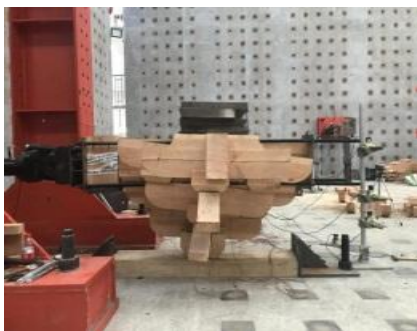
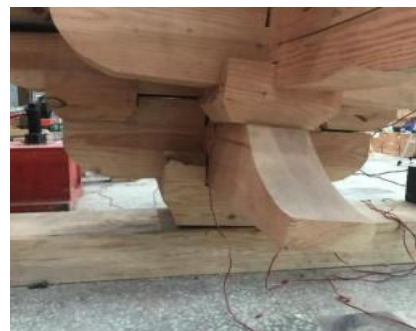
Fig.7 – Failure mode of Dougong under longitudinal loading

When the displacement was loaded to 30mm, the Ear of the Ludou split (Fig. 7a); the gap between the horizontal components increased, and Mazhatou appeared the phenomenon that it was out of tenoning (Fig. 7b). When the displacement was loaded to 60mm, there was a large cracking sound in the Dougong; there was a clear slip between the horizontal components; the Dougong overall tilted (Fig. 7c), and the bottom had the phenomenon of warping (Fig. 7d). During subsequent loading, the friction between the horizontal layers slipped back and forth. The wood cross-pattern pressure damage appeared at the intersection. Some components were seriously out of tenoning, but the Dougong showed good deformation ability and ductility.

(a) Split in the ear of the Ludou

(b) Tenon at the Mazhatou

(c) The overall tilt of the Dougong

(d) Bottom cock up

Under the action of vertical horizontal loading, the Dougong drove the Mazhatou by Zhengxinfang, and then transmitted force to the upper Mangong and the Linggong. The upper structure transmitted the force to the second layer's Guazigong and Erang through the Sandou and the Jiaohudou. Then the second layer of components was transmitted by the Sandou and the Jiaohudou to the third layer of Nidaogong and Touang, and finally to the beam frame through the Ludou.

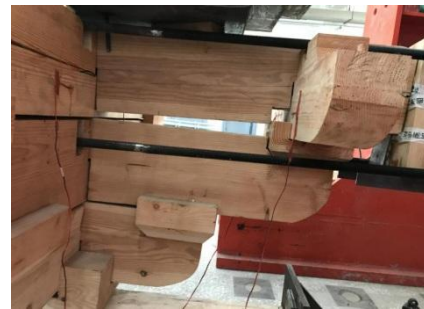
Fig.8 – Failure mode of Dougong under transversal loading

In the process of loading to 20mm, there was a large friction between the Sandou and the Gong, and there was occasional cracking sound in the components. In the process of loading to 40mm, the Dougong was inclined obviously, and there was an obvious gap between the horizontal layers (Fig. 8a). In the process of loading to 50mm, the splitting sound was frequent; there was obvious slip between layers, and the phenomenon was out of tenoning at the Sandou (Fig. 8b). After loading to failure, the Dougong still showed good deformation ability and ductility in this direction.

(a) Significant clearance of horizontal layer

(b) Tenon at the Mazhatou

Under the action of transverse horizontal load, the Mazhatou drove the Zhengxinfang, the Mangong and the Lingpiong. The upper structure transmitted the force to the Guazigong and Erang through the Sandou and the Jiaohudou, then to the Nidaogong and Touang, and finally to the beam frame through the Ludou.

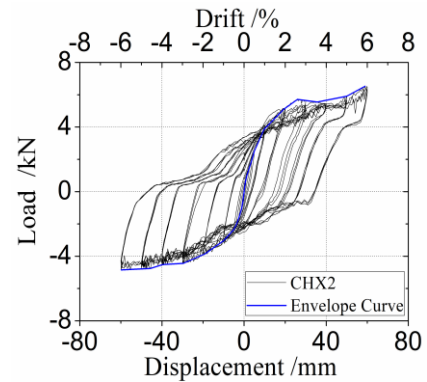
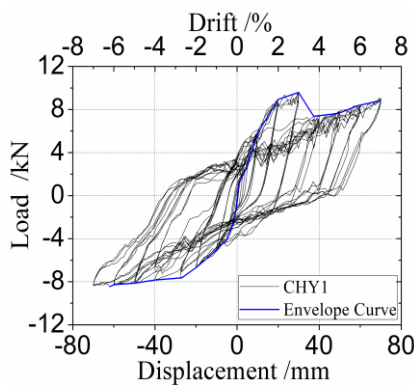
Fig.9 – Load-displacement relationship curves

The load–displacement curves of Dougong under vertical monotonic load and horizontal cyclic load are shown in Figure 9.

The peak load P_{peak} , the corresponding peak displacement Δ_{peak} , the limit displacement of the structural damage Δ_u and the corresponding limit load P_u are determined by the load–displacement curve under the monotonic load and the average skeleton curve under the cyclic load (the absolute values of the positive and negative skeleton curves are averaged). The yield point under the monotonic load is defined as the point corresponding to the $0.4P_{peak}$ load value of the rising segment, and the yield point under the cyclic load is determined by the ideal elastic-plastic method based on energy equivalence (EEEE). The yield load P_{yield} , the yield displacement Δ_{yield} , the stiffness of elasticity stage $K_e = P_{yield} / \Delta_{yield}$ and the elongation coefficient $D = \Delta_u / \Delta_{yield}$ are defined. The main mechanical performance parameters of each test specimen are shown in Table 2.

1. The peak load and the limit load of each test piece are equal that the bearing capacity of each specimen does not decrease during the loading process, indicating that after the components of Dougong have a large displacement, they can still maintain their overall carrying capacities though the parts have

damaged. On the other hand, it also shows that the deformation ability of the wooden structure is strong and the method of displacement control should be adopted in the design.

2. Under the action of vertical load, the stiffness of the curve has increased in the initial loading with the parts of the Dougong tight; In the middle and late stages of loading, the stage of curve appears "serrated" because parts of the wood are cracked by pressure. The carrying capacity of the Dougong component reaches 384.31kN, which shows good carrying capacity.

3. The carrying capacity of the horizontal vertically loaded Dougong specimen is 5.17kN, which is 58% of the carrying capacity of the horizontal loading under the Dougong specimen, because the Dougong bites more in the horizontal card slot, showing better carrying capacity. The longitudinal and lateral elastic phases are equally rigid at 0.67kN/mm and 0.63kN/mm respectively. The limit displacement of the Dougong under the vertical load effect is 53.19mm (the angle of displacement is 5.37%), and the limit displacement under the effect of the horizontal load is 62.67mm (the angle of displacement is 6.32%), both of which reach more than 1/20 of the angle of displacement, which shows the good deformation ability of the Dougong.

4. The hysteresis curve of the Dougong specimen under the effect of the low cyclic reversed loading is full and shows good ability of energy dissipation. The ductility coefficient of the Dougong components under vertical load is 8.34 and the ductility coefficient under the horizontal load is 5.11, which shows good ductility.

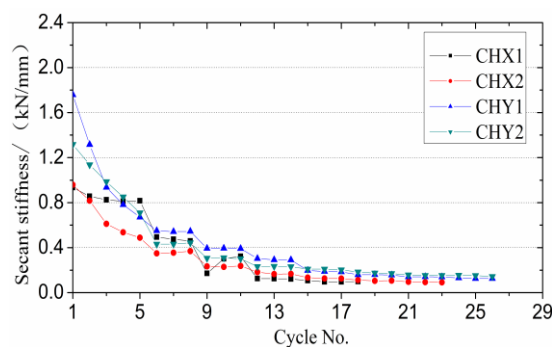
Fig.10 – Secant stiffness curves

The effective stiffness curve of each test specimen under cyclic load is shown in Figure 10, which can be seen:

1. With loading, the bite of the parts of the Dougong gradually loosens, and even appears the phenomenon that it is out of tenoning. In the curve of effective stiffness, the stiffness shows a significant decrease and eventually remains at a low level, which is consistent.

2. The stiffness level of the Dougong is always slightly in the horizontal direction higher than that in the vertical direction because the part of the Dougong is connected more in the horizontal card slot than that in the vertical card slot and the integrity of the specimen in the horizontal direction is slightly better than that in the vertical direction.

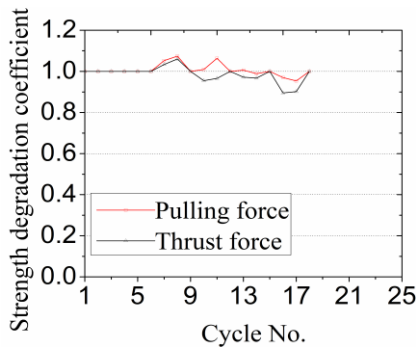
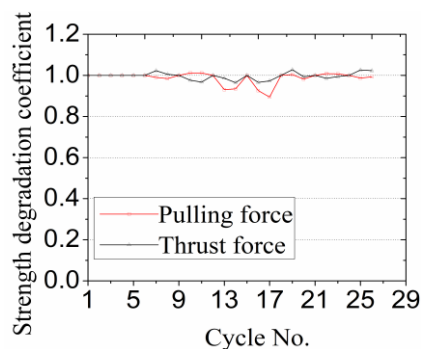
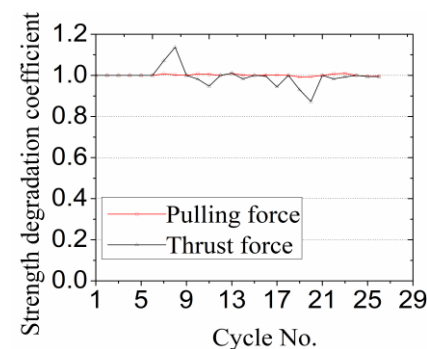
Fig.11 – Strength degradation curves

The curve of the strength degradation coefficient under the displacement amplitude value at all levels can reflect the trend of strength degradation in the overall structure, and the strength degradation curve of each test specimen is shown in Figure 11, which can be seen.

1. In the loading process, the various parts of the Dougong show different degrees of damage with the increase of lateral displacement, including the cross-line plastic deformation and cracking of the wood at the intersection, which is also reflected in the strength degradation of the curve.

2. Each group of test specimen of has the strength degradation to less than 20% before the destruction occurs, indicating that under the effect of the earthquake, Dougong still can maintain a good collaborative characteristic and maintain the overall carrying capacity though the various parts of the slip and misalignment.

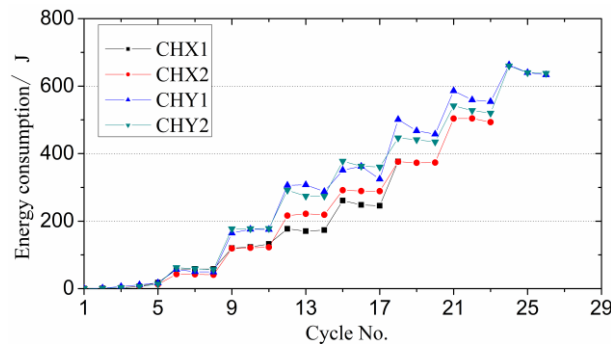
Fig.12 – Energy dissipation characteristics within each cycle group of specimens

As an important index to measure the seismic performance of the Dougong, energy dissipation can be measured by the sum of the areas surrounded by the hysteresis curve, which reflects the stiffness, ductility and other factors. The energy dissipation of each load cycle is shown in Figure 12, which can be seen.

1. The energy dissipation of the Dougong mainly comes from friction between the components and the crushing and cracking of the wood. During the loading process, the total stroke of friction increases, showing the increase of energy dissipation level with the increase of displacement amplitude. In the three cycles of the same displacement magnitude, the first cycle increases the deformation of the Dougong; there will be a new wood split and the release of elastic strain energy, showing the maximum energy dissipation level. At the 2nd and 3rd cycles, there is no new cleavage, so there is a degree of decrease in consumption.

2. The capacity of energy dissipation of the Dougong in the horizontal direction is always slightly higher than that in the vertical direction, because the effective stiffness of the Dougong in the horizontal direction. The reaction force under the same displacement amplitude value is larger, so the area of the hysteresis loop is also larger, which also shows consistency with the stiffness degradation curve in sections.

3. With the increase of displacement, the energy dissipation has always been increased and there is no decline in the phenomenon, which shows that the Dougong under the effect of earthquake can show good energy dissipation and ductility.
