LARGE SCALE SHAKE TABLE TEST OF SLAB-TO-PIERS INTERACTION IN RC COUPLED WALLS

Keywords: RC coupled walls, Shake table test, Floor-to-piers interaction, Large scale experiment

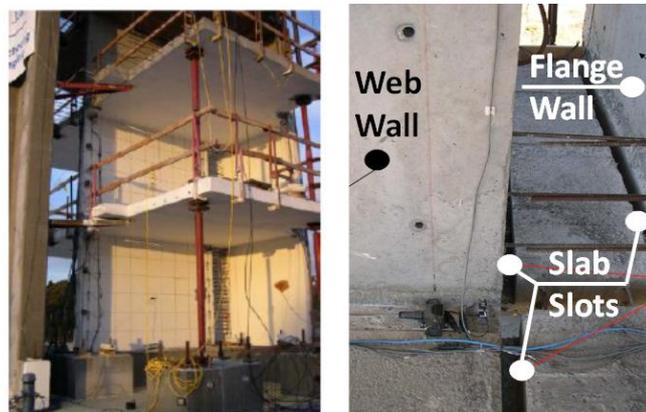
Fig. 1 – Cantilever RC wall tested at shake table at UCSD:

- a) the wall and “gravity columns”, used to support slab and provide the stability in the direction perpendicular to the wall plane
- b) the slab slots (courtesy Panagiotou MM et al. [5])

The experiments [5], [6] clearly demonstrated the importance of the flexural response of the slab to the overall behavior of RC coupled walls. For example, in the experiment [5] (see Fig. 1a) slabs were supported on one side by the wall and on the other side by “gravity columns”. There was a small gap intended to assure unrestricted vertical movement of the slab at the location of gravity columns. In spite of that, the gravity columns restricted the upward movement of the slabs, causing the 3D interaction between the tested wall and the gravity columns by means of the flexural deformations of the slabs.

In the same experiment it was demonstrated that relatively thin slab can also provide considerable coupling between wall piers. The analyzed rectangular wall was connected by the perpendicular stabilizing wall only by slabs in order to avoid their interaction. To additionally minimize the coupling effect, slabs were slotted at the connection with the walls. They were only 5 cm thick at the slot (see Fig. 1b). A considerable shear forces were generated along the whole length of the slots, resulting in the substantial increase of the axial force in the tested wall. The bending moments and shear forces in the wall were also increased, due to the induced axial forces.

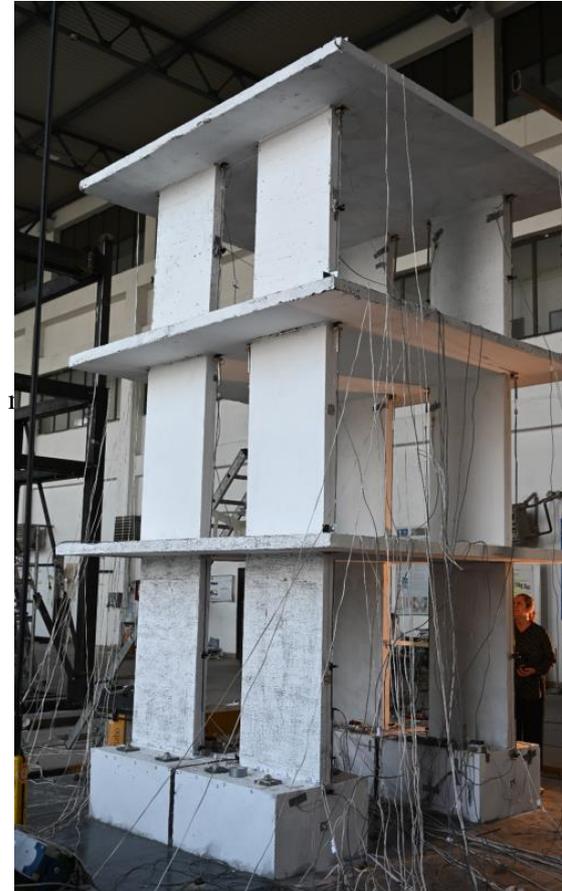
- d) Optical measurements of deformations were performed at outer faces of bottom story of all walls

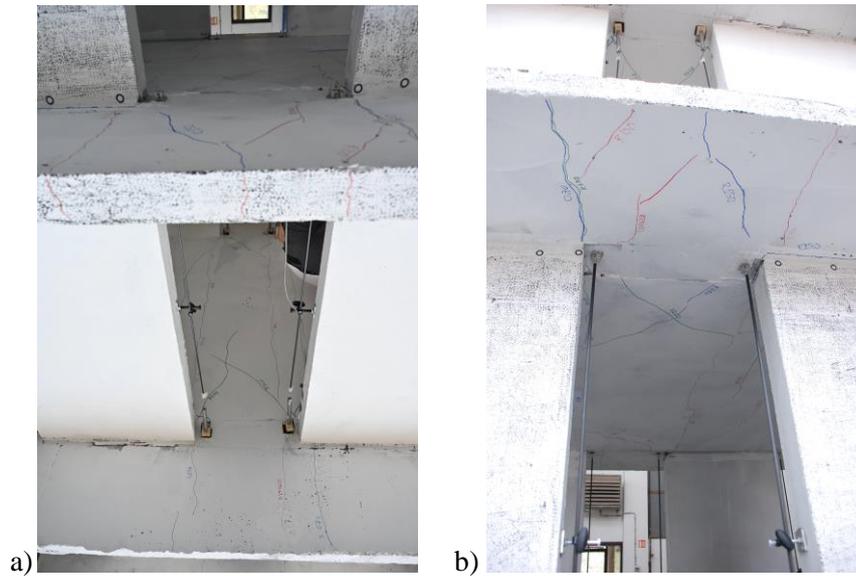
Fig. 6 – Cracks were formed at a) the top and b) at the bottom surfaces of the slabs, all over their width between two rows of wall piers

The response of the tested building was essentially elastic up to the test R120. The first cracks were observed at the bottom of the wall piers and in the 1st story slab near the joints with the walls, after the test R030. When the seismic intensity was increased, the cracks appeared also in the second and the third slab. The cracks in the slabs were first limited to the area near the joints with the walls. When the seismic intensity was increased, they were gradually expanded to the whole width of the slabs between the two rows of wall piers (see Fig. 6). The cracks were clearly visible at the top and at the bottom surfaces of the slabs.

In the test R120 the response of the building entered the nonlinear range. The cracks in the slabs were spread over the full width of the slab in between the two rows of the wall piers (see Fig. 6). The width of the cracks in the slabs was considerably increased. The yielding of the reinforcement in the slabs was achieved. The effective width of slabs was equal to their total width. The flexural strength of slabs was fully activated, generating considerable axial forces in wall piers (see Fig. 2). The frame effect, generated by the slabs was considerable (see also the discussion in section 4.3).
