MASONRY PANEL TESTING IN MALAWI

A holistic seismic risk management framework for East Africa, with particular focus on Malawi, is under development as part of the EPSRC-sponsored Global Challenges (GCRF) grant PREPARE. The project aims to co-produce practical tools and guidelines for enhanced disaster preparedness in close partnerships with local governmental and academic institutions. For the seismic vulnerability assessment of masonry buildings in Malawi, a series of tests were conducted in the field and in the Civil Engineering laboratory of the Malawi Polytechnic in Blantyre. The specimens and applied loads are of three main types: (a) single bricks subjected to uniaxial compression and three-point bending; (b) masonry prisms subjected to compression, direct tension and interface shearing; and (c) masonry panels of different brick configurations and reinforcement subjected to in-plane compression/shearing and out-of-plane bending in two planes. The specimens were built by local artisans using locally produced materials to simulate actual field conditions and indigenous construction methods. The different kinds of reinforcement tested were inspired by the recommendations of the

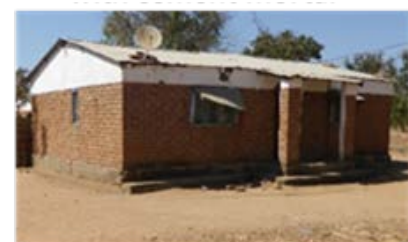
(a) unfired bricks / mud mortar

(b) fired bricks / mud mortar

(c) fired bricks / cement mortar

Fig. 2 – Typical houses in rural and urban areas of Malawi made of unreinforced bricks and mortar. [7]

Fig. 2 shows typical houses in Malawi that are, almost exclusively, one-storey buildings made of locally moulded, sun-dried or fired clay bricks and mud or low-strength cement mortar. Walls are often single-skin, against the local guidelines. Double-skin walls are built in the case of higher-income households; however, they are not always adequately constructed. Roofs are typically pitched, constructed by wooden beams and covered using iron corrugated sheets, or thatched (Fig. 2(b)). Quality of materials is low; compressive strengths of bricks vary between 1 and 10 MPa (typically lower than 5 MPa), even within the same batch. The mortar used to bond the bricks varies from plain mud to cement-sand mixtures. The latter typically have a cement-to-sand ratio significantly lower than the either 1:4, suggested for structural masonry (or 1:3 for foundations and special applications) according to MS791-1 [17] or the minimum ratio of 1:6 recommended in the Safer House Construction Guidelines [8]. In local construction practice, the ratio typically depends on the income level of the household and it is generally lower than 1:6 (often 1:8 or even lower) [9].

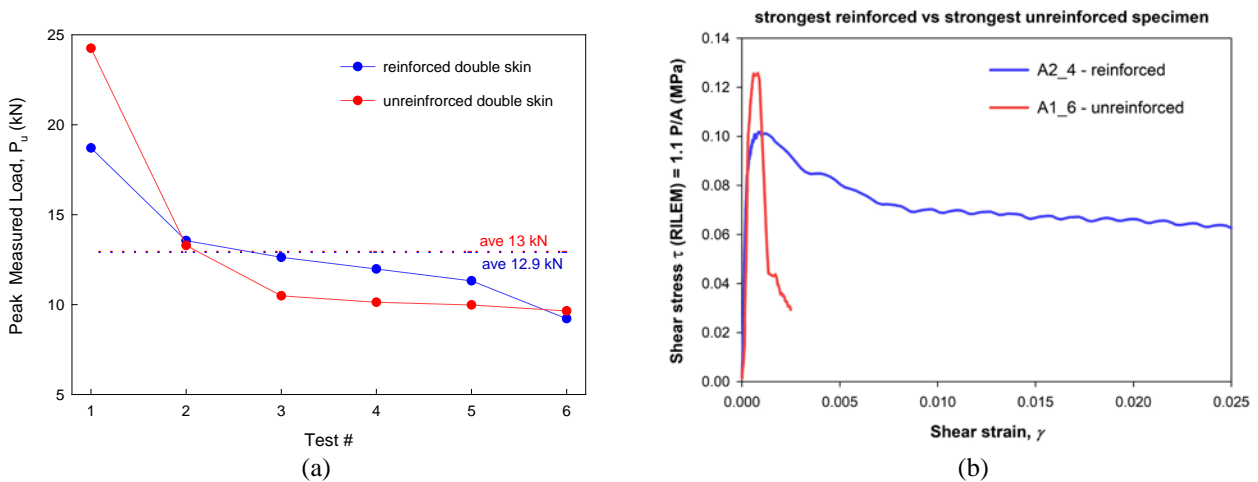
Fig. 10 – (a) Peak measured loads from in-plane tests on double-skin unreinforced panels and panels reinforced using brick force wire; (b) Comparison of strongest unreinforced double-skin panel to strongest reinforced with force brick wire, from in-plane tests. Measured shear strain; shear stress interpretation after RILEM [27] standards.

Results from the in-plane shear tests are shown in Fig. 10(a) in the form of peak measured load P_u . Two types of panels are shown here for comparison: (1) unreinforced double-skin walls and (2) double-skin walls of the same geometry and material, reinforced using horizontal layers of brick force wire. The results indicate that both panel types have almost identical average shear strengths (average peak measured loads in both types of tests were 13kN.) with reinforced panels exhibiting, naturally, a smaller scatter. The failure mechanisms, however, are different as shown in Figs. 10(b) and 11: failure mode in unreinforced panels is brittle, along the mortar interfaces. On the other hand, reinforced panels exhibit a more uniform distribution of cracks – concentrated mostly along the diagonal.

By comparing the strongest of each type (Fig. 10(b)), the unreinforced panel carried a larger load. The initial (“elastic”) stiffness is identical – as both panels are of the same material and geometry – but the unreinforced one has a brittle failure mode while the reinforced one carries loads up to a nominal shear strain of 2.5%. Evidently, the reinforcement increases ductility, not strength.

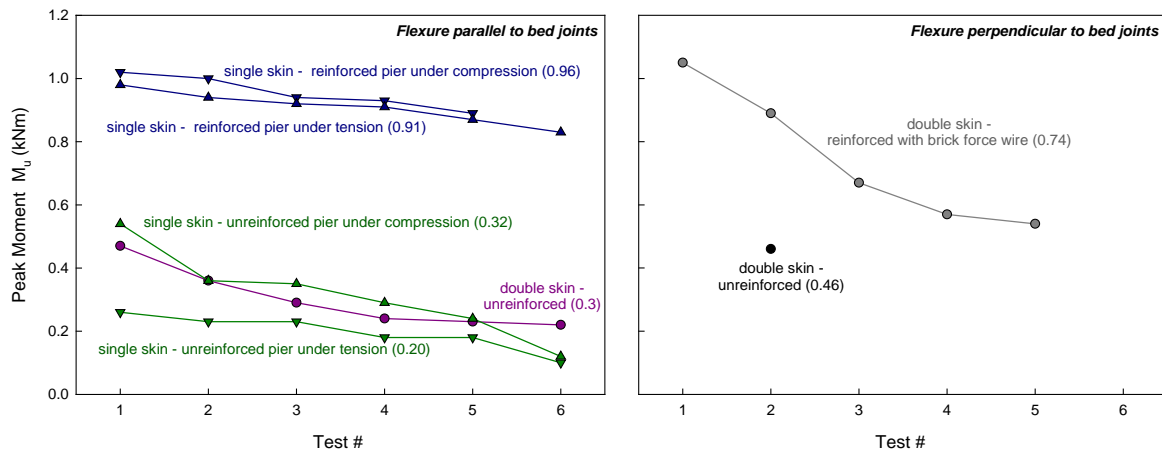
Fig. 12 – Peak measured moments from out-of-plane flexural tests on different types of reinforced panels, parallel and perpendicular to the bed joints.

The out-of-plane flexural behaviour is among the most critical parameters influencing the performance of masonry structures under seismic loading. Figs. 12 and 13 present results in terms of measured (derived from test data) peak moments (Fig. 12) and moment-deflection curves (Fig. 13). As evident from both figures, the reinforcement with external brick force wire along the two sides of the pier has significantly improved the out-of-plane response parallel to the brick courses which is the weaker of the two modes of failure.
