PERFORMANCE OF PRECAST CLADDING PANELS WITH ROCKING CONNECTIONS UNDER LATERAL CYCLIC LOADING

Abstract

Keywords: precast structures; architectural cladding; rocking motion; connections; sealants

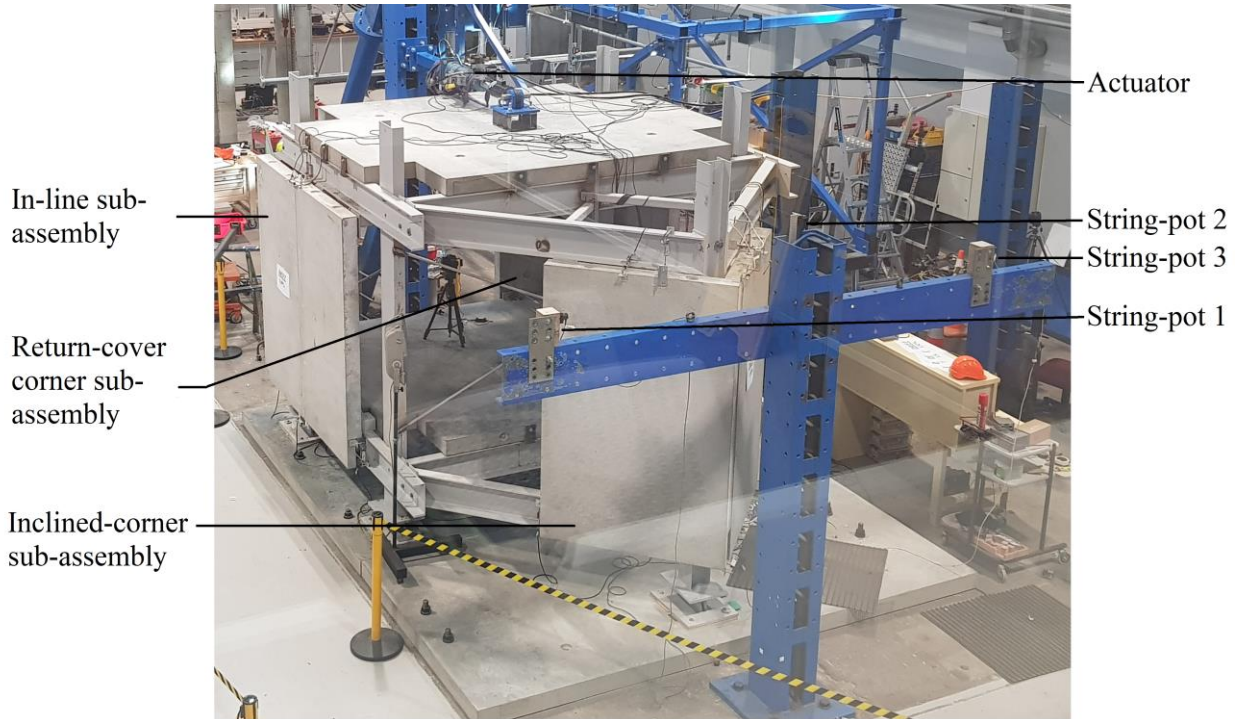
Fig. 2–Test setup, instrumentation, panel sub-assemblies

A one-story 3D steel frame structure (Fig. 2) is designed and erected to test three different sub-assemblies of panel pairs: inclined-corner assembly, return-cover corner assembly and in-line assembly (Fig.2 and Fig. 3). The individual panel dimensions and their calculated/designed in-plane inter-story drift capacities are shown in Table 1. The connections at the base of the column and between columns and beams are hinged to allow a shear mode of deformation in the structure when the top slab is subjected to lateral quasi-static cyclic loading up to maximum inter-story drift of 4.18 % following FEMA 461 [23] loading protocol (Fig. 4). The bottom

A 300kN actuator with stroke length of ± 200 mm is attached to the center of the top slab. Three string-pots (string-pot-1, 2 and 3) are used to record the top frame displacements (Fig. 2). They also detect any sloppiness and torsion in the frame. Each sub-assembly is instrumented with potentiometers (Fig. 6) to gauge the uplift at edges of panels, changes in the vertical joint width and out-of-plane movements of panels, where necessary. Paper masking tapes with measurements outlined up to 100mm, to scale, are adhered near the vertical slot to measure approximate sliding of the bolt in the slot. Two horizontal lines are drawn across the sealant at each vertical joint to measure the shear displacements in the sealant at peak inter-story drifts in each cycle.

The structure was subjected to lateral cyclic displacements at the center of the top slab. The top displacements in Frame A and Frame B were recorded by string-pot-3 and string-pot-1, respectively, (Fig.2). The force-drift hysteresis loops for Frames A and B are shown in Fig. 7. Note that the corresponding forces shown in Fig.7 are of the entire structure, not for a particular frame. These recordings show that the structural connections in the frame have some slackness which is clearly distinct while pulling the structure (positive drift cycles). The loading first starts (in the negative direction) with some initial stiffness due to shearing resistance provided by the interposed sealant. Under small lateral forces applied to the top connections of the panel, the panels are expected to behave as integral elements with the structure as they are equilibrated by the

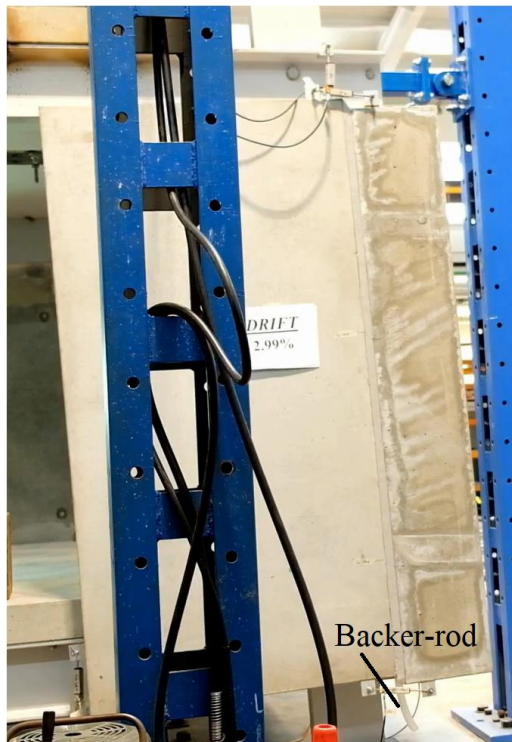
b. Return-cover corner sub-assembly

Fig. 8 – Rocking of panels at peak of first -3% inter-story drift cycle

The panels exhibited rocking motion (Fig. 8) as expected under the lateral cyclic loadings. The bolt inside the vertical slot of the steel-embed slid ‘smoothly’, aided by grease, when the panels rocked as shown in Fig. 9. Visual observations during and after the testing showed no noticeable spalling or cracking of panels, no yielding of steel components and no loosening of the steel-embeds. The joint width was found to remain approximately constant throughout the test. However, significant shear deformation in sealants was observed in the joint interfaces (Fig.8.a and Fig.8.b) except in the joint interface of the inclined-corner sub-assembly (Fig.8.c), where panels CP1 and CP2 rocked without inducing significant differential vertical displacements at the joint.

sealant was found to be around 132%. Moreover, due to alternate rise and fall of the panels during their rocking motion, the backer-rod was observed to gradually slide downwards (Fig.8.a and Fig.8.b).

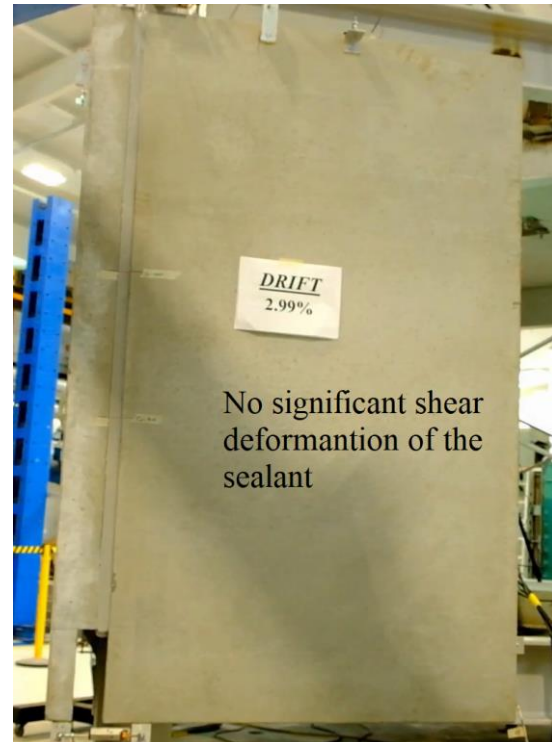
c. Front-view of inclined-corner sub-assembly
