## SHAKE TABLE TESTING PLAN FOR MULTIPLE NON-STRUCTURAL ELEMENTS & CONTENTS IN A LOW-DAMAGE STRUCTURAL STEEL BUILDING

### Abstract

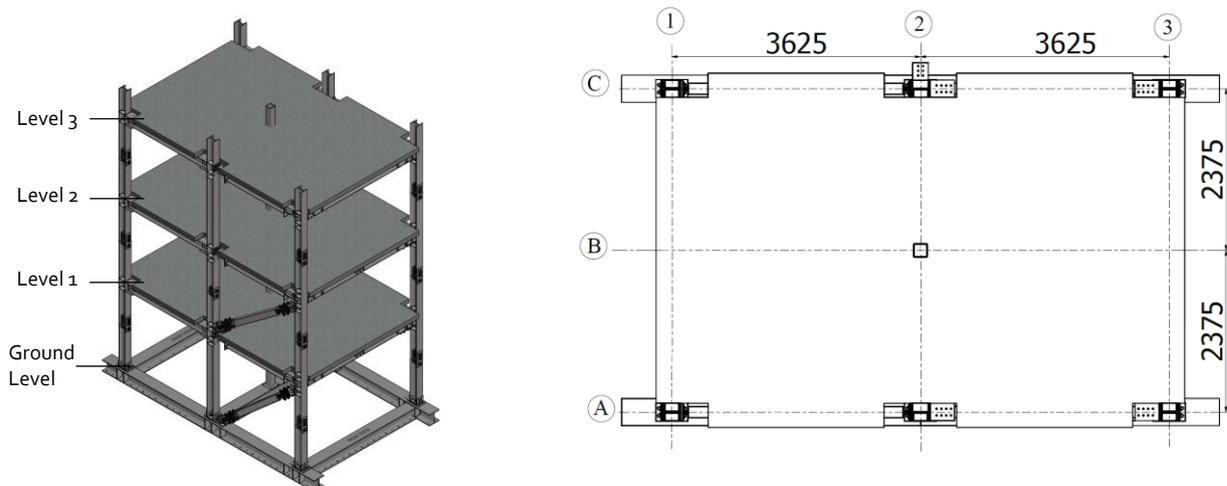
Fig. 1 – Test structure 3D & plan view

The Robust Building Systems (ROBUST) project is aimed at enhancing the seismic resilience of buildings by introducing and validating low-damage design concepts for the structural and non-structural elements. A three-story, full-scale, structural steel building will be tested at the International Joint Research Laboratory of Earthquake Engineering (ILEE) at Tongji University (Fig. 1). The structure has two bays in the longitudinal direction and one bay in the transverse direction, and will incorporate a number of high-performance connections (low-damage friction energy dissipaters) in the form of sliding hinge joint, resilient slip friction joint, symmetric friction connection and GripNGrab [8,9,11,20]. The test structure will be subjected to unidirectional and bidirectional horizontal shaking with ground motions corresponding to the design-basis (10% in 50 years) and maximum considered earthquake (2% in 50 years) intensity levels for Wellington (soil class C & importance level 2). The set of prospective ground motions will include normal-directivity, near-field forward-directivity (pulse-like), and long duration subduction ground motion records.

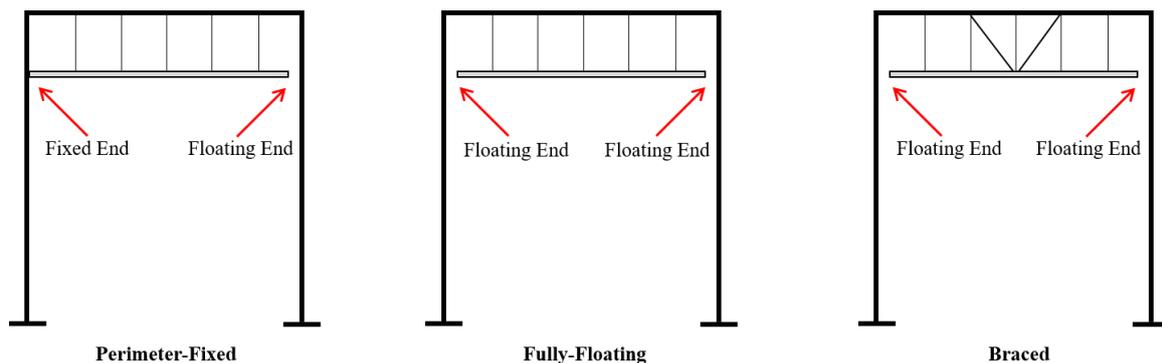
Fig. 2 – Types of suspended ceilings

Damage to suspended ceilings has been widely reported and primarily includes the dislodging and breakage of tiles, failure of the inter-grid and perimeter connections, buckling of the grids, and failure of the perimeter angles [13,14,25,30]. The perimeter-fixed suspended ceilings are one of the most widely used suspended ceilings in New Zealand, in which two sides of the perimeter are riveted to the perimeter angles, while the other two sides are floating, i.e. the grid is simply resting on the perimeter angle without any attachment. The primary seismic demand on the ceiling grids is axial force which accumulates along the length of the grid towards the perimeter, where it is to be resisted by a riveted connection with the perimeter angle (Fig. 3a). The failure hierarchy for perimeter-fixed suspended ceilings, evaluated from component tests, reveals that the single rivet (3.2mm) perimeter connections are the most vulnerable components of the whole ceiling system [15]. Different solutions have been proposed to avoid the critical damage states, e.g. the seismic clips for inter-grid connections and double rivets for perimeter connections [15,31,34].

The use of braced ceilings is also popular in New Zealand for large plenum depths and large floor areas. In such ceilings, the component failure modes discussed above can be avoided as the seismic resistance is entirely provided by the bracing (Fig. 2 & 3b). These braces are, however, proprietary in nature and their design details can vary from building to building. The seismic performance of such ceilings, typical of NZ practices, has not been investigated yet.

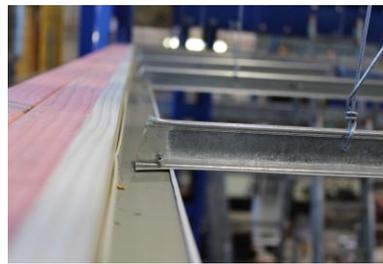
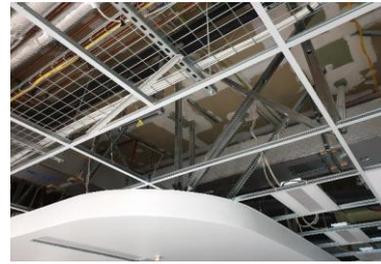
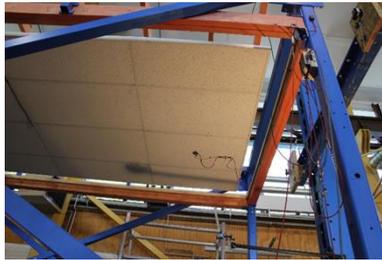
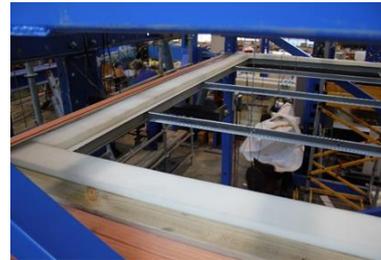
a. Perimeter-Fixed

b. Braced

c. Fully-Floating without Isolation Foam

d. Fully-Floating with Isolation Foam

Fig. 3 – Types of suspended ceilings [31]

Recently, a novel low-damage suspended ceiling has been proposed and its concept validated experimentally [32]. This ceiling is comparatively simpler to perimeter-fixed and can avoid the typical damage associated with the grids as it is completely isolated from the surrounding structural system and is only hung from the floor slab using hanger wires (Fig. 3c). These wires have negligible lateral stiffness and therefore are not prone to failure due to seismic demand. Being isolated from the surrounding structure by a gap, the only concern about the fully floating ceiling is its lateral displacement. As demonstrated in [32], these displacements can be restrained effectively by filling the perimeter gap with an isolation material (Fig. 3d).

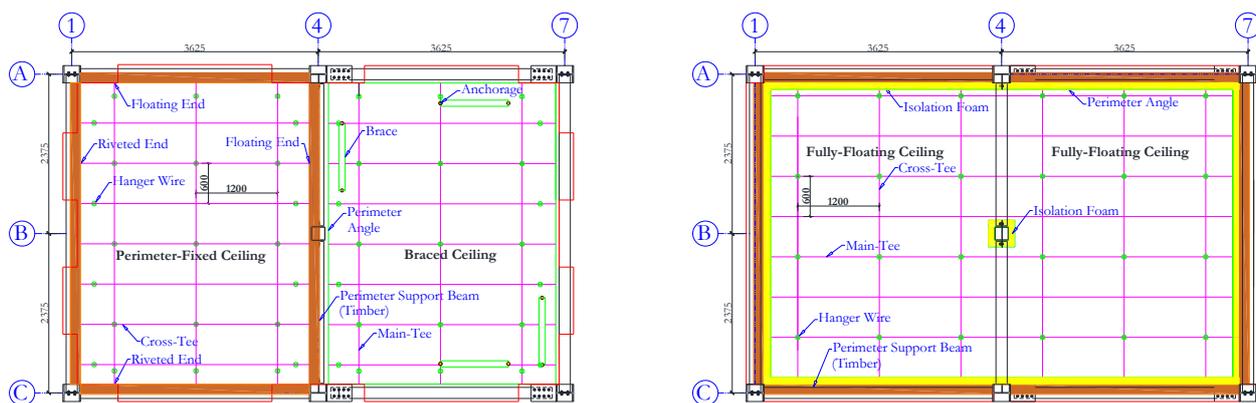
Fig. 4 – Suspended ceilings in test structure

The primary objective of this test is to compare the seismic performance of the traditional perimeter-fixed and braced ceilings with the novel low-damage fully-floating variant. The perimeter-fixed and braced variants will each be installed in one half of the second level in order to compare their performance under the same floor acceleration demands (Fig. 4). The fully floating ceiling will be installed on the full third level to assess its performance, primarily the displacement response and the efficacy of the isolation material in restraining its displacements (Fig. 4).

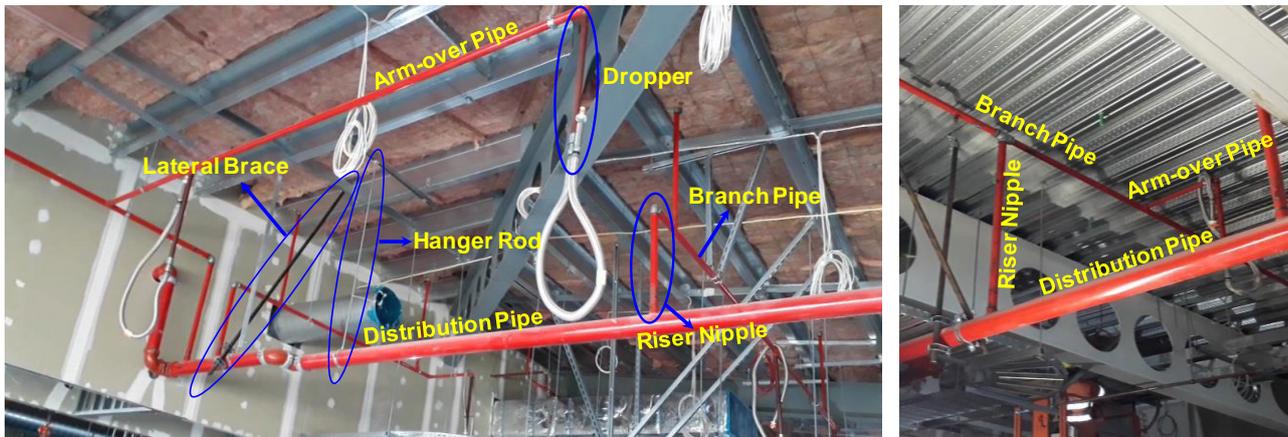
Fig. 5 – Components of a fire sprinkler piping system

Damage to fire sprinkler systems can compromise both the fire safety and functionality of a building during an earthquake. The damage primarily includes fractured piping connections, failure of hangers and braces, and damaged sprinkler heads due to interaction with surrounding building elements, such as ceiling panels [18,19,27,33,37,41]. Damaged piping connections leads to leakage of water which can flood entire floors and thus can render a building inoperable [5,19,27,41].

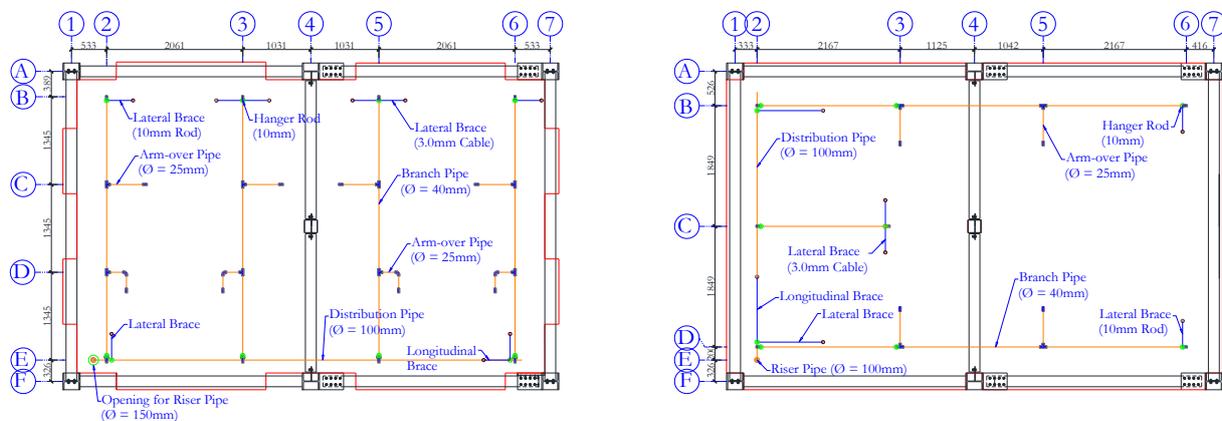
Fig. 6 – Sprinkler piping configurations in test structure

In this test, fire sprinkler piping systems will be installed on the second and third level (roof) of the test structure and will only be connected through a riser pipe traversing the floors. The piping configuration will be different on both levels due to the need for different performance aspects to be addressed (Fig. 6).

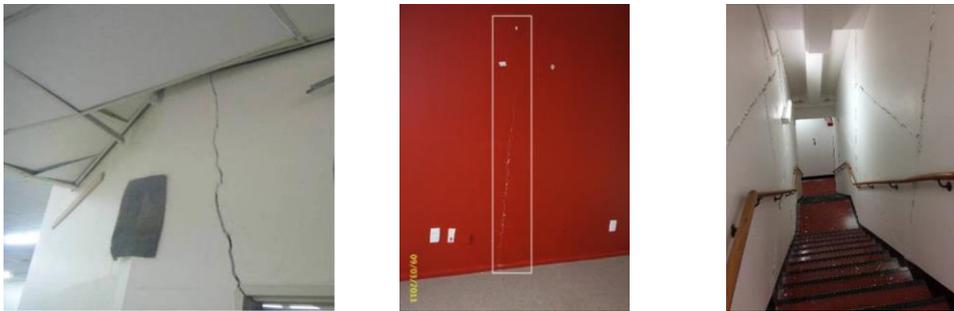
Fig. 7 – Damaged partition walls [3,13,40]

European countries. They provide a sound and fire proof space in residential and commercial buildings. However, due to brittle finish materials such as drywall, plaster and stucco these walls show limited deformation capacity leading to damages at 0.2% inter-story drift and total loss of economic value around 2% inter-story drift [24]. The damages to internal drywall partitions have been extensive following the 2010 Darfield earthquake [13], 2011 Christchurch earthquakes [40] and 2016 Kaikoura Earthquake [3]. Some examples of the damages are shown in Fig. 7. Such widespread damage can lead to evacuation, consequent downtime and repair costs, which can reach up to 90% of the total building repair costs [12,42]. It is, therefore, crucial to increase the seismic resilience of partition walls to avoid such unfavorable outcomes. Several tests of partition walls with isolated (not mechanically attached) steel studs and tracks/runners, vertical joint gaps at the interfaces of wallboards and between the wallboards and adjacent vertical boundary elements (e.g. structural column, orthogonal partition wall) have shown improved seismic performance of the partition walls [22,28,40]. However, larger widths of vertical gaps cause aesthetic issues and higher initial costs associated with gap fillers and labor requirements.

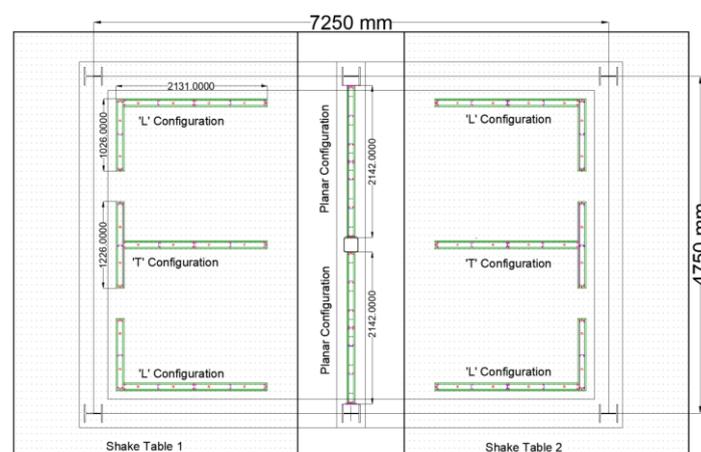
Fig. 8 – Partition walls in test structure

In order to observe and verify the seismic resiliency of the partition walls incorporating these novel details, three configurations of the partition walls ('Planar', 'L' and 'T') with these novel details will be placed in the ground level of the test structure. The 'Planar' configuration will be attached on top of the ring beam and the top beam directly above, whereas, the 'L' and 'T' configurations will be attached directly on top of the shake table below and the composite deck above as shown in Fig. 8.

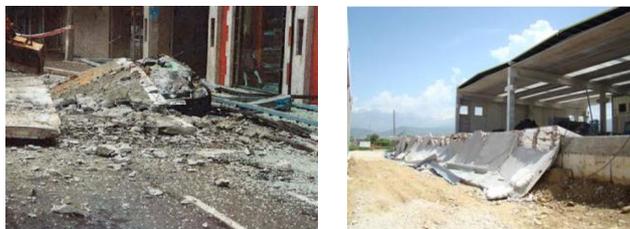
Fig. 9 – Damaged panels [2,10]

Architectural cladding or façade systems came into picture with the advent of frame structures. The main function of cladding is to provide a barrier between the interior and exterior environment of the building. In seismically active zones, precast concrete panel systems are generally characterized by their connections and joints. It is common practice to isolate the precast cladding panels from movements of the flexible structure through tie-back (slotted/oversized holes) or push-pull (flexible threaded rods) connections [1,29]. Unfortunately, several failures of sliding fastenings (and/or panels) were observed following the recent earthquakes around the world [2,4,10,23] due to faulty installation and/or inadequate displacement and strength capacities of the connections (Fig. 9). The slotted connections typically performed poorly in relation to their design intent during the recent Canterbury earthquakes [35]. Damages to the precast cladding panels can lead to economic losses, repair downtime and fatalities. This has motivated the development of novel precast concrete cladding connections which allow panels to rock under seismic actions, without any significant diagonal forces being developed within the panels, to increase the seismic resiliency of the panel system.

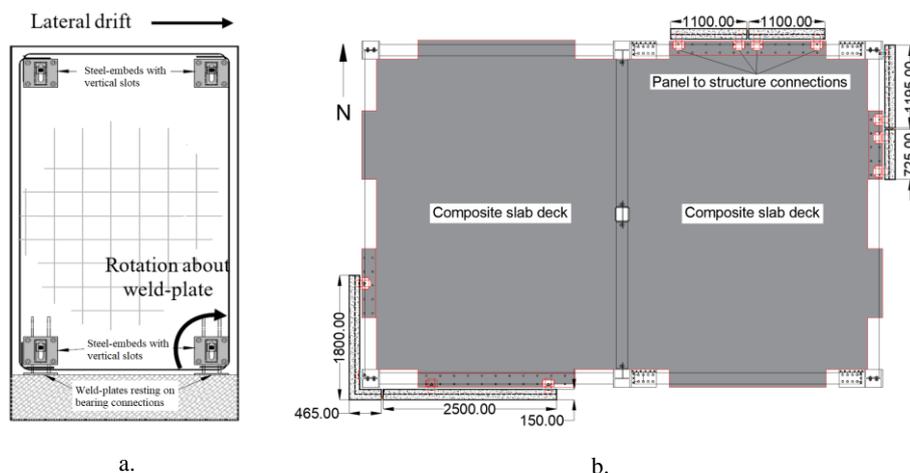
Fig. 10 – a) Novel steel connections; b) Plan showing panel configurations at two opposite corners of the test structure.

The low-damage connections to be used in this research include steel-embed with vertical slots and weld-plates cast into the panels as shown in Fig. 10a. The weld-plates seat on top of the bearing connections and prevent the local spalling and chipping of concrete during rocking of panels. The vertical slots in steel embeds allow panel to efficiently rock up to desired inter-story drift while resisting the out-of-plane face loads in the panels. They are also expected to reduce the possibility of clashing between panels located at corners of buildings even at small vertical joint gaps. Further details regarding the concept, design, fabrication, installation and higher seismic resiliency of the panel system under lateral cyclic loadings can be found in [6,7].

To verify the improved seismic performance of the precast panel system comprising these novel connections under dynamic shaking, one story height precast cladding panels will be installed at the diagonal corners on the upper two stories of the test structure as shown in Fig. 10b.

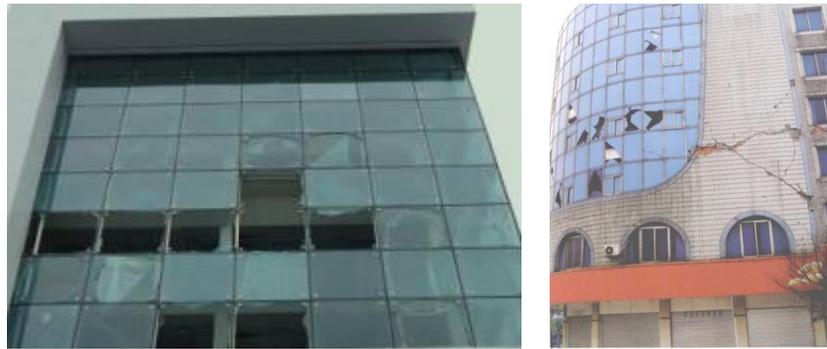
Fig. 11 – Glazed Curtain Wall Damages [4,43]

Unitized glazed curtain walls (UGCWs) have become widely used as exterior cladding of multistory building structures. They are regarded as desirable because of their aesthetic, thermal, lighting and construction characteristics. However, damage in previous earthquake events, as shown in Fig. 11, has caused significant economic loss and posed a life-threat to passersby and to occupants.

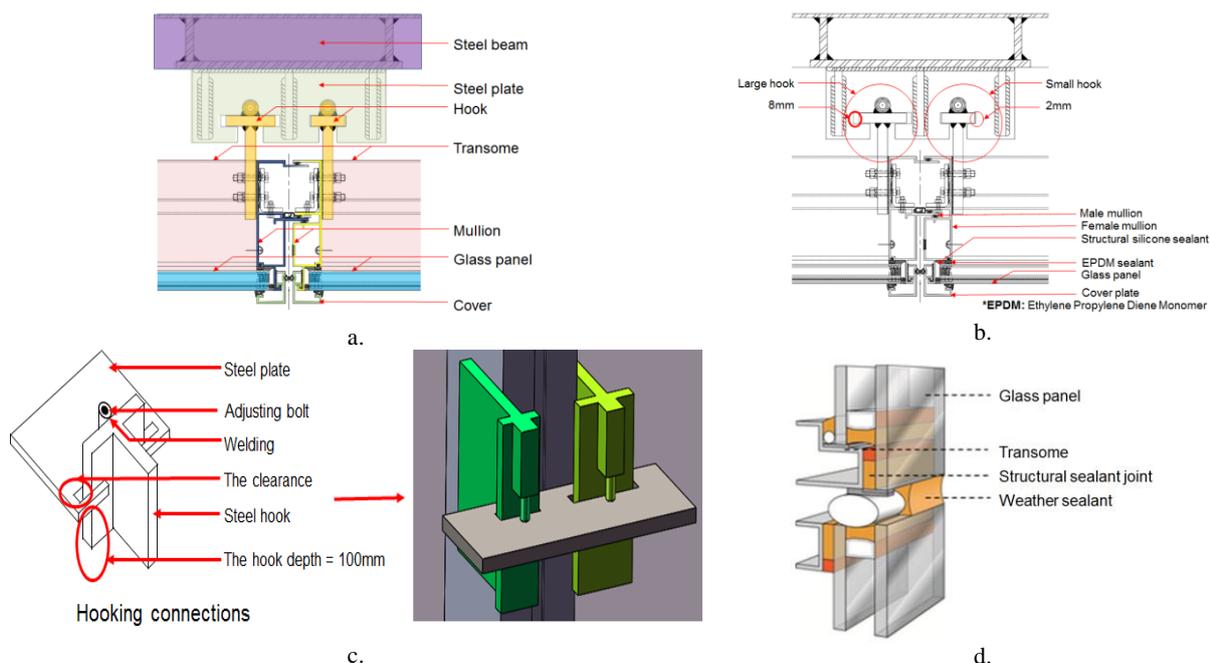
Fig. 12 – (a) Plan view of mullion; (b) Sealant details; (c) Hook details; (d) 3D view of transom [26]

UGCWs typically consist of pre-assembled modular panels consisting of several panels of glass held within metal (often aluminum) frames with vertical elements (mullions) and horizontal elements (transoms) by structural silicone sealants. Soft material is also placed between panels to provide protection of the building from the external environment. It may be seen that there are 3 barriers to air movement (with 2 internal chambers). The glass, frame, and soft material (silicone or rubber), together provide lateral force resistance (Fig. 12). In typical Chinese construction, panels are suspended from the top by hooks (which allow uplift), and sit within slots on the top of the panels below which allow in-plane movement and vertical uplift, but limit out-of-plane movement. Panels are then clipped together along the vertical edges. In some cases, especially when large inter-story drifts are expected, shear keys are placed at the bottom of panels into the top of the panel below restricting in-plane movement.

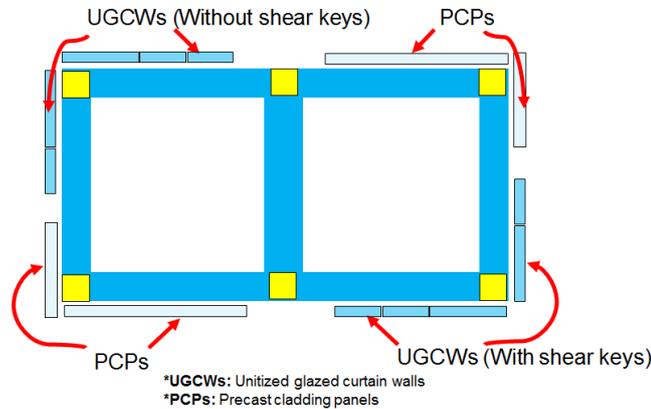
Fig. 13 – UGCW Test Configuration

UGCWs are to be placed on the top two levels and opposite corners of the test structure. The UGCWs configuration includes three side-by-side primary panels in the longitudinal direction and two adjacent panels in the transverse direction at each corner as shown in Fig. 13. UGCWs panels at one corner are equipped with shear keys, while no shear keys are provided at the other corner.

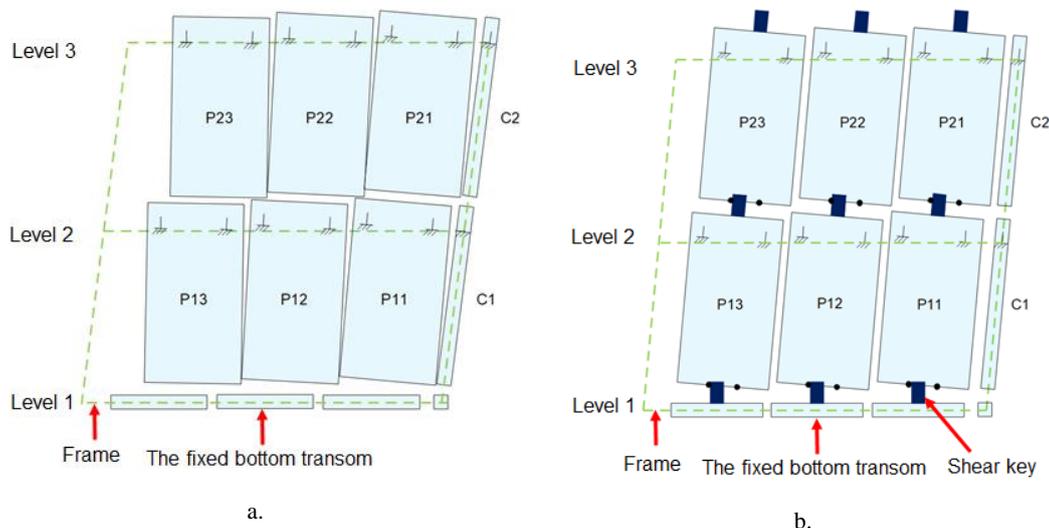
Fig. 14 – Deformation mode of UGCWs: (a) without shear keys; (b) with shear keys.

The expected effect of shear keys on deformation mode is shown in Fig. 14. It is expected that large drifts with minimal damage may be obtained with shear keys, but even when shear keys are not provided the performance may also be satisfactory for some configurations and when inter-story drifts which are not too large. For UGCWs without shear keys, the drift capacity may be related to the clearance between adjacent panels.

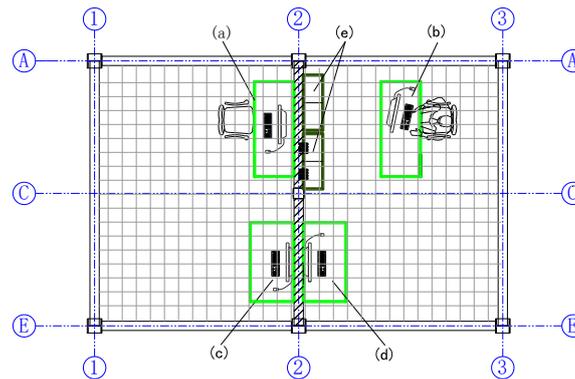
Fig. 15 – Plan view of contents set in the third story

During recent severe earthquakes, it was observed that contents, such as beds, bookshelves, tables and photocopiers might move over long distances at high velocity and cause injuries, damage, and business disruptions. A number of analytical and experimental studies have been carried out on the sliding of contents at the University of Canterbury [44]. For further study of the seismic response of contents under different constraints, five groups of contents will be set in the third story. The five groups of contents are shown in Fig. 15. The different layouts are introduced as following:

- i. A table obstructed by the partition wall (one-way sliding), a computer on the table and a chair;

- ii. A table not obstructed by the partition wall (two-way sliding), a computer on the table, a chair and a manikin;
- iii. A table restrained to the partition wall (no sliding), and a computer on the table beside the partition wall;
- iv. A table restrained to the partition wall (no sliding), and a restrained computer on the table;
- v. Two bookshelves, with one obstructed by the partition wall (one-way sliding), while the other one is restrained to the partition wall (no sliding).
