EFFECT OF IN-PLANE SHEAR STIFFNESS ON DYNAMIC CHARACTERISTICS OF FULL-SCALE CEILING SYSTEM

Keywords: JPN-US suspended ceiling; In-plane shear stiffness; Numerical analysis model; Shaking table test

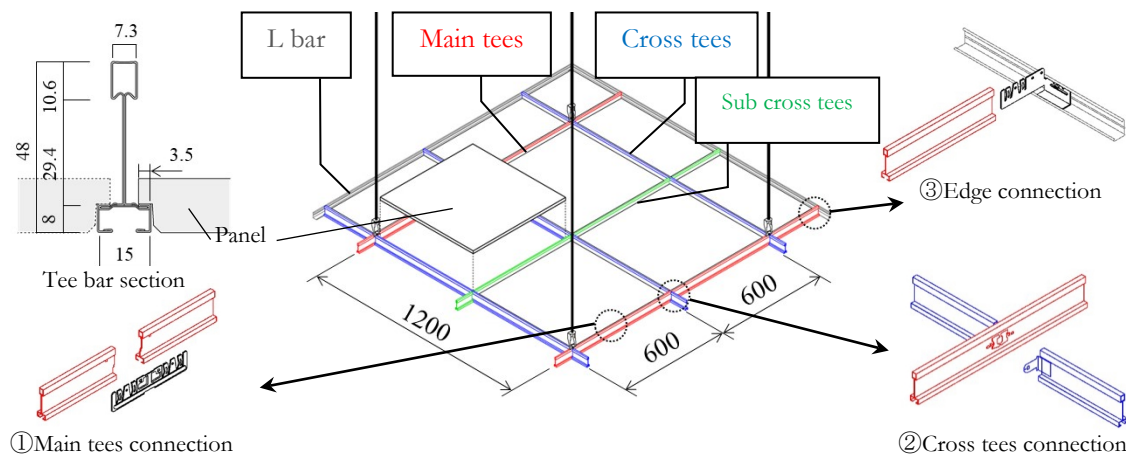
Fig. 1 Component configuration of the JPN-US ceiling

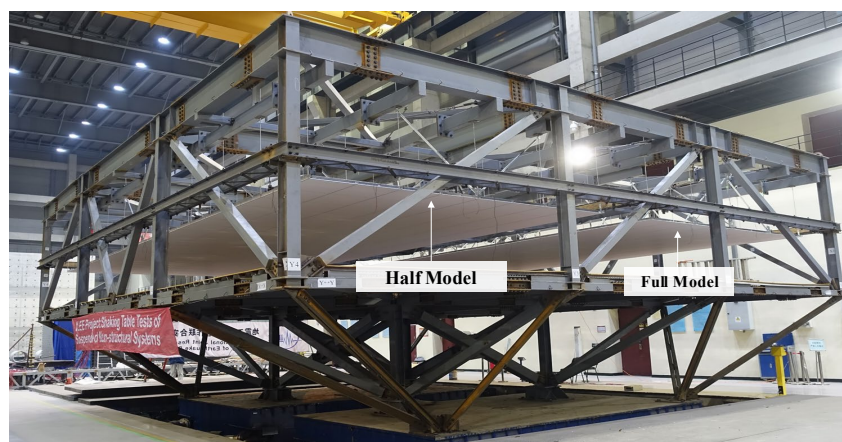
Photo 2 Overall view of the test specimen and supporting frame

This experiment is designed to confirm the effect of brace arrangement on the seismic performance of the ceiling system, in particular, focus on the influence of eccentricity of the brace mounting position, and the evaluation of the ceiling-in-plane shear stiffness shown in the past studies [7]. Testing was conducted by using two of the 4m x 6m bi-axial shaking table at Earthquake Engineering Hall of Tongji University in Shanghai, China (Photo 2). The frame supporting the ceiling specimen and the outline of the specimen is shown in Fig.2. The test specimens have two ceilings of the same size, which plane dimensions are 4.8m x 12m (160 ceiling panels of 600mm x 600mm). To observe a completely stable state of the ceiling system, a clearance around 200mm is provided around the ceiling surface so that it does not interfere with the steel beam for measurement even after vibration.

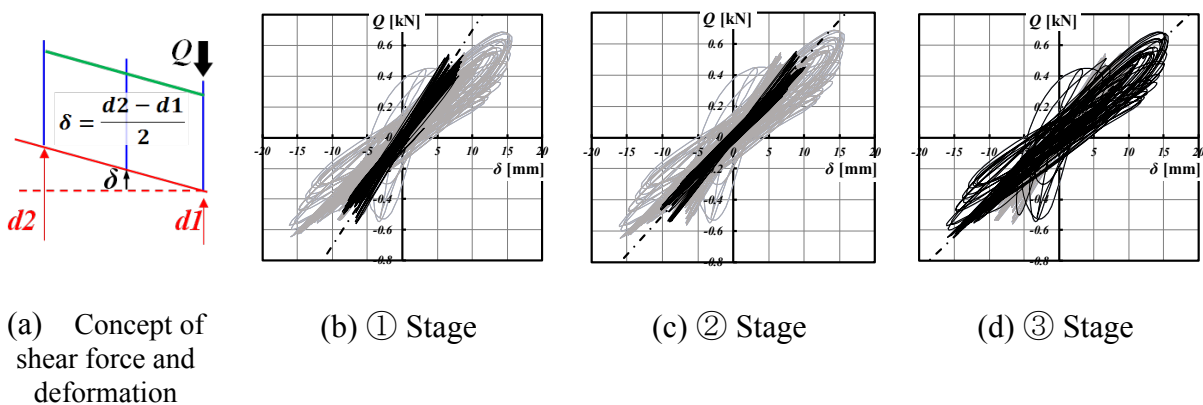
Fig.7 In-plane shear force and deformation per panel during Sweep 500gal

Fig. 6, 7, and 8 show the displacement time history, shear force-relative displacement of the outermost panel, and Y-direction displacement distribution at the d3 position (where the brace is installed at the 9.6m position in Figure 8) of the half model. First, in stage ①, the displacement at the place where the brace is installed gradually increases, and the mounting bracket attached to one of the V-shaped braces breaks, causing a transition to stage ②. After that, the mounting bracket of the other brace is also broken, and the process moves to stage ③. In stage ③, due to the disappearance of the bracing effect, the inertial force concentrates on the remaining brace that has not yet broken, so that the panels near the remaining brace fall and the displacement further increases. Later, the ceiling surface collided with the surrounding beams, and the ceiling surface was almost completely collapsed. **Photo 3** shows the situation of the panel falling, the breaking of the suspension bolt in full model, and breaking of the mounting bracket in half model.

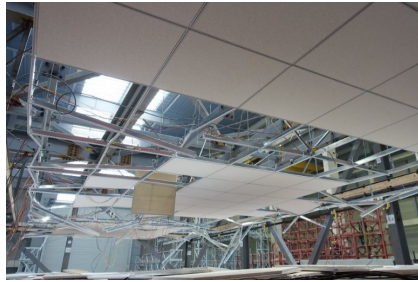
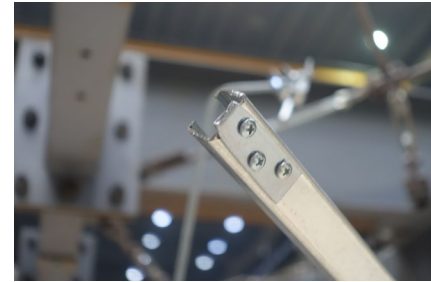
(a) The situation of the panel falling

(b) Early fracture due to low cycle fatigue of suspension bolt

(c) Failure of brace mounting bracket

Photo3 Failure mechanisms confirmed by experiment

When larger motion is input at Sweep 250gal in X-direction, in the full model, the inertial force in longitudinal Y-direction was collected by main T-bar from a middle tributary area of 1200mm and transmitted to the middle braces. Premature failure of suspension bolts occurred at suspension base due to low-cycle fatigue failure causing by the high amount of eccentricity. This failure results in large displacement and creates a greater inertial force to neighbor restraint braces, and as a result, suspension bolt fractures one after another, causing ceiling system losing its lateral restraint and collapsed by collided with the surrounding beams. However, the half model is still undamaged due to the small amount of eccentricity.

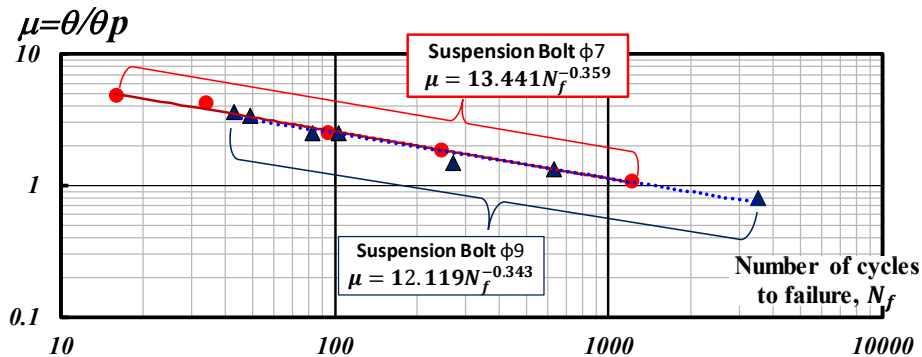
Fig.19 shows the relationship between the deflection angle amplitude and the number of cycles to failure N_f . It can be seen that the larger the acting bending moment or deflection angle, the easier the early rupture due to low cycle fatigue failure, and the relationship is expressed by the equation in the figure.

Fig. 19 Relationship of Deflection angle and N_f
