## SHAKING TABLE TESTS ON CHINESE STYLE SUSPENDED CEILING SYSTEMS

### Abstract

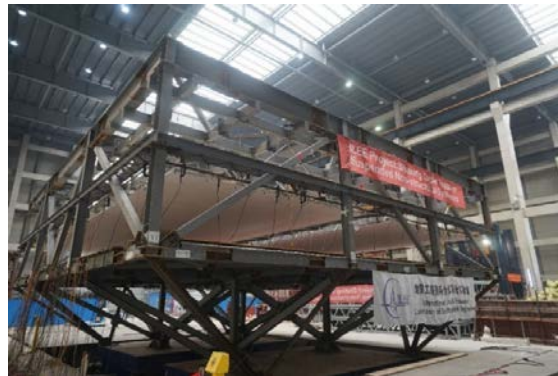
Fig. 1 – Overall view of the steel platform

The shaking table test is the most common method of evaluating the seismic performance of SCSs. The steel platform was used as a test carrier to hang the ceiling. The design of the platform should take into account two basic requirements: (a) the platform has a high fundamental frequency outside of the range of natural frequencies of suspended ceilings to avoid resonance; (b) the platform has reasonable height to facilitate ceiling assembly, maximize its rigidity and minimize the need of calibration of the excitations input to the specimens. Based on the above considerations, the steel platform was designed and constructed for the full-scale shaking table test on Chinese style SCSs. It has two-story with the plane dimensions of 12.84mx11.64m and the height of 5.40m, as shown in Fig. 1.

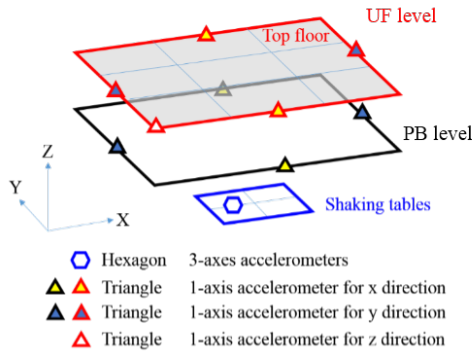
(a) Accelerometers on the steel platform

The location and number of accelerometers installed on the platform are shown in Fig. 3a. To verify the real input of the shaking tables, one 3-axes accelerometers were placed on the shaking tables. There were 5 and 4 accelerometers installed on the top floor (UF level) and peripheral beams (PB level), respectively.

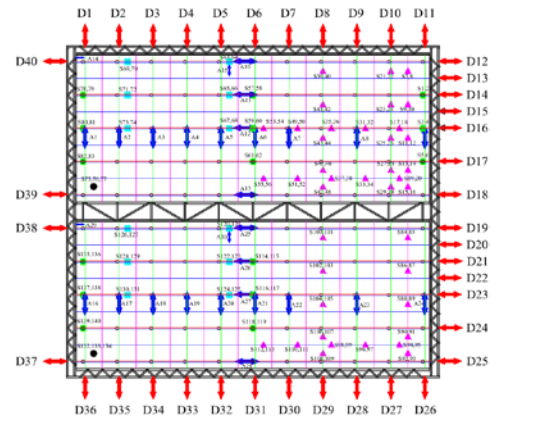
(b) Instruments on the ceiling

A total of 210 instruments including 30 accelerometers, 40 displacement transducers and 140 strain gauges were installed on the specimens to measure the responses of the ceiling system. The location and number of these instruments are shown in Fig. 3b.

Legends	Instrumentations	Ceiling A	Ceiling B
	Displacement transducers for x and y direction	20 CHs	20 CHs
	Accelerometers for x and y direction	15 CHs	15 CHs
	Strain gauges for axial force in M8 threaded rods	18 CHs	12 CHs
	Strain gauges for inner forces in some panels	3 CHs	3 CHs
	Strain gauges for axial force in some grids	50 CHs	30 CHs
	Strain gauges for axial force in carrying channels	12 CHs	12 CHs

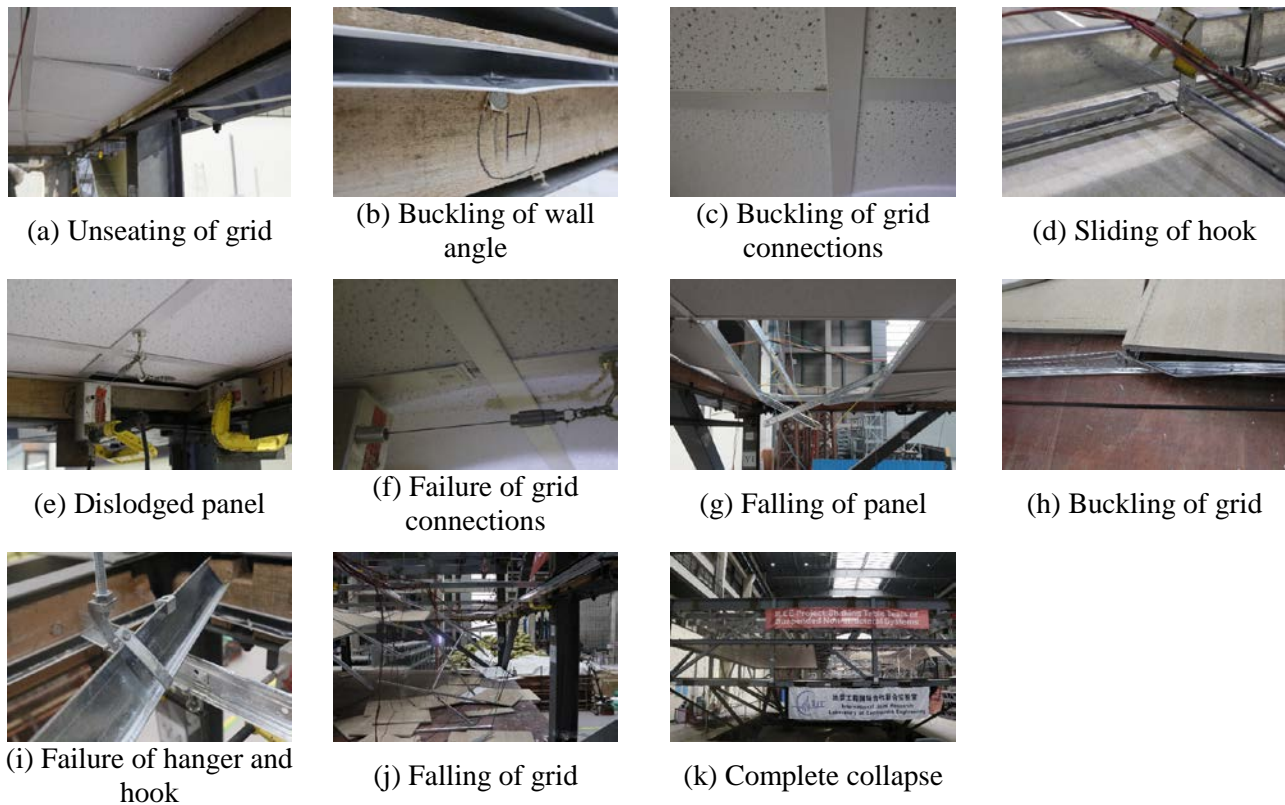
Fig. 5 – Failure process during test

The observed failure process of two specimens is summarized in Table 2 and Fig. 5 showing the sequence of damage to the components of SCS. The damage to the two ceilings after the last run was shown in Fig. 6. After the input of sweep wave with the highest intensity in X direction the rapid unseating of peripheral grid ends from the wall angles, the huge pounding between the ceiling edge and surrounding board, the failure of a large number of ceiling grid connections, and the subsequent falling of lay-in panels supported on grids occurred in Ceiling A, whereas no panels falling off and only a few grid connections buckling and failing were observed in Ceiling B. Compared with Ceiling B, the ratio of falling lay-in panels to total panels reached 71.03% for Ceiling A after all runs were completed. Compared with Ceiling A, the damage to Ceiling B was much slighter. The above results reveal that the Chinese style SCS with seismic clips has better seismic performance than the one without seismic clips.

Serial no.	Damage mode	Ceiling A	Ceiling B
1	Unseating of grid	Y	N
2	Buckling of wall angle	Y	N
3	Buckling of grid connections	Y	Y
4	Sliding of hook	Y	Y
5	Dislodged panel	Y	Y
6	Failure of grid connections	Y	Y
7	Falling of panel	Y	N
8	Buckling of grid	Y	N
9	Failure of hanger and hook	Y	N
10	Falling of grid	Y	N
11	Complete collapse	Y	N
