ANALYSIS OF DAMAGE PHENOMENON BY VIDEO IN VIBRATION TEST OF CEILING / CABLE TRAY USING LARGE SHAKING TABLE

Keywords: US-style suspended ceiling; Cable tray; Damage Phenomenon by Video; Shaking table test

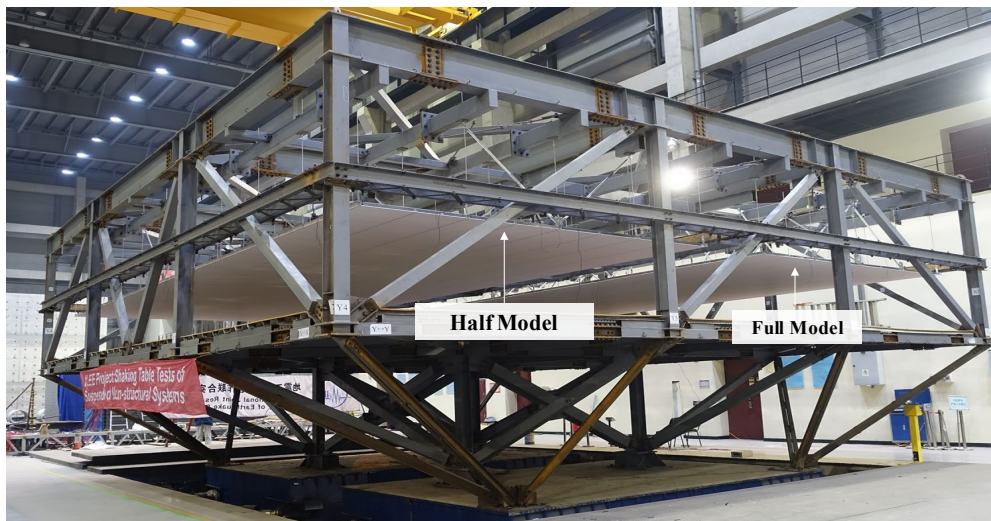
Photo 1 Overall view of the test specimen and supporting frame

Testing was conducted by using two of the 4m x 6m bi-axial shaking table at Earthquake Engineering Hall of Tongji University in Shanghai, China (**Photo 1**).

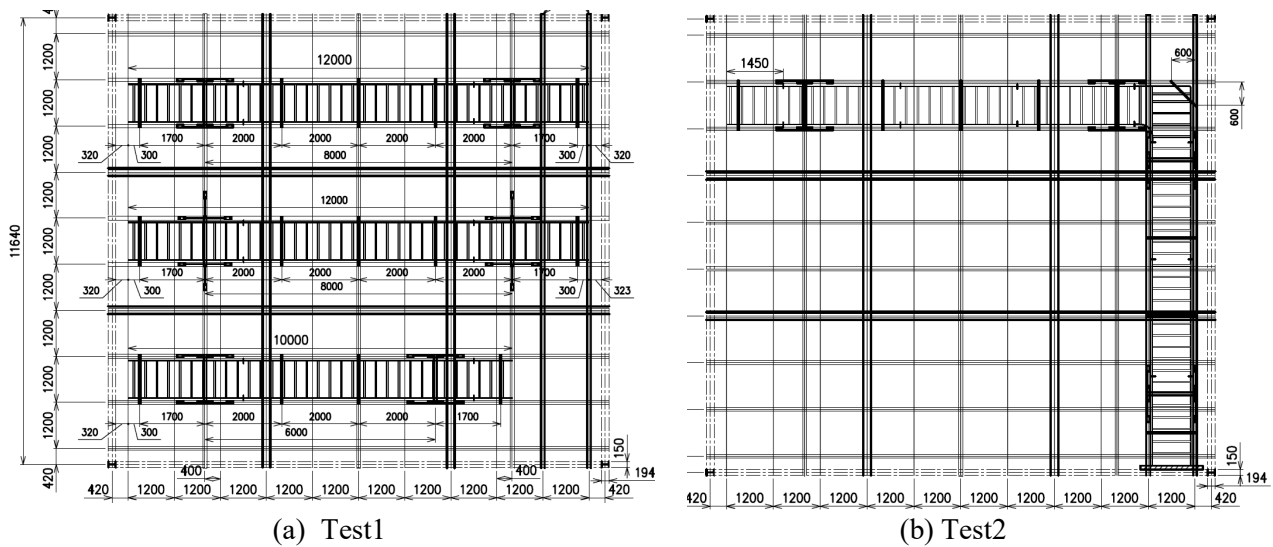
Fig.2 Cable tray layout

The cable tray system tests were carried out twice, Test 1 and Test 2 as shown in Fig.2(a) and (b). As for the Test 1, three long cable tray systems which have different seismic elements Type B, Type A and Type SA were tested and the distribution of each seismic element was set to minimum amount required in Japanese design guideline. In each types have same braces in cable tray direction but different seismic element in perpendicular direction.

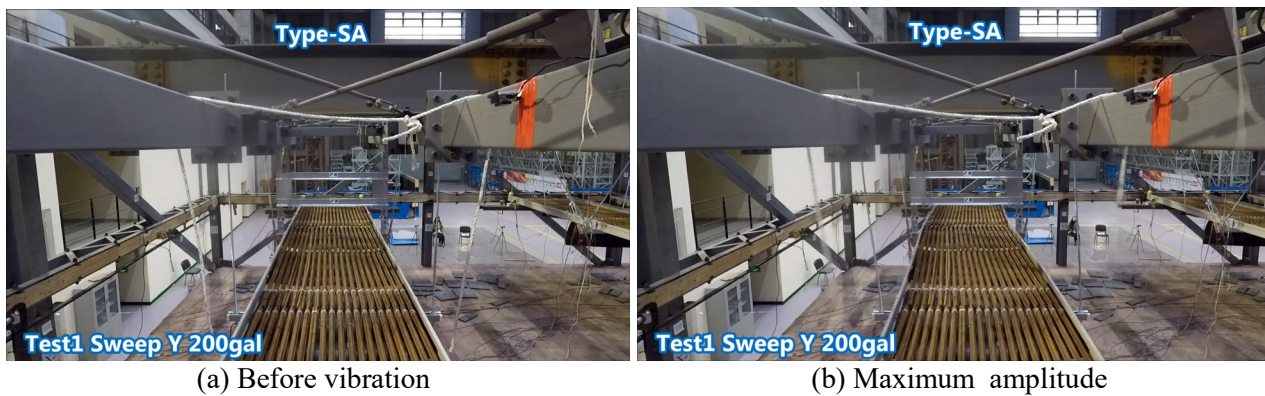
Photo 7 Cable Tray Type-SA

Type-SA had higher amplitudes at higher frequencies, but did not damage the cable tray. Type A increased in amplitude at low frequencies, and the originally rectangular main and sub-girder grids were converted to parallelograms near the seismic reinforcement, causing the sub-girder to drop. Type B increased in amplitude at low frequencies like Type A, but the sub-girder did not drop.

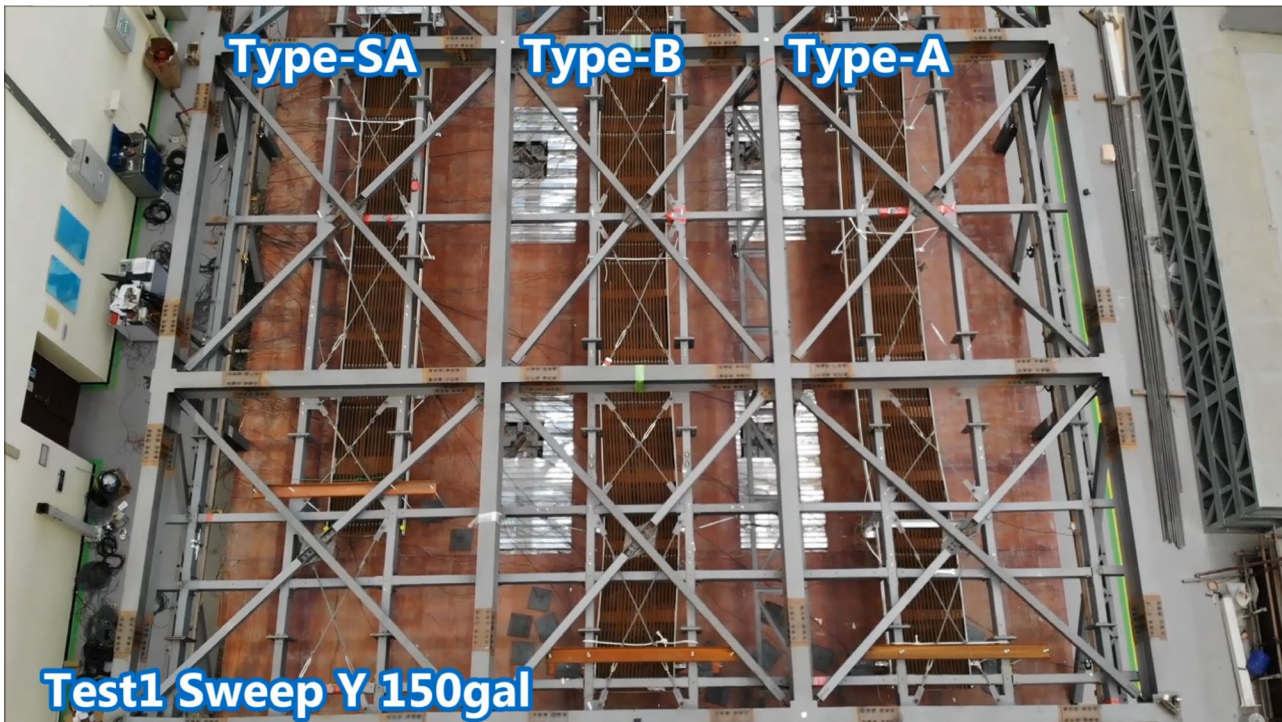
Photo 10 Cable Tray Test1 experiments taken with a drone

Photo 10 shows the experiment of the cable tray Test1 taken with a drone. The difference in vibration characteristics between Type-SA, Type-A, and Type-B can be seen from the recorded video.

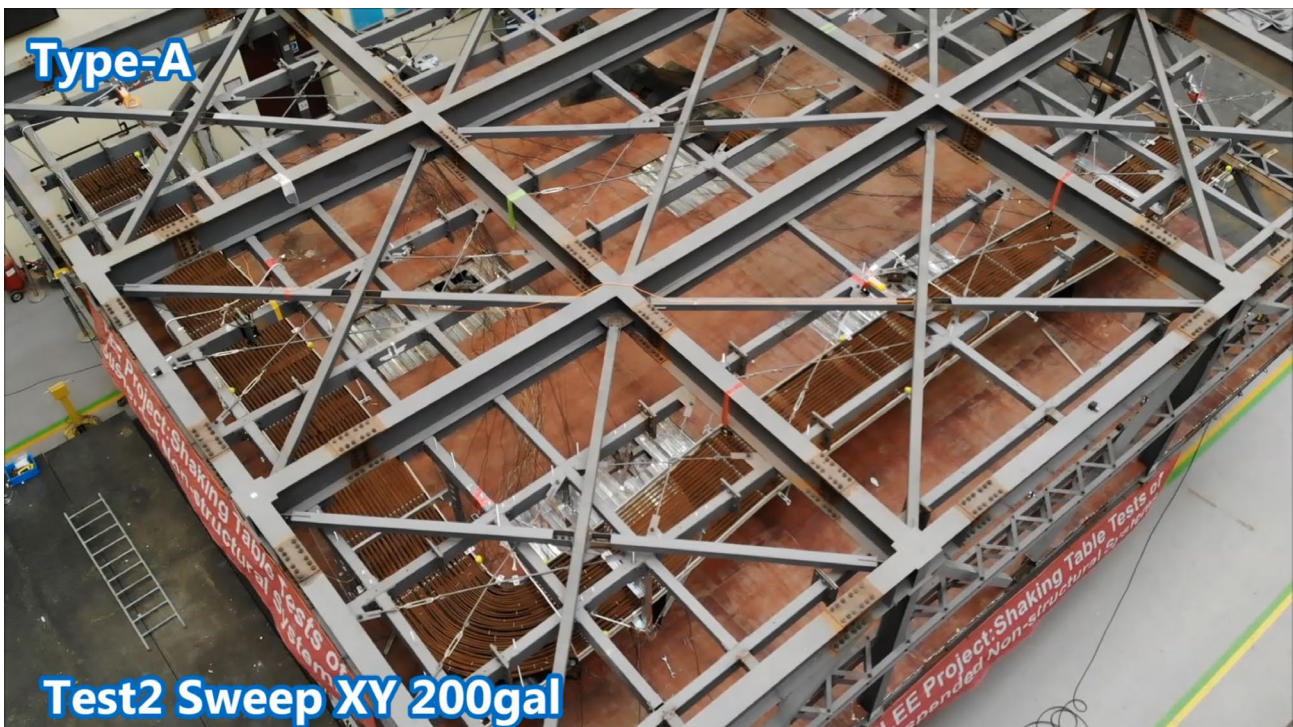
Photo 11 Cable Tray Test2 experiments taken with a drone

Photo 11 shows the experiment of the cable tray Test2 taken with a drone. The displacement of the cable tray was large during the class A seismic support, but no damage occurred in the bending area.
