EXPERIMENTAL STUDY ON ULTIMATE STATE OF CIRCULARLY PLACED BASE ANCHOR

Abstract

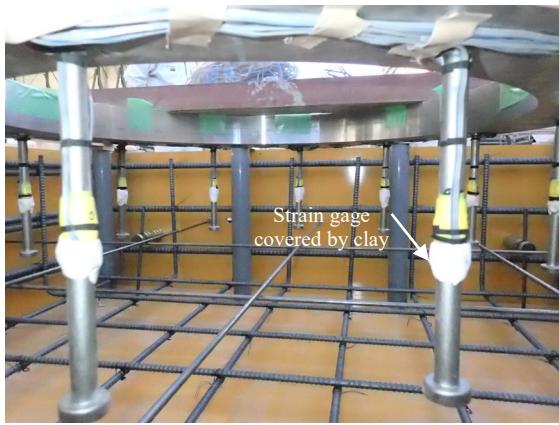
Fig. 5 – Strain gages on anchors

Fig. 5 shows the installation of the strain gauge on the anchor. Two uniaxial strain gauges are installed at the center of each anchor axis. Fig. 6 shows the placement of anchors and the loading direction. The actuator is connected from the north side of the specimen. The loading axis is in the north - south direction. The two gauges on each anchor are installed on the forward and backward surfaces in the loading direction, that is, the north and south surfaces. In the following, the bolt located to the north of the specimen will be called "Anchor No.1". The others will be called "Anchor No.2" to "Anchor No.12" for each in clockwise order when viewed from above.

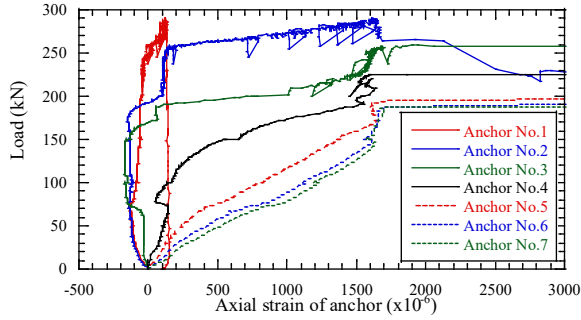
Fig. 9 – Relation between load and strain of anchors(No.1 to No.7) in monotonic loading

Fig. 9 and Fig. 10 show the relation between the load and strain of each anchor. Each figure includes Anchor No.1 and Anchor No.7 which are on the loading axis. Fig. 9 includes the anchors on the east side of the loading axis. Fig. 10 includes the anchors on the west side of the loading axis. The seven legends in each figure are arranged from north to south in order from the top. The horizontal axis in the figure represents the average value of two strain gauges installed on each anchor. The positive value on the horizontal axis is the tensile strain, and the negative value is the compressive strain. Though a strain exceeding $10,000 \times 10^{-6}$ was observed in the test, the yield strain is shown up to about yielding strain of $1,571 \times 10^{-6}$ in the figures to see the yielding condition of the anchor.

From Fig.9 and Fig.10, at the initial stage of loading, tensile strain was generated in the seven anchors on the south side including Anchor No.4 and No.10 located east and west of the specimen. As the load increased, Anchor No. 7, which was on the southernmost and the tensile end of the moment, reached the yield strain first. Next, it was confirmed that the strain reached the yield strain in order from the anchor on the south side to the anchor on the north side. Though Anchor No. 1, 2, 3, 11 and 12 showed the compressive strain at the beginning of loading, these turned the direction of the strain change to the tensile side as the loading progression. Finally, eleven anchors other than Anchor No.1 yielded.

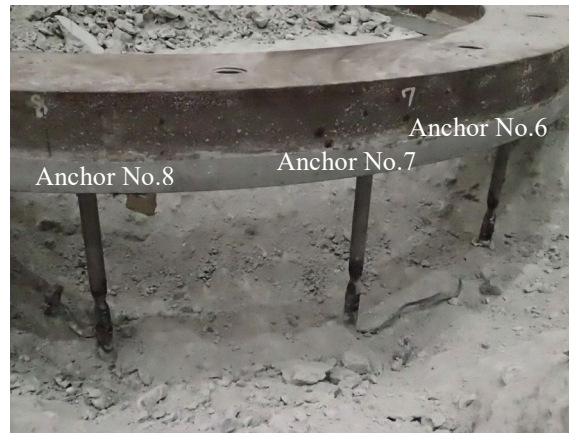
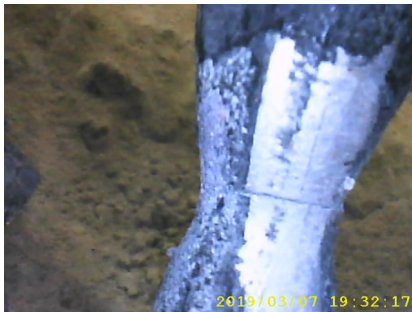
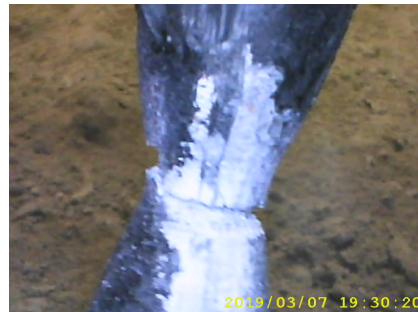
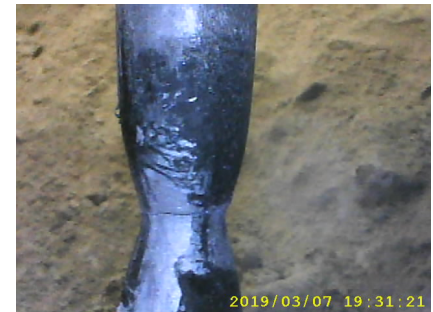
Fig. 12 – Exposed anchors after monotonic loading test

Fig.12 shows the exposed anchors by removing the foundation concrete after the loading test. These are the three anchors (Anchor No.6, 7 and 8) from the southern end. The necking of the anchor was confirmed near the center of the axis where the strain gauge was attached (see Fig. 12 (a)). Fig.12 (B), (c) and (d) show the close-up around the necking with a fiberscope. All three anchors had been broken. After the maximum load during the test, the load suddenly decreased three times with the sound emission. It is considered that these load reductions and sound emissions are due to the sequential break of Anchor No.6, 7 and 8 as shown in Fig. 12. The order of the anchor break is not clear, but it is probable that Anchor No. 7 at the tensile edge broke first, followed by Anchor No. 6 or Anchor No. 8.

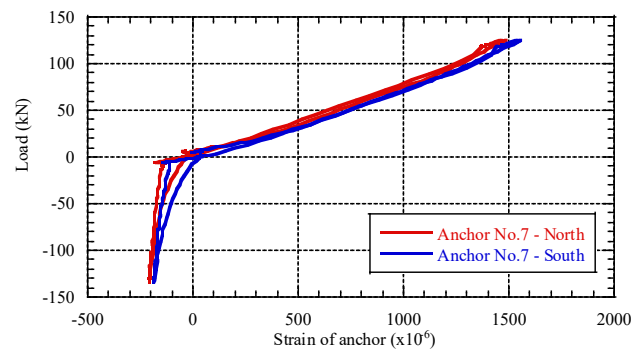
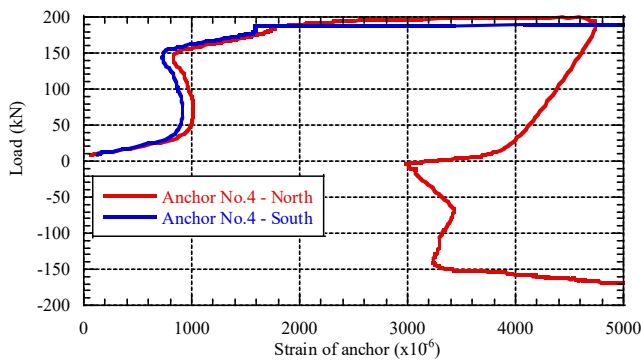
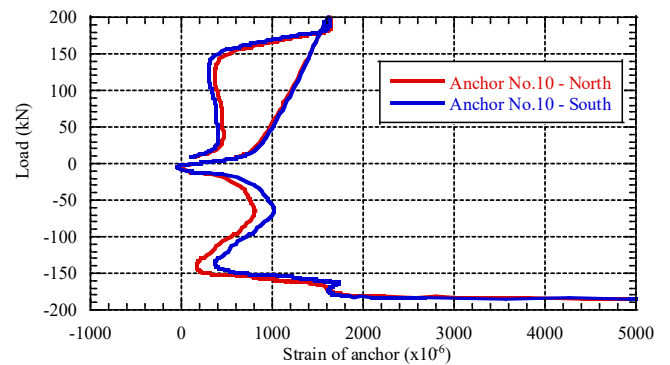
Fig. 14 –Relations between load and strain of anchors in cyclic loading test

Fig. 14 shows a typical example of the relation between load and anchor strain in cyclic loading test. The horizontal axis in these figures represents the strain of the anchor, where tension is positive and compression is negative. The vertical axis represents the load. The load toward the north is positive and the load toward the south is negative.

Fig. 14 (a) and (b) show the relationship between load and strain of Anchor No.1 and Anchor No.7 in the second cycle ($\pm\delta_y = \pm 2.5\text{mm}$). When the load is positive, compressive strain occurs in Anchor No. 1 on the north side and tensile strain occurs in Anchor No. 7 on the south side. The magnitude of the strain is small in the compressed anchor. This is assumed to be due to the effect of bearing pressure between the foundation concrete and the bottom surface of the plate. The loading amplitude in the second cycle is the yield displacement in the monotonic loading test. In this cycle, Anchor No.1 and Anchor No.7 each reached the yield strain of $1,571 \times 10^{-6}$.

Fig. 14 (c) and (d) show the relation between load and strain of Anchor No.4 and Anchor No.10 in the fourth cycle ($\pm 4\delta_y = \pm 10\text{mm}$). In Fig. 14 (d), the strain of Anchor No.10 changes only on the tensile side for both positive and negative loads. In addition, since both Anchor No. 4 and Anchor No. 10 reached the yield strain, so it is considered that all anchors yielded by the fourth cycle.

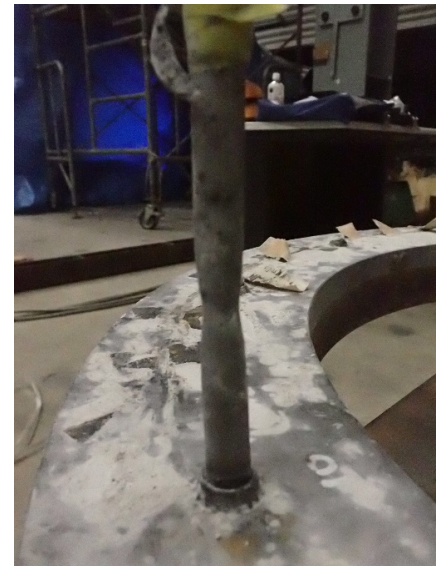
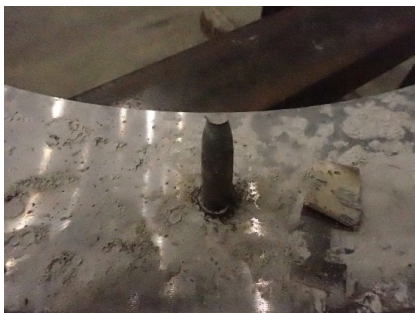
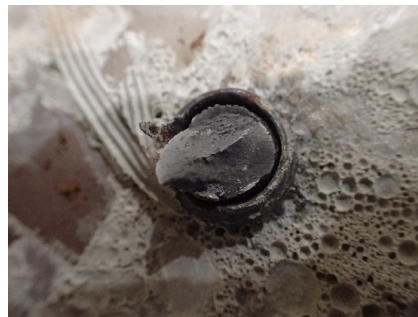
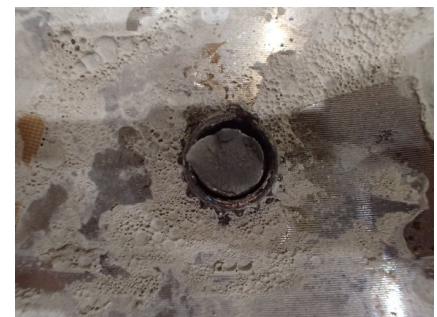
Fig. 15 – Damaged anchors

Fig.15 shows the base plate and anchor that were taken out after the test. Fig. 15 (a) shows the entire lower surface of the base plate, and Fig. 15 (b) to (e) show the condition of each anchor. As shown in Fig. 14 (a), eleven anchors except Anchor No. 10 were broken. Looking at the broken anchors, the broken state is divided into two types. Anchor No.1 to No.4, Anchor No.11 and No.12, which were on the north side at the time of the test, broke at a position of about 40 mm to 50 mm from the lower surface of the base plate. On the other hand, Anchor No. 5 to No.9 on the south side broke near the joint to the lower surface of the base plate.

In the above, it is mentioned that in the sixth cycle (see Fig. 13 (h)), from horizontal displacement of -25.50mm to -37.09mm, the load drop of about 30kN with the sound of anchor break occurred. When the loading point is displaced to the negative side, that is, to the south side, it is the anchor located on the north side that becomes tensile. Therefore, the five breaking sounds generated in this cycle are considered to be any of Anchor No.1 to No.4, Anchor No. 11 and No.12. Assuming that the anchor break occurs sequentially from the tensile edge of the moment, it is probable that five of them except Anchor No. 4 broke in the sixth cycle.

In the 7th cycle, there were six load drops of about 10 kN with smaller sound and finally a load reduction of about 30 kN with larger sound. It is considered that one of the six load drops of about 10 kN accompanied by a small sound was caused by something other than anchor break. It is thought that the remaining five load drops were caused by the break of Anchor No. 5 to No. 9 on the south side.

The load drop of about 30kN accompanied by the last large sound is considered to be due to the break of Anchor No.4 from the similarity of the sound magnitude, the load drop amount and the breaking mode. Since Anchor No. 10 remains without break, it is reasonable to assume that Anchor No. 4 on the opposite side of the loading axis broken last.
