USE OF UAVS IN RESIDUAL DISPLACEMENT MEASUREMENT FOR MOORING FACILITIES AFTER EARTHQUAKE

Y. Ohya⁽¹⁾, E. Kohama⁽²⁾

⁽¹⁾ Principal Researcher, National Institute of Maritime, Port and Aviation Technology, ooya-y@p.mpat.go.jp

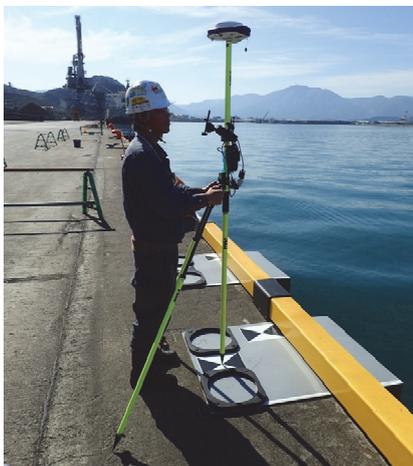
Photograph 1 – Survey using RTK-GNSS method with GNSS receiver. Coordinates are measured at the center of the anti-aircraft sign on the quaywall model.

Two types of UAVs were used with different flight methods: a rotary-wing and a fixed-wing, as shown in Table 1. In addition to the differences in flight methods, the major difference is the presence or absence of RTK positioning. In this study, a fixed-wing UAV capable of RTK positioning was used for the survey to confirm the usefulness of RTK positioning. To compare the accuracy of the displacement measurement, a direct measurement method with a GNSS receiver capable of RTK positioning (hereinafter referred to as RTK-GNSS) was also used (Photograph 1).

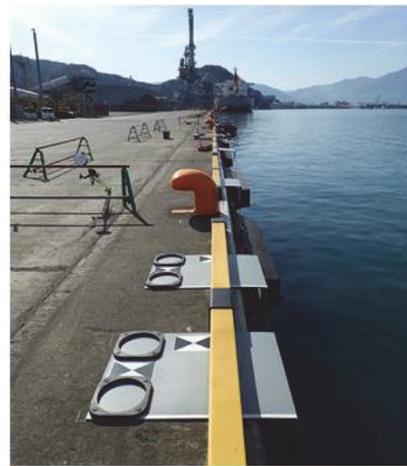
Photograph 2 – Installation of the model of quaywall (after moving). The prescribed displacements of the model are 5, 10, 20, and 50 cm horizontally and 16 cm vertically from the front.

Five models of the quaywall made of wood veneer were set up in parallel to simulate the residual displacement of the quaywall (Photograph 2 and Fig. 1). To simulate different displacements caused by an earthquake during this experiment, each model was set to displacements of 5, 10, 20, 50, and 16 cm horizontally and vertically, and moved by a prescribed amount of displacement while being measured with a measuring tape.

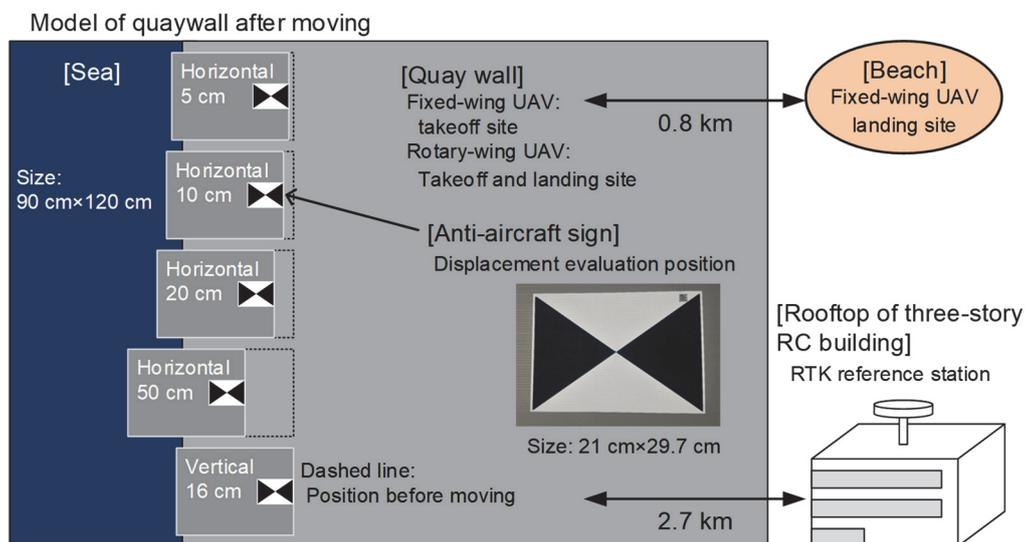
Fig. 1 – Schematic diagram of quaywall model

The on-site field experiment was conducted at Tsuruga Port in Shiga Prefecture, Japan. A 230-m long berth was targeted for the survey, and the models of the quaywall were installed in a part of the berth, and the displacement was evaluated at the position of the models (Figs. 1 and 2). Images were photographed by the UAVs before and after the models were moved a prescribed amount, and the difference in coordinate values before and after the movement was defined as the amount of displacement. The RTK-GNSS, which has a

For the RTK-GNSS, the reference station was set at a distance of 2.3 km from the quaywall, assuming an actual operation, as shown in Fig. 1. Because the RTK-GNSS evaluates the relative distance between the reference and the measurement points, the effect of the crustal movement can be eliminated from the measured values if the amount of crustal movement that occurs during a large earthquake is the same for both points. In other words, if the displacement is evaluated from the comparison of the coordinates before and after the earthquake, the crustal movement will be included, and the amount of residual displacement necessary for determining of the availability of the facilities cannot be evaluated. The UAV equipped with RTK positioning (fixed-wing type) used the same reference station as the RTK-GNSS.

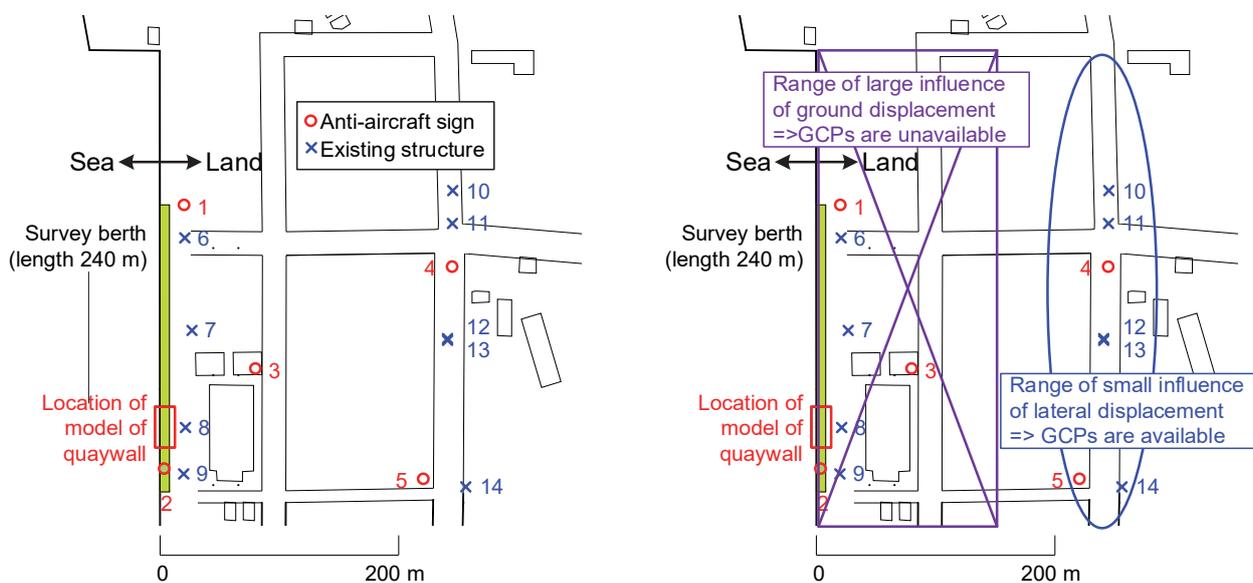
Fig. 2 – Location of quaywall model and GCPs (left) and restriction of GCP use after earthquake (right)

In the case of a large-scale earthquake, the GCPs behind the quaywall are unlikely to be available owing to a ground displacement. When GCPs are moved, it is necessary to measure their coordinates after the earthquake, but it is difficult to enter the site for a coordinate measurement owing to the issuance of a tsunami warning. For the range of influence of the ground displacement, referring to the case of Kobe Port (Fig. 3), if the ground is displaced within a range of 150 m from the waterfront, the GCP on the landward, which is located more than 200 m from the waterfront, will not move. Therefore, it is assumed that only the GCP on the landward side can be used after an earthquake (Fig. 2).

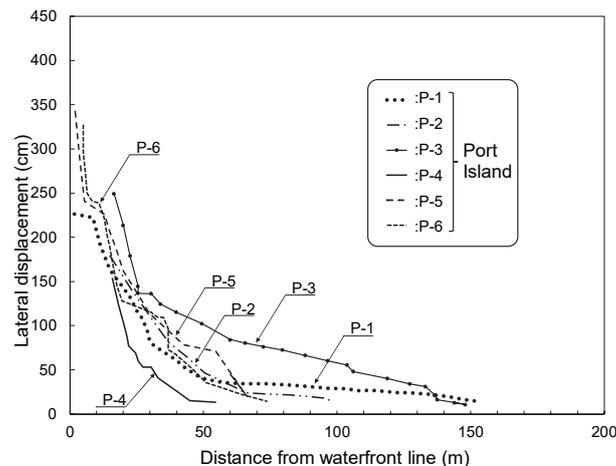
Fig. 3 – Distribution of lateral displacement behind the quaywall^[4]

Fig. 3 shows the relationship between the distance from the waterfront and the horizontal displacement at Port Island during the 1995 Hyogoken-nanbu Earthquake. This displacement distribution was obtained by measuring the widths of the cracks on the ground surface and adding them together. In addition, horizontal displacements of more than 2 m occurred at the quaywall, and the displacements of most of the measuring lines converged at a constant point 150 m from the waterfront. It is clear that when soil liquefaction occurs in reclaimed land, the displacement of the quaywall will affect the area several hundred meters away.

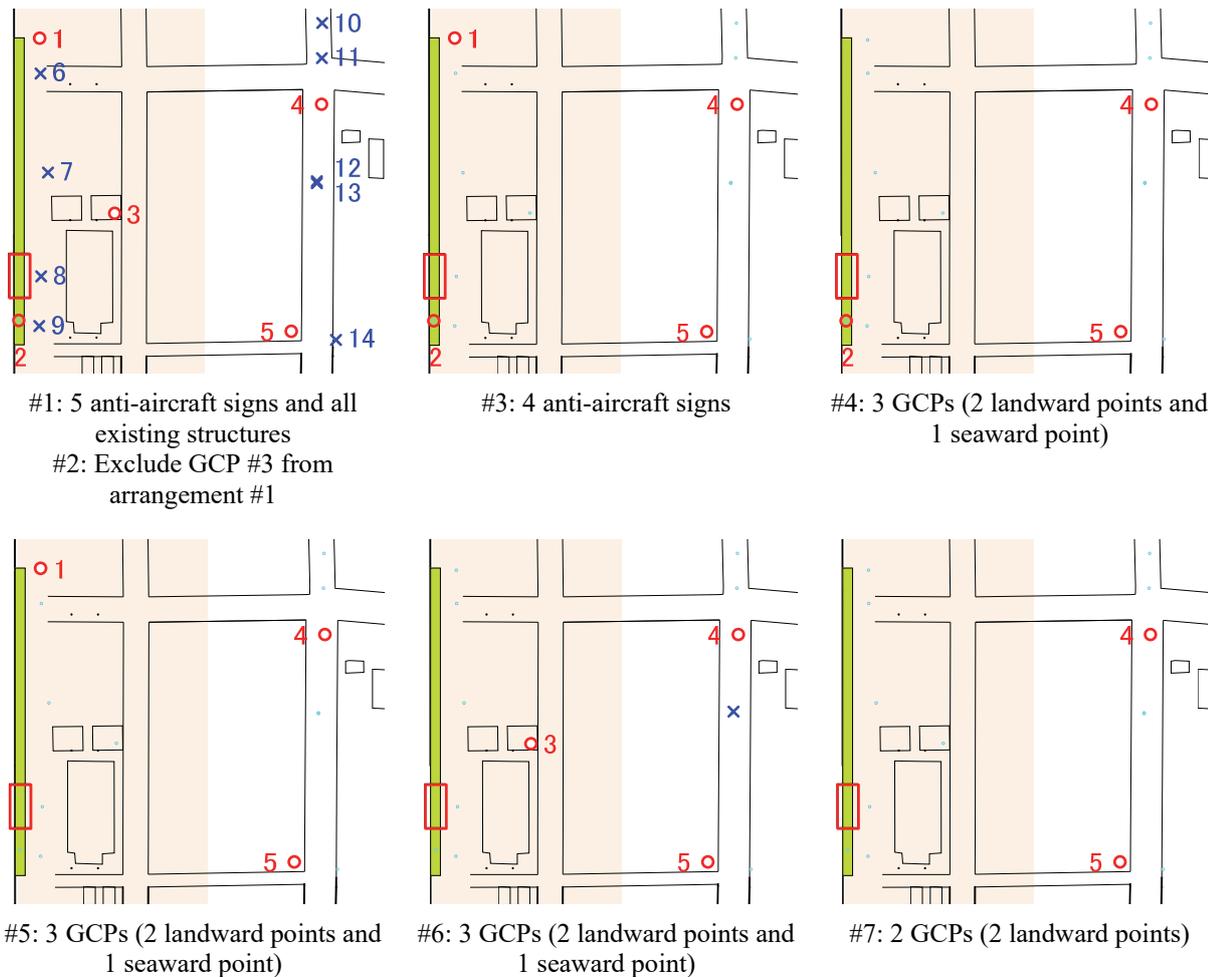
Fig. 4 – Arrangement of GCPs for image processing

Fig. 4 shows the list of GCP arrangements set during the image processing. In this study, in addition to the anti-aircraft sign, parts of the existing structures were used for the GCP. Many different GCP arrangements were considered added to the two GCPs on the landward that can be available at the time of disaster (arrangement #7). The case of no GCP was set because it was unclear whether image processing was possible without GCPs and whether accuracy could be ensured after an earthquake. In addition, a fixed-wing UAV capable of RTK positioning can ensure a high measurement accuracy for photographic coordinates without setting the GCP, and thus it was used to confirm whether RTK positioning is advantageous during a disaster. Arrangements #1 and #2 use almost all of the measured GCPs, and are compared with arrangement #3, which is installed only in the four corners of the photography range.

As described below, the image processing of only two points on the landward side, which is assumed to be after a disaster (arrangement #7), resulted in poor orthoimage quality and an inability to identify the coordinate evaluation position, and even when it could be identified, the displacement was on the order of

meters. Therefore, in addition to the two points on the landward side, one additional point was added on the seaward side to create a three-point GCP configuration (arrangements #4, #5, and #6). These three cases with three GCPs are different in terms of the distance between one GCP on the seaward side and the model of the quaywall. These cases correspond to the case in which a person enters the facility at the time of disaster and measures the coordinates of one GCP point, or where a single GCP point is set on a substantial structure that is unaffected by ground displacement, although this is not a realistic condition.

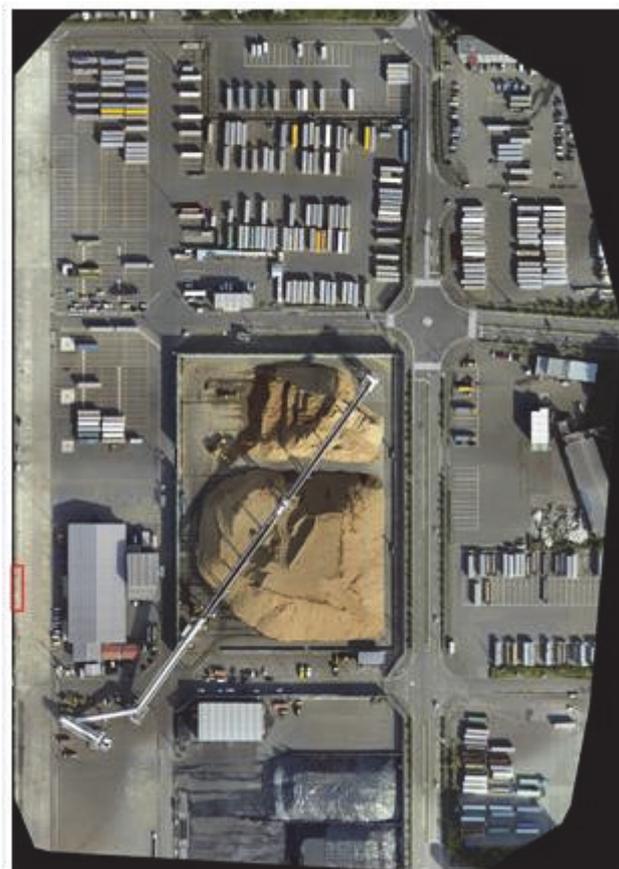
Fig. 5 – Orthoimage photographed by fixed-wing UAV before moving. The location of the quaywall model is shown in the square box.

More than 100 images photographed by the UAVs (Table 1) were applied for the image processing using Pix4Dmapper software^[5] to produce the orthoimages and a digital surface model (hereinafter referred to as DSM), as shown in Figs. 5 and 6. Then, using Global Mapper software^[6], the displacement evaluation positions were set from the orthoimages and the coordinate values were extracted from the DSM. The displacement evaluation position was the center of the anti-aircraft sign attached to the quaywall model.

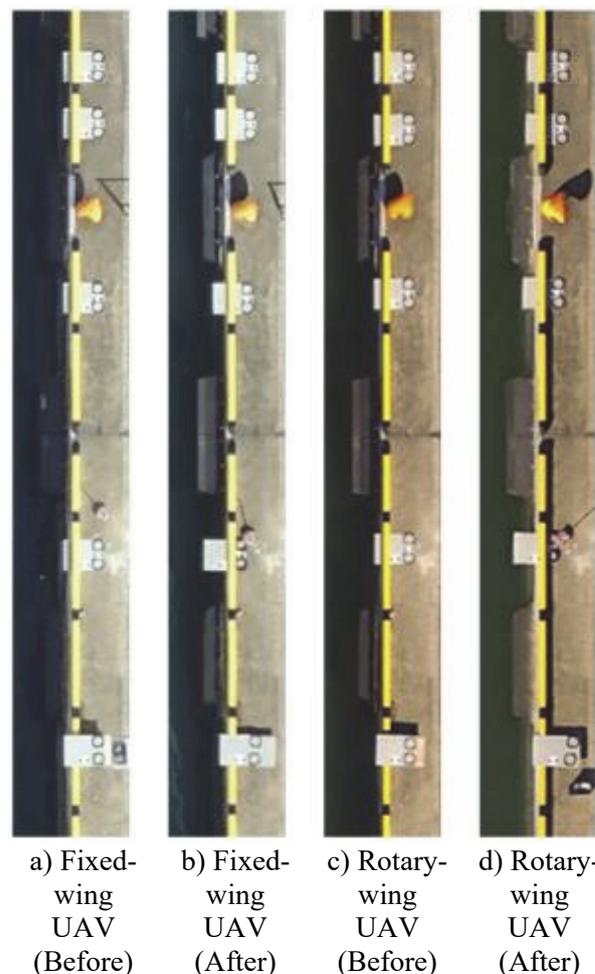
Fig. 6 – Enlarged orthoimage near the quaywall model. The prescribed displacements of the model are 5, 10, 20, and 50 cm horizontally and 16 cm vertically from the top.

In this study, the resolution of the images was low owing to the high flight altitude of 100 m. However, the enlarged orthoimages showed that the image quality was good enough to identify the center of the anti-aircraft sign. In addition, the difference in the movement of the quaywall model between the prescribed displacement of 5 cm and 10 cm could be clearly judged visually from the enlarged orthoimages (Fig. 6).

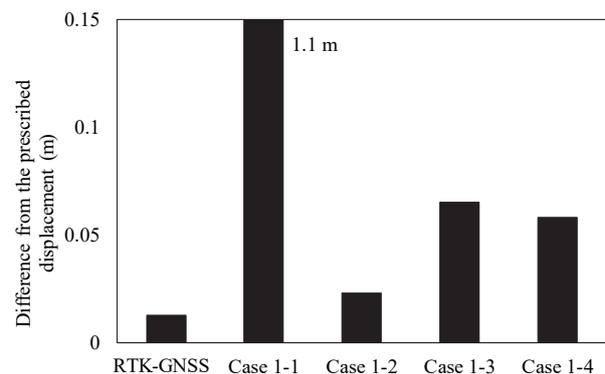
Fig. 7 – Comparison of measurement accuracy in Part 1. Vertical axis: Error in each case. RTK-GNSS: Average of two results of RTK-GNSS. Case 1-1 is 1.1 m above the maximum value of 0.15 m on the vertical axis.

The results of UAV photogrammetry are shown for a total of four cases: rotary-wing (without RTK positioning) and fixed wing (with RTK positioning), and the presence or absence of the GCP set during image processing. Fig. 7 shows the error in bold from Table 3. The error was 23 mm for the rotary-wing UAV (Case 1-2) and 58 mm for the fixed-wing UAV (Case 1-4) when the GCPs were set, and the accuracy was higher for the rotary-wing. However, looking at the results other than the maximum value in Table 3, the fixed-wing UAV results were also measured with an accuracy of less than 1 cm. The reason for this difference in accuracy might be due to the blurriness of the images. The fixed-wing UAV has a higher flight altitude and a lower overlap ratio than the rotary-wing UAV, and the camera is fixed to the main body (in the case of a rotary-wing UAV, it is fixed to the gimbal), which is considered to be a disadvantage in the measurement conditions.

Without the GCP, the error of the rotary-wing UAV was more than 1 m, and the measurement error of the positional coordinate became the error of the displacement difference. By contrast, the error of the fixed-

wing UAV was 65 mm, indicating a certain accuracy of the displacement measurement even without the GCP. When evaluating the displacement of a facility from the positional coordinates of three-dimensional point group data, correction by the GCPs is essential during image processing; if RTK positioning is available, a certain level of accuracy can be ensured for a displacement measurement because the coordinate measurement accuracy is high even without correction by the GCPs. In addition, as mentioned earlier, RTK positioning can be used to exclude the crustal movement, and photogrammetry using a UAV capable of RTK positioning is advantageous as a method for measuring the residual displacement of the mooring facilities in the event of a large-scale earthquake.

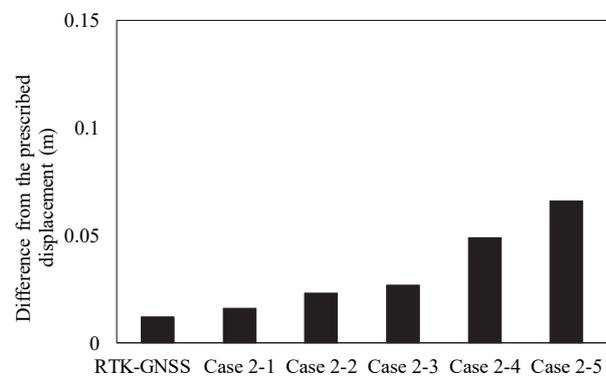
Fig. 8 – Comparison of measurement accuracy in Part 2. Vertical axis: Error in each case. RTK-GNSS: Average of two results of RTK-GNSS.

Table 4 shows a list of the measurement results for part 2 together with the results of RTK-GNSS, and Fig. 8 shows the error in bold from Table 4. The error in Case 2-1 using all GCPs was 16 mm, and the error in Case 2-2 placing GCPs at four locations on the four corners of the photographic area was 23 mm, indicating that the measurement accuracy was the same as that of the RTK-GNSS. However, it should be noted that the conditions in both cases were based on the assumption that the GCPs did not move even after the earthquake, as shown in part 1.

In Case 2-6, which assumes that a ground displacement occurs up to 150 m behind the quaywall during an earthquake and that the coordinates of GCPs within this range are unavailable, image processing was performed using two GCPs 200 m away from the quaywall, where the effect of the ground displacement is small. However, owing to the poor image quality of the orthoimages, the displacement evaluation locations could not be identified, or even if they could be identified, the amount of displacement was on the

order of meters. Therefore, the results of the case of the two points on the landward are not shown in Table 4 and Fig. 8.

The error of Case 2-3, in which the GCPs are arranged in a triangular configuration with two landward GCPs 200 m away from the quaywall and one near the quaywall, is 27 mm, which is not significantly different from the accuracy of the quadrilateral configuration cases (Case 2-1 and Case 2-2). However, when the third GCP point was farther away from the model installation position, the error became larger and the accuracy became lower (49 mm in Case 2-4 and 66 mm in Case 2-5).

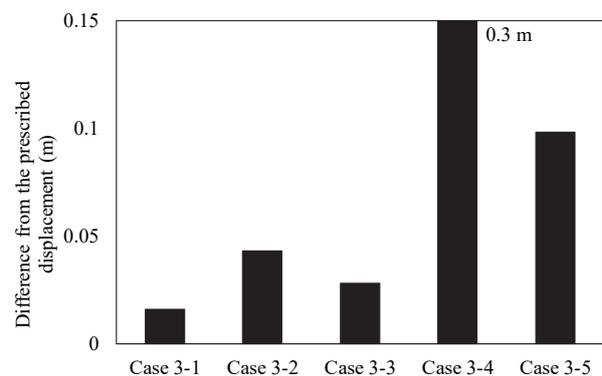
Fig. 9 – Comparison of measurement accuracy in Part 3. Vertical axis: Error in each case. Case 3-4 exceeds the maximum vertical axis of 0.15 m by 0.3 m. Case 3-1 has the same GCP arrangement before and after the earthquake (same as in Case 2-1).

Table 5 shows a list of the measurement results for part 3, and Fig. 9 shows the error in bold from Table 5. When different GCPs were used before and after the movement, the accuracy was low in all cases except Case 3-1. The coordinates include the error caused by the GCP arrangement, and this error is considered to be larger when the number of GCPs is small and they cannot be placed on all sides of the photographic area. Because the displacement is calculated from the difference in the coordinates before and after the movement, the effect of this error is expected to cancel each other out and become small when the same GCP configuration is used. However, if the GCP configuration is different before and after the movement, the error caused by the GCP configuration is different before and after the movement, and thus the effect of the error is not reduced by taking the difference of the coordinates, resulting in a low accuracy result. In particular, in Cases 3-4 and Case 3-5, where three GCPs were used, using the same GCP configuration before and after the movement reduced the error to several times that of the four-corners configuration case,

but using a different GCP configuration after the movement significantly reduced the accuracy of the displacement.

If the number and arrangement of GCPs are insufficient to ensure the level of accuracy, using the same GCP arrangement before and after the earthquake can reduce the effect of errors caused by the GCP arrangement and avoid a decrease in the accuracy of the displacement measurement. In other words, the measurement error can be reduced by setting the GCP before the earthquake to evaluate the residual displacement according to the GCP arrangement available after the earthquake.
