MESH-WRAP RETROFITTING FOR RAMMED EARTH BUILDINGS – TEST RESULTS OF FULL-SCALE STATIC TESTS

Keywords: Rammed earth; full-scale static test; building orientation; retrofitting; Bhutan

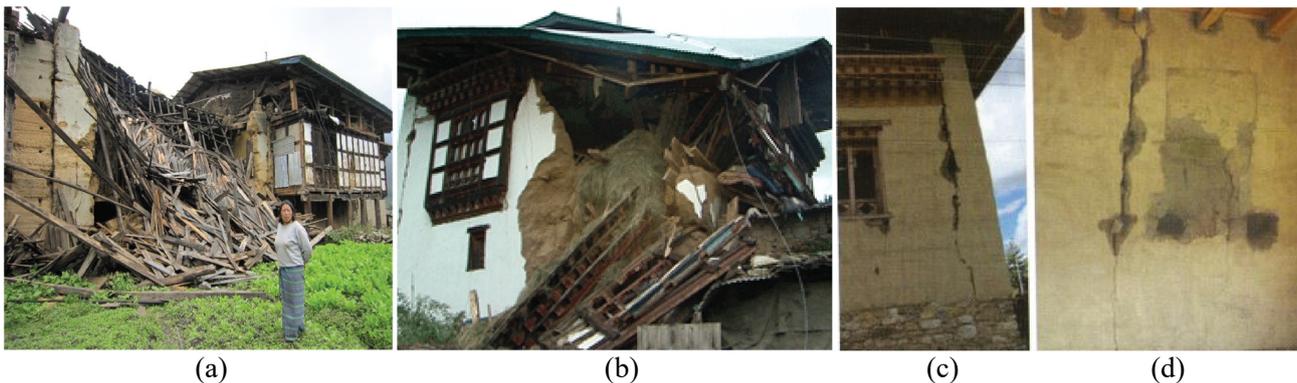
Fig. 1 – Rammed earth buildings damaged by 2011 earthquake: (a) Out-of-plane wall collapse; (b) Corner overturning; (c) Corner crack; (d) Vertical crack under loading point of floor joist.

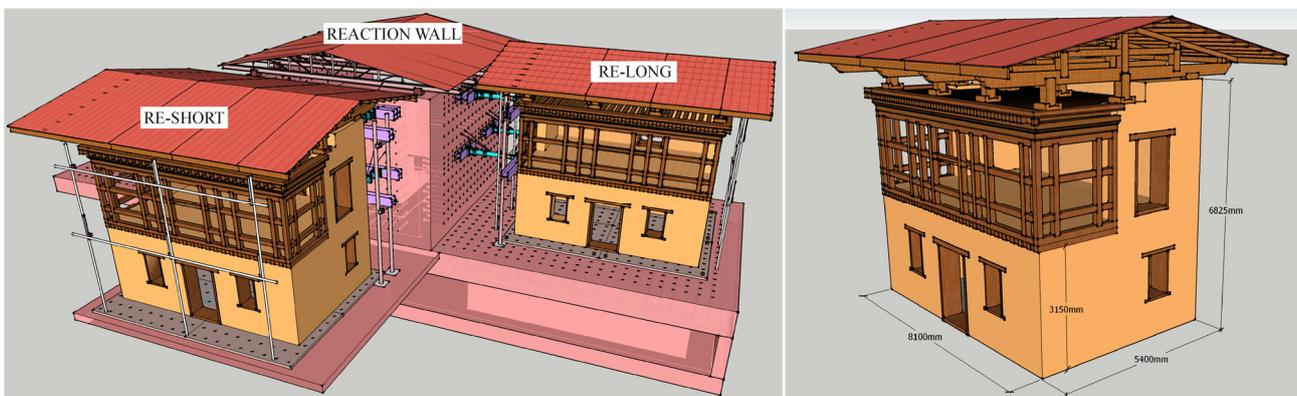
Fig. 2 – Overview of full-scale static tests and specimen details

Initially, two full-scale unreinforced buildings were constructed for static test at two different loadings, one loaded in short-span (RE-SHORT) and other in long-span (RE-LONG). The construction lasted almost four months and completed in early September 2018. The overview of full-scale static test is given in Fig.2. The specimens were the replication of the Bhutanese rammed earth building dominating typology having two stories, where the ground floor has solid walls with small openings for doors and windows, and the first floor has a large opening in the front façade. The design and dimensions for both rammed earth buildings were considered the same with a floor area of 8.1 m × 5.4 m and 6.83 m height excluding the roof (Fig.2). The building specimens were constructed over the strong reinforced concrete slab by local artisans, following the typical Bhutanese rammed earth construction practice [5,11,12]. The soil was prepared in order to get a suitable mixture by checking the correct water content through a traditional field test. A handful of moist earth is squeezed and tossed up in the air, about a meter away from the ground, the mixture is considered suitable if falling back on the ground, breaks into two or three major pieces [11]. About 200mm thickness moistened soil layer was then poured inside the wooden formwork (Fig.3) and rammed manually till the desired height, using

Two parameters were considered for the current study, first the loading direction to the wall and second the retrofitting technique. The specimens were named according to the parameters: i) Rammed earth-unreinforced and loaded in short-span (RE-U-SHORT), ii) Rammed earth-retrofitted and loaded in short-span (RE-R-SHORT), iii) Rammed earth-unreinforced and loaded in long-span (RE-U-LONG) and iv) Rammed earth-retrofitted and loaded in long-span (RE-R-LONG). It should be noted that the RE-U-SHORT and RE-U-LONG were retrofitted after first phase of testing and they were renamed RE-R-SHORT and RE-R-LONG, respectively.

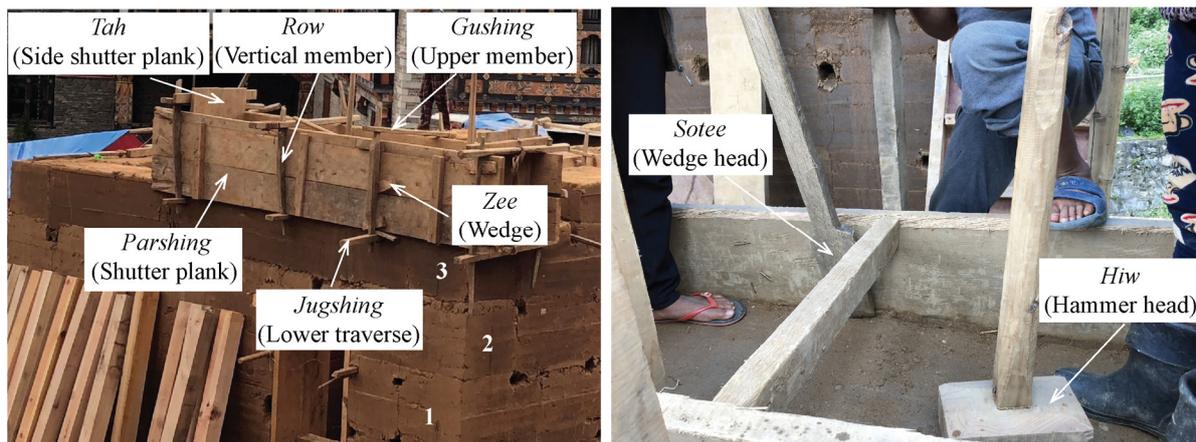
Fig. 3 – Formwork and ramming tools details

hardwood rammers having different base shapes. A rammer with hammer head was used for normal compaction and smooth finishing at the edges was achieved using a rammer with wedge head. The details of ramming tools used for compacting rammed earth layers are shown in Fig. 3. One completed rammed earth block consisted 600mm height and 600mm thickness, and the length of each block differed depending on the location of the openings. Each block comprised six rammed earth layers whose thickness was 100mm at its final compaction. The blocks at the corners (marked 1, 2 & 3 in Fig.3) and junctions are placed alternately to avoid continuous head joint.

Fasteners were used to affix the meshes to the walls. U-hooks were used all through the wall to anchor mesh to the wall. Meshes on two faces of the wall were firmly connected by transversal threaded bars having 12mm diameter and 600mm length. These threaded bars were inserted through the *jugshing* holes, an opening created upon removal of *jugshing* (Fig. 3).

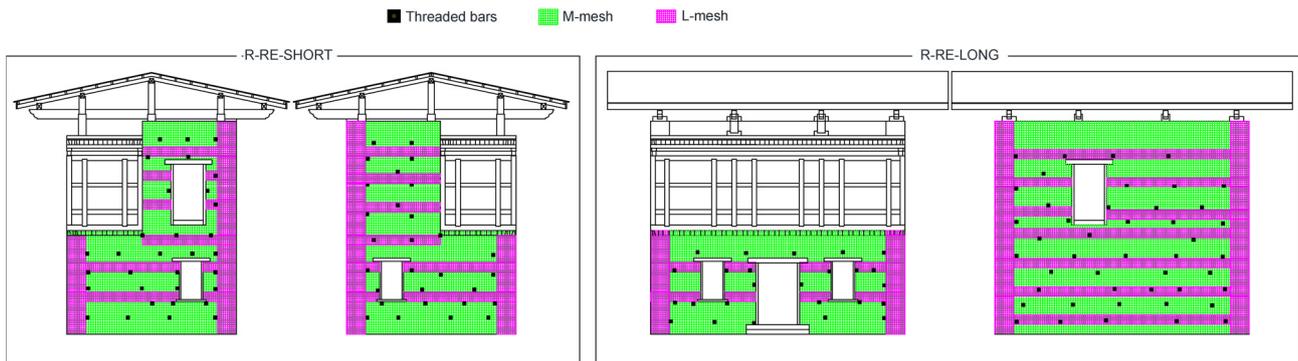
Fig. 4 – Mesh layout for rammed earth buildings (RE-R-SHORT and RE-R-LONG)

- (i) Fix M-mesh (highlighted with green in Fig. 4) on both faces of the wall using fasteners. The details of the mesh layout at the exterior face of the wall are presented in Fig.5, and it should be noted that the layout is maintained same in the interior face of the walls as well; The mesh was also provided at the floor levels of an elevation at which the loading was applied.

- (ii) Lay L-mesh (highlighted with pink in Fig. 4) over the joints of M-mesh both in horizontal and vertical to avoid local failure of main mesh;
- (iii) Provide uniform lapping length of 300mm in vertical and 60mm in horizontal;

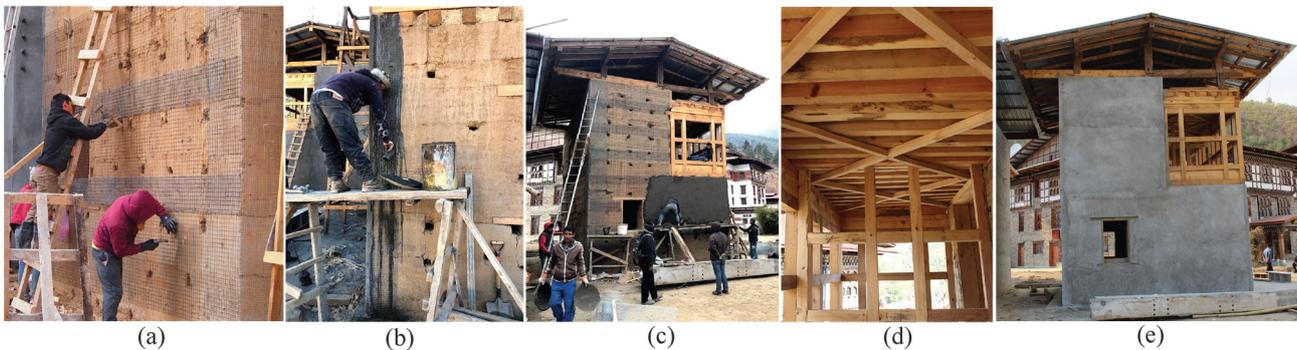
Fig. 5 – Retrofitting work details: (a) Fixing mesh; (b) Wetting wall surface with cement slurry; (c) Applying cement plaster; (d) Providing bracing under floor joists; (e) Final view of building after retrofitting work.

The entire retrofitting work for both the buildings were completed within three weeks. The specimens RE-R-SHORT and RE-R-LONG were tested again in March 2019 after two months of curing period. Some details of retrofitting work are presented in Fig. 5.

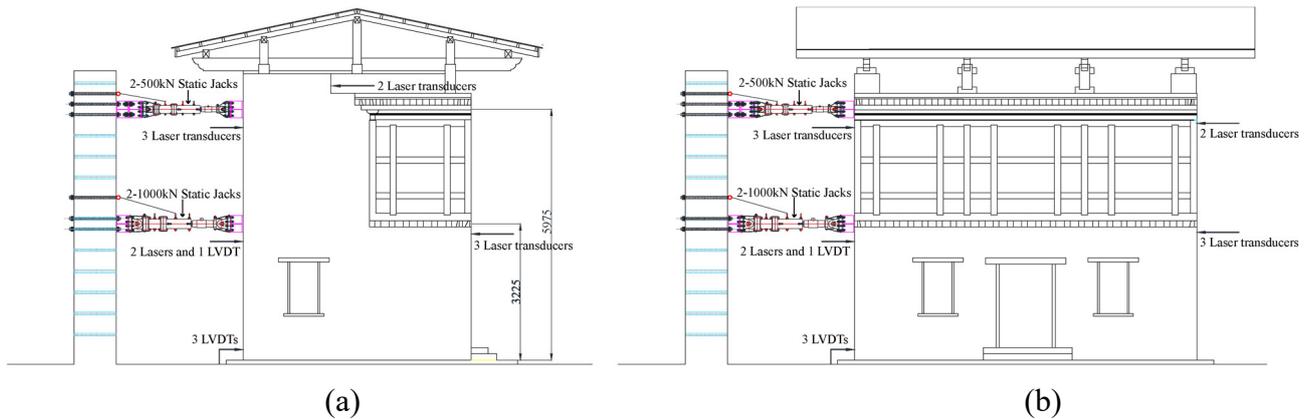
Fig. 6 – Full-scale static test set-ups: (a) Loaded in short-span, (b) Loaded in long-span.

2.4 Test set up

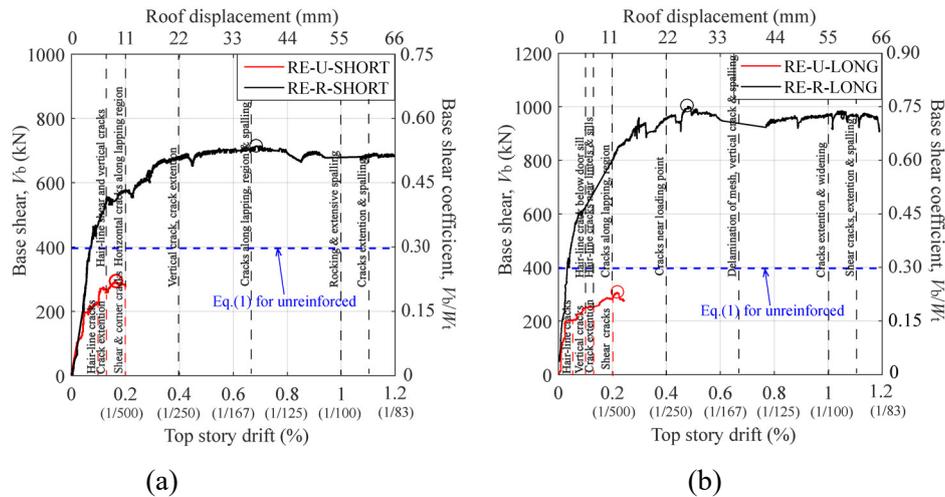
Fig. 7 – Relationship between base shear and story-drift: (a) Loaded in short-span and (b) Loaded in long-span

The capacity curves for all tested specimens are presented in Fig. 7. The strength of the rammed earth building is represented in story shear, and the deformation is represented in terms of roof displacement and the top story-drift. Further, an equivalent base shear coefficient is also presented, given by the ratio of the cumulative base shear of the building (V_b) to the total seismic weight of the building ($W_t = 1333$ kN). The story shear at 1FL, which also represents the cumulative base shear, is taken as the summation of horizontal loads at 2FL and 1FL. To plot the top story-drift, the mean value of three transducers placed at 2FL are considered. The cumulative base shear from the experimental results of each building specimens is presented in Table 2. In both the loading cases, the specimens retrofitted with mesh showed better strength than their counterparts. The capacity of unreinforced building loaded in short-span (RE-U-SHORT) was improved by 2.43 times with the mesh-wrap retrofitting technique and for the unreinforced building loaded in long-span (RE-U-LONG) was improved by 3.25 times.

The capacity curve was almost linear when the story-drift was within 0.05% for RE-U-SHORT and RE-U-LONG, 0.13% for RE-R-SHORT and 1.0% for RE-R-LONG. On further application of the load, the response of rammed earth building specimens showed non-linear which was characterized by its first appearance of cracks. The damages for all the specimens were monitored at the predefined target story-drift through visual observations and video recordings. The resulting cracks are illustrated in Fig. 8 and Fig. 9 for the unreinforced and retrofitted buildings, respectively. Cracks for only in-plane walls are presented since the out-of-plane wall did not show major crack during the test. In general, the cracks evolved near the openings, loading areas and corners for the unreinforced buildings. For the retrofitted buildings, the cracks were usually

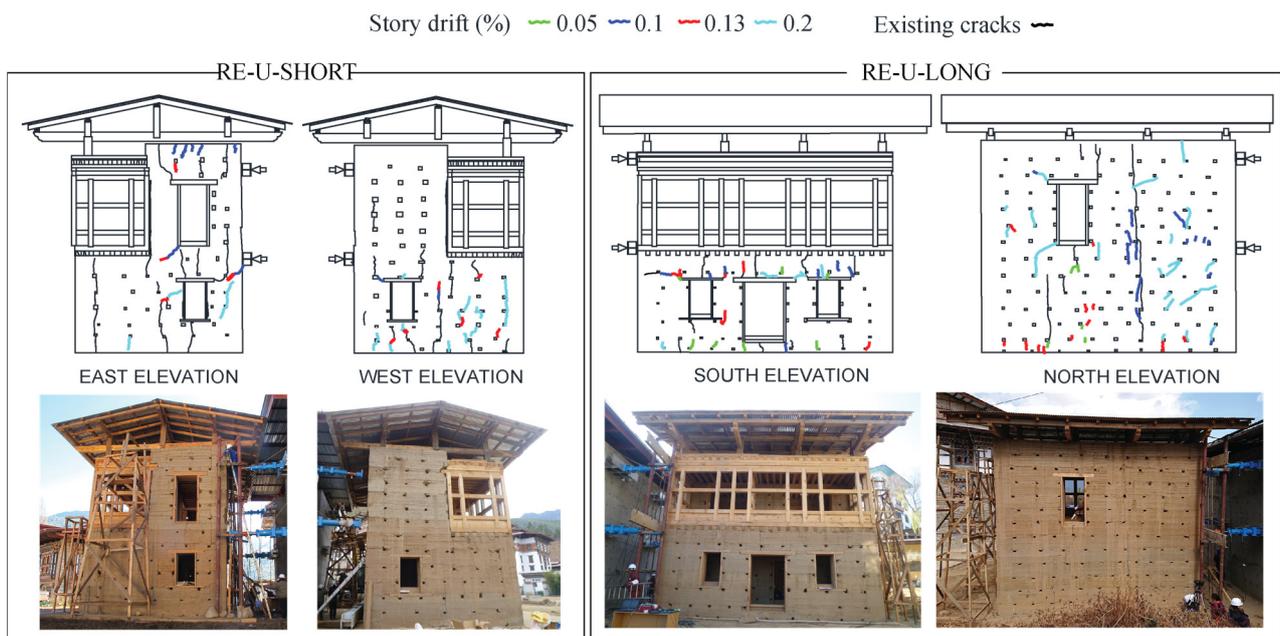
Fig. 8 – Crack patterns observed in unreinforced buildings: (RE-U-SHORT) and (RE-U-LONG)

found in the lapping region of the mesh both in horizontal and vertical. The shrinkage cracks appeared during the drying period of the buildings are marked with black in Fig. 8 for the unreinforced buildings. These shrinkage cracks were normally found originating from the head joints, bed joints and near openings illustrating the vulnerable areas of rammed earth structures. The cracking evolution in each building are highlighted below:

RE-U-SHORT: No cracks were visible during the first stage of loading within story-drift of 0.05%. The first few hair-line cracks originated near openings, window sill, loading area and at top rammed earth block in east elevation, and near lintel and *jughshing* holes of west elevation when the story-drift was up to 0.1%. The cracks propagated on both in-plane walls on further application of load, and the story-drift was up to 0.13%. Within the story-drift of 0.2%, there was an extension of previous cracks and new shear crack in east elevation was also observed. In the west elevation wall, a vertical corner crack evolved 600mm away from the corner at the same story-drift. The test was stopped at story-drift of 0.2%.

RE-U-LONG: Few hair-line shear cracks were observed mainly originating near *jughshing* holes for both in-plane walls during the first phase of loading within story-drift of 0.05%. At story-drift of 0.1%, a horizontal crack propagated towards the window lintel in south wall along with minor cracks in other areas. In the north elevation, the existing long vertical crack (formed during the drying period) widened which could have been induced by an inside transverse wall perpendicular to this crack. At story-drift of 0.13%, few new minor cracks appeared both in in-plane walls. With the last phase of loading at story-drift of 0.2%, numerous shear cracks initiated in the north wall. In the south wall, a minor shear crack appeared above the door lintel.

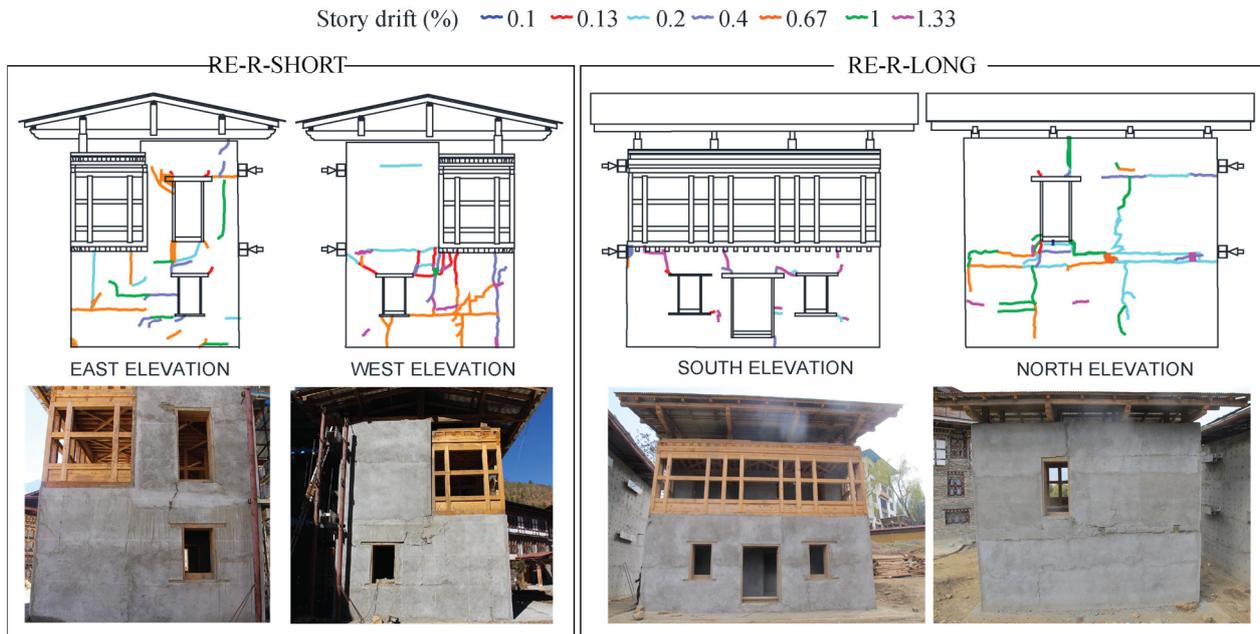
Fig. 9 – Crack patterns observed for retrofitted buildings: (RE-R-SHORT) and (RE-R-LONG)

RE-R-SHORT: No cracks were detected during the first and second phase of loading. However, in the third stage within the story-drift of 0.13%, cracks in lintels of both in-plane walls were noticed. There were also numerous vertical cracks between the two window openings of the west elevation. On further application of load within story-drift of 0.2%, the previous crack extended and horizontal crack initiated along the lapping areas in the west elevation. In east elevation, a vertical crack appeared along the lapping in the corner. When the story-drift was within 0.4%, a horizontal crack evolved near window of east elevation and corner crack in the top most rammed earth block. In west elevation, a long vertical crack appeared along the lapping region. Significant cracks were seen within the story-drift of 0.67%. The plaster started falling off as the crack extended. The building started rocking with the appearance of the crack in the base when the story-drift was within 1.0%. A crackling sound due to dislocation of timber components was heard on further application of load and the test had to be stopped at story-drift of 1.33 for safety reasons. Within story-drift of 1.33%, the previous crack propagated in size and there was extensive spalling of plaster.

RE-R-LONG: In the first stage of loading within the story-drift of 0.05%, cracks were invisible. In the next loading, a minor crack evolved near the sill level of door in south elevation within the story-drift of 0.1%. Few new minor cracks were visible near lintels and sills of both in-plane walls within the story-drift of 0.13%. A notable large horizontal crack appeared along the lapping region of south elevation followed by spalling of plaster within the story-drift of 0.2%. A vertical crack also appeared at the same position of existing shrinkage crack. Only minor cracks were seen in the north elevation. In the next stage of loading within the story-drift of 0.4%, the horizontal crack near loading point initiated in both in-plane walls. The horizontal crack elongated followed by appearance of a new vertical crack below the door of south elevation when story-drift was up to 0.67%. Within this drift, delamination of mesh was also observed at an elevation where the load was applied. The extension of previous crack continued with propagation in crack width at next stage of loading within the story-drift of 1.0%. Some plaster fell off at the top part of south elevation wall. At the final stage, the loading was applied until the story-drift was 1.33%. In this stage, numerous shear cracks were visible in north elevation, and in the south elevation there was spalling of plaster exposing the mesh inside.

The mesh-wrap retrofitting technique was found compatible with the rammed earth walls with minimal delamination in the loading area. The proposed retrofitting method was effective in controlling the crack appearance in the specimens wherein the cracks were uniformly distributed throughout the wall and prevented crack concentration in a specific wall region.

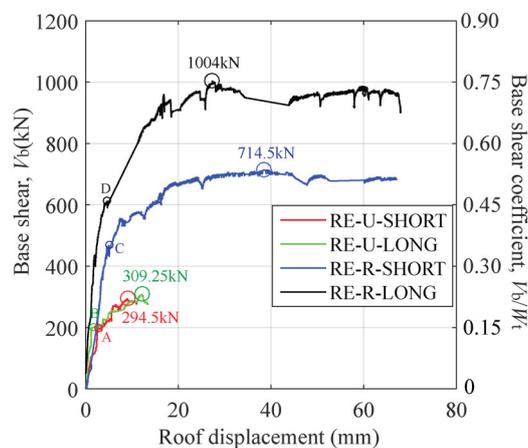
Fig. 10 – Capacity curve of all building specimens

A comparative study was done to understand the building response at two different orientations towards the loading in terms of the building capacity (Fig. 10) and damages incurred during the loading. The retrofitted rammed earth building loaded in long-span (RE-R-LONG) had considerably higher strength than the retrofitted rammed earth building loaded in short-span (RE-R-SHORT). The strength of RE-R-LONG was 1.41 times the RE-R-SHORT. However, the strength of RE-U-LONG was almost the same as RE-U-SHORT. The marginal difference in their capacity was probably because the shrinkage crack formed during the drying period in RE-U-LONG was more prominent and wider, which could have compromised the capacity of the building. The building orientation towards the loading influenced its' response under the static loading. The building, when loaded in short-span was almost symmetrical in plan with respect to the loading direction. The in-plane walls (east and west elevation of RE-SHORT) have almost same mass distribution, and the crack observed in these elevations were also almost uniform with same intensity. However, the building was asymmetrical when loaded in long-span. There was variation in mass distribution between two in-plane walls and subsequently, the amount of damages incurred in two elevations varied. The south elevation with higher mass suffered larger amount of damages than the north elevation.
