17<sup>th</sup> World Conference on Earthquake Engineering, 17WCEE Sendai, Japan - September 13th to 18th 2020

# SEISMIC RETROFITTING OF SCHOOL BUILDINGS IN THE KYRGYZ REPUBLIC

S. Brzev<sup>(1)</sup>, U.T. Begaliev<sup>(2)</sup>

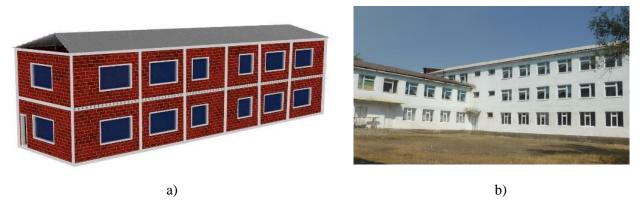
Fig. 1 – Typical masonry school building in the KR (Type 3): a) a conceptual isometric view, and b) exterior view of a typical school [1]

A survey of more than 5,400 schools was performed as a part of systematic effort by the World Bank to develop classification of the building stock for school buildings in the KR [10, 11]. Based on the survey, masonry buildings account for 58% of the overall school building stock in the country, while RC buildings account for 21% of the overall school building stock. The remaining 21% are either timber buildings or adobe buildings. A classification of building typologies in Central Asian countries was previously developed as a part of the Earthquake Model for Central Asia (EMCA) project [12]. Code SNiP KR 22-01-98 also includes a classification of the building typologies and prescribes corresponding seismic evaluation approaches. The Manual classifies schools in the KR into 8 building typologies (types), as summarized in Table 1. Typical masonry school (Type 3) is shown in Figure 1.

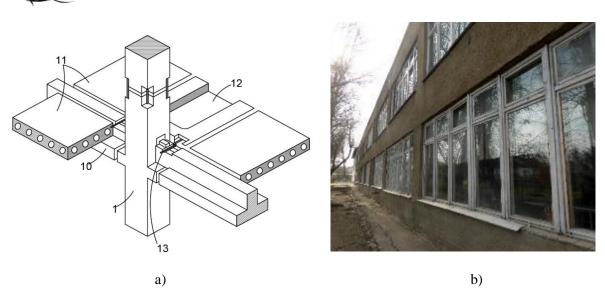
Fig. 3 – Typical precast RC school building in the KR (Type 5): a) precast RC beams, columns, and the connections, and b) exterior view of the building showing precast RC panels [1]

RC school buildings constitute more than 20% of the overall stock in Kyrgyz Republic. Before the 1990s (during the Soviet Union), precast concrete technology was commonly used for construction of residential and public buildings, including schools. Precast RC frame construction with exterior precast RC panels (Type 5 in Table 1) is known as Seria IIS-04 (Госстрое СССР, 1964), and it was one of the standard precast (prefabricated) construction systems in the former Soviet Union (refer to [15] for more details). This technology was used both for the construction of residential buildings (9- to 12-storey high), and also public buildings such as schools (1- to 4-storey high). All structural elements, including foundations, columns, beams, slabs, staircases, and wall panels, were manufactured in specialized plants. The building assemblage started at the foundation level with precast RC footings. Subsequently, RC columns were erected in vertical position and joined by welding above the floor level. Subsequently, beams are lifted in the final position (note that columns have corbels on two sides to receive RC beams). Beams are joined to the columns by welding, and finally cast-in-place concrete is placed to fill the voids. Beam-column connections are usually considered as rigid for seismic design purposes. Floor system consists of precast hollow-core planks. Connections between the floor planks and the RC beams, and the connections between the planks in longitudinal direction are achieved through welded plates (welding was performed at the construction site). Design engineers in the KR usually consider these floors as rigid diaphragms for seismic design purposes. The façade in these buildings consists of precast concrete panels which are connected to the columns by welding. Details of the panel-to-column connections are shown in Fig. 3a. A façade view of the school with exterior precast panels is shown in Fig. 3b.

Precast RC frame buildings (Seria IIS-04) are vulnerable to seismic effects due to the welded beam and column joints. Welded connections are rigid and brittle and have a limited ability to dissipate earthquake energy. There is no evidence of ductile detailing of RC beams and columns, which can be expected since most buildings of this type were constructed in the 1960s and 1970s. Failure of exterior RC wall panels is also possible once the capacity of welded connections has been reached. Buildings of this typology experienced severe damage and collapse in a few earthquakes in the former Soviet Union, including the 1988 Spitak, Armenia earthquake (M 7.5, MSK intensity IX-X); 1984 Gazli, Russia earthquake (M 7.2, MSK intensity IX); and the 1994 Shikotansk, Russia earthquake (M 8.1, MSK intensity more than 10) [15, 16]. Precast hollow-core RC slabs may also pose a risk from earthquakes [17]. It is believed that poor seismic performance of hollow-core slabs in the NZ earthquakes was due to elongation of beams in ductile RC frames. Precast RC frame structures in the KR are found to be flexible due to relatively large spans and absence of shear walls to control lateral drift, hence there is a concern of poor seismic performance of floor systems in these buildings.

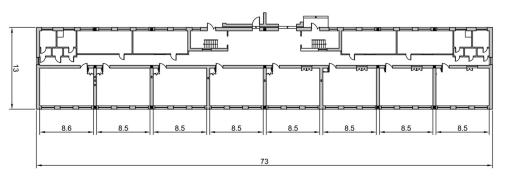
Fig. 4 – Masonry school case study: a) school plan showing building blocks separated by seismic gaps, and b) architectural plan for block A [1]

The school building presented in the case study has H-shaped plan, and it consists of 4 rectangular-shaped building blocks (2- or 3-storey buildings) separated by seismic gaps. The largest block, A, is 73 m long and 13 m wide and is 3-storey high. This is a Type 3 masonry building typology and the main lateral loadresisting system comprises of loadbearing masonry walls made of solid clay bricks bonded by cement-based mortar. Exterior walls are 51 cm thick and interior walls are 38 cm thick. According to the original drawings there are two types of RC inclusions within the masonry walls (Level 1 and Level 2). Level 1 inclusions are RC column-like elements inside the masonry walls, which are connected with RC beams at the floor level in order to achieve RC frames in transverse direction of the building. Level 2 inclusions consist of secondary RC vertical ties placed around the openings and wall intersections. Seismic bands and lintel beams are provided at each floor level. Four 6 mm diameter horizontal bars embedded in mortar joints are placed at 300 mm vertical spacing in 51 cm thick masonry walls, and two 6 mm bars at 300 mm spacing are placed in 38 cm thick walls. Floor system consists of precast hollow-core slabs, as explained earlier in the paper. The roof system consists of pitched roof with corrugated galvanized iron roofing and timber rafters supported by exterior walls, and vertical timber posts supported by precast floor slabs. Seismic evaluation and retrofit approach for this building were described in detail [1]. Block A shown in FIGURE X will be discussed in this section.

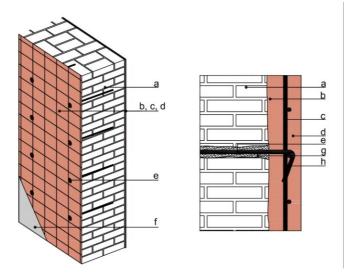
a) existing masonry; b) first layer of concrete; c) steel wire mesh;d) second layer of concrete; e) steel anchors; g) hole in the masonry wall filled with epoxy resin or cementitious grout;h) steel anchor with a 90-degree hook.

Fig. 6 – Seismic retrofitting techniques for masonry walls: a) RC jacketing and b) CFRP strips [1, 18]

The adopted seismic retrofit scheme for the walls comprises of double-sided RC jackets (Fig. 6a). Initially, the wall surface was prepared by removing existing plaster. RC jackets were 80 mm thick and were constructed using shotcrete technology, that is, by spraying fresh concrete through a hose in two 40 mm thick layers (Fig. 7b). Steel reinforcing mesh was installed in the middle of the jacket, and attached to the existing wall by means of through-wall steel anchors (Fig. 7a). The anchors were installed in predrilled holes and bonded to the existing masonry walls by means of cement-based grout. The size and spacing of anchors was determined by design: 12 mm diameter steel bars were used and 4 anchors were installed per square metre of the wall surface. RC jacketing was provided continuously from the foundation to the roof level. For cost optimization purposes, the extent of reinforcement for RC jacketing varied along the building height. Steel reinforcement at the ground floor level where seismic demand is largest, and the amount decreased at upper floors. Fig. 8 shows ground floor plan with walls which need to be retrofitted (highlighted in colour).

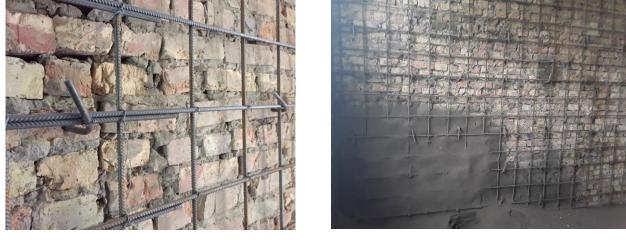
Fig. 7 – Features of RC jacketing technique: a) wall reinforcement and anchors, and b) shotcrete application (photos: S. Brzev and U. Begaliev) [1]

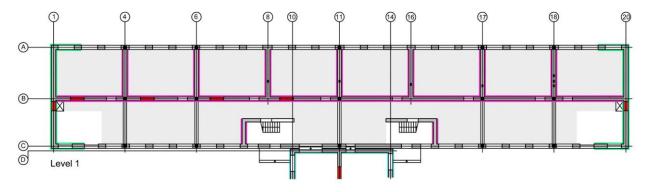
Fig. 8 – Ground floor plan showing the walls earmarked for RC jacketing [1, 18]
