## EFFECT OF SURFACE ROUGHNESS ON NON-DESTRUCTIVE TESTS FOR SCREENING OF LOW-STRENGTH CONCRETE

M. Maliha<sup>(1)</sup>, H. Chu<sup>(2)</sup>, T. Nishiwaki<sup>(3)</sup>, A. F. M. S. Amin<sup>(4)</sup>

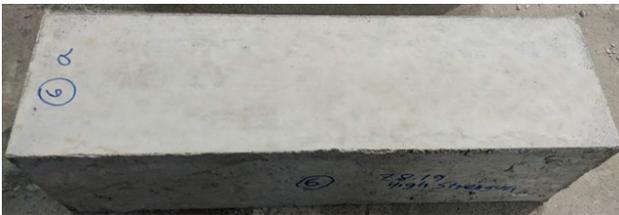
(c) Actual surface and recorded image with 3D scanning device for low degree of roughness

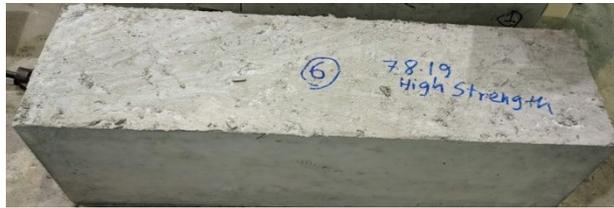
(d) Actual surface and recorded image with 3D scanning device for medium degree of roughness

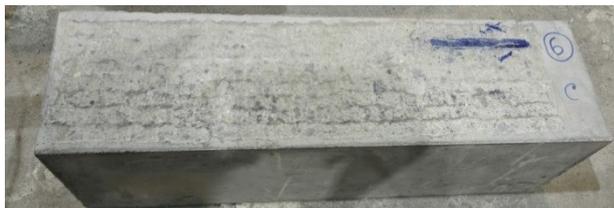
(e) Actual surface and recorded image with 3D scanning device for high degree of roughness
