## Seismic Retrofit of Kumamoto Castle Keep Towers Damaged At 2016 Earthquakes

Kumamoto Castle was constructed around 400 years ago. There were over 90 buildings and gates in the site. The most iconic buildings are the two keep towers reconstructed in 1960. The keep towers were damaged by Kumamoto earthquakes at 2016. Currently the keep towers are under restoration work using passive controlled structural system.

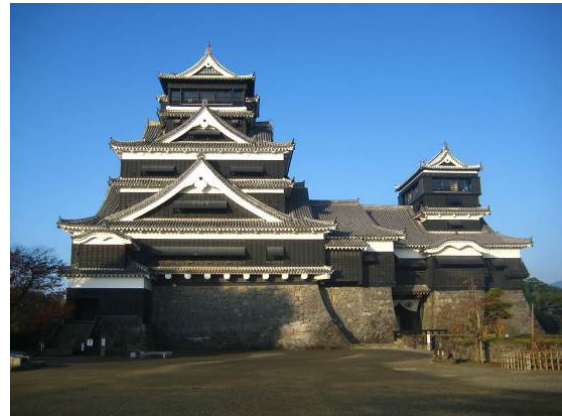
Fig.2 – Keep Towers

Originally, the two keep towers were wooden structure supported by ground and stone walls before being burned down in 1877. The current keep towers were reconstructed in 1960 based on their old photos and documents. The larger keep tower (left one in Fig.2) is a 6-story building. The smaller keep tower (right one in Fig. 2) is a 4-story building. Both of them have a basement floor inside the stone-walls.

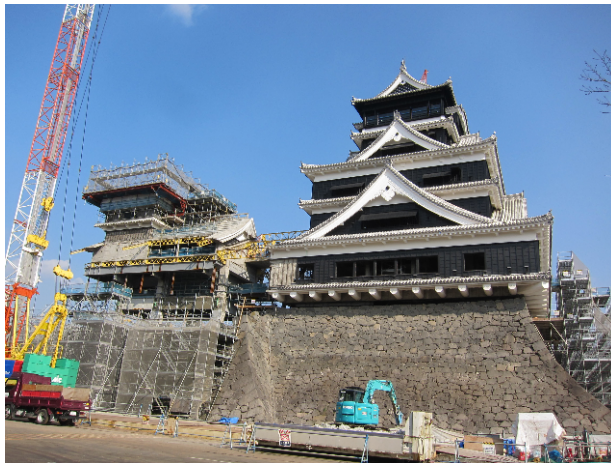
Fig.3 – Restoration Construction Site

The exterior was kept the same shape and materials as the original. The damaged exteriors were changed by traditional construction methods. At the beginning of the restoration construction, 3D scanning and detailed measurement were conducted to figure out all dimensions.

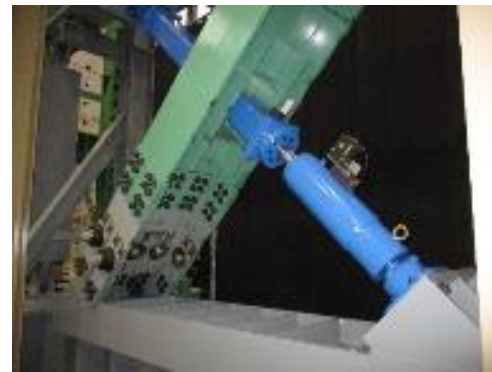
Fig.11 – Cross Damper experiment

Using the excitation machine, this Cross Damper system was verified the combination performance in stress-deformation curves.

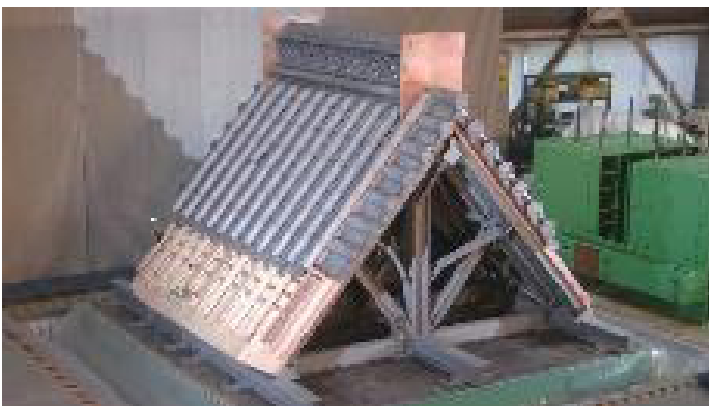
Fig.14 – Real size specimen

We made a real size specimen of roof top having steep slope and ridge tiles on the top. Three dimensional excitation was used to inspect the strength of roof tiles and nails using the dynamic response of the large keep tower. The dynamic response are three direction X,Y,Z simultaneously. The roof tiles were slightly moved at the acceleration at 2.8G and no damages found at roof tiles, nails, and roof boards.

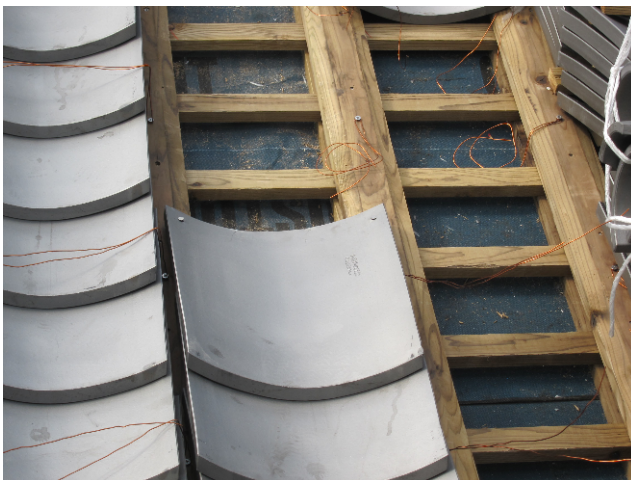
Fig.16 – Connection of plain type roof tiles

The plain type roof tiles are connected by steel nails at the two corners. The convex type roof tiles are connected by copper wire at the top end. The connection strength of the nails were inspected by the random pickup during the construction.
