COMPREHENSIVE SEISMIC UPGRADE OF A NON-DUCTILE CONCRETE MOMENT-RESISTING-FRAME BUILDING APPLYING FRP

Abstract

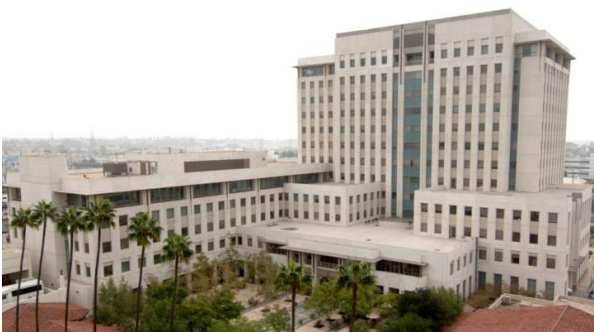
Fig. 1 Thirteen-story building

The subject structure is a 13-story office building located in downtown Los Angeles with a two-level subterranean parking podium and large mechanical roof penthouses located at levels 6 and 12 (Fig. 1). In plan the building is L-shaped below the 6th floor, with approximate maximum dimensions of 300 feet by 352 feet. At levels 7 through 13, the projecting tower has maximum dimensions of 210 feet by 117 feet. Story height is 20 feet at the ground level, and 13.5 feet in the upper levels. The superstructure's structural system consists of cast-in-place (CIP) RC MRFs for lateral force resistance (LFR) and PC gravity framing with CIP concrete slabs. The MRFs generally consist of 48-inch-deep by 30-inch-wide beams and 48-inch deep by 36-inch-wide columns, except at the top floor and penthouse levels. At grade, the MRFs discontinue with

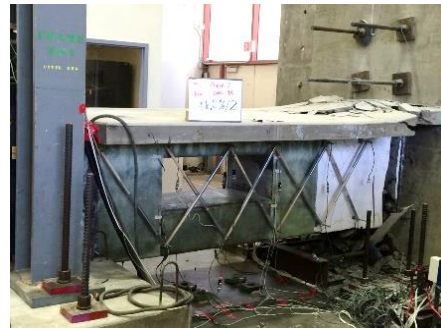
Specimen 1 (existing)

Specimen 1A (FRP strengthening)

Fig. 7 Photos of MRF beam specimens at ultimate limit state

Figure 7 shows the comparison of Specimen 1 (w/o opening strengthening) and Specimen 1A (w/ opening strengthening) at the ultimate limit state as the former failed prematurely with excessive damage at beam opening and the latter developed a plastic hinge at the end. The component tests definitively confirmed the effectiveness of FRP strengthening at the opening.

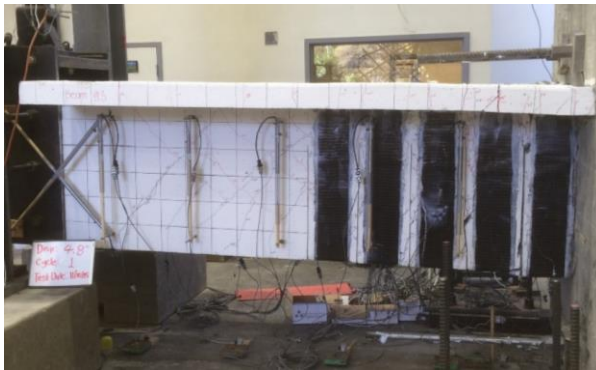
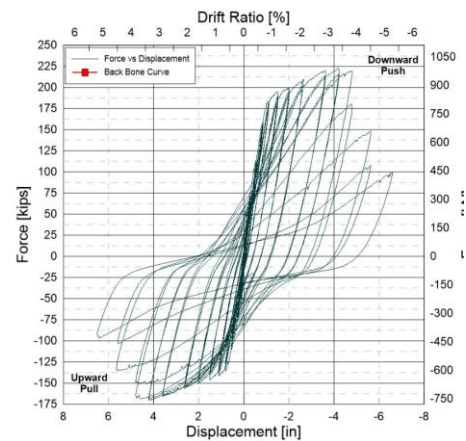
Fig. 8 –Setup of Specimen 3 (batten/groove strengthening at end) testing & force-deflection curve

The batten/sawcut shear strengthening concept was proven affected in the component test, sustaining the beam end region shear through a total rotation of 0.038 radians. Cyclical testing results represented by the force-deflection curve for Specimen 3 are shown in Fig. 8. Not only did the observed rotation approach

the code SMRF rotation requirement of .04 radians, but it also well exceeded the computed ASCE 41 prescriptive total rotation parameter of 0.027 radians.

Beam plastic behavior in the end region as observed in the testing was very stable, with beam flexural cracking developing at the sawcut groove near the column face, and sequentially progressing into the other grooves within the “1d” region. Throughout the test, FRP battens and CFA remained undamaged until the local failure at the bottom edge of the second batten from the end which occurred simultaneous with the strength loss of the beam specimen. The FRP batten detail’s compatibility with the concrete and overall effectiveness in supplementing shear strength was demonstrated in the component test.

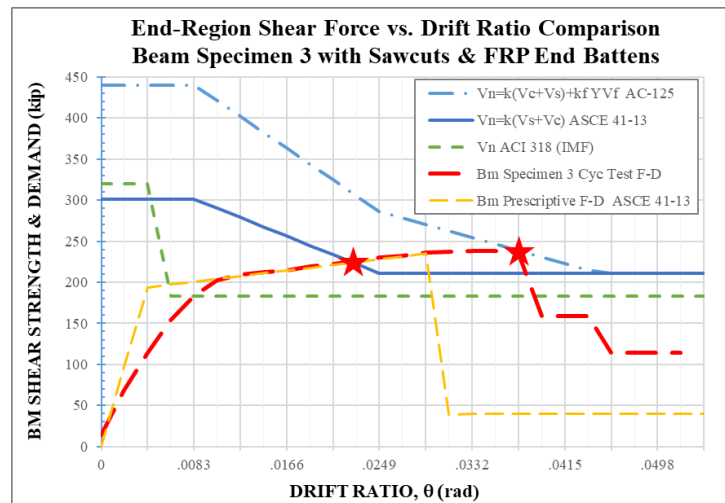
Fig. 9 – End-region shear vs. rotation comparison

The contribution of the added FRP battens to the MRF beam end-region shear strength is relatively small at large rotations but can contribute significantly to the rotational capacity before fracture. This is shown by the two red stars on the force-deflection backbone in Fig. 9, representing the existing (0.022 rad) and the FRP Batten strengthened (0.038 rad) configurations based on the results of the component tests. Also apparent from the figure is the relatively conservative estimation of the ASCE 41 prescriptive beam force-deflection (moment-rotation) curve versus that observed in the component testing.

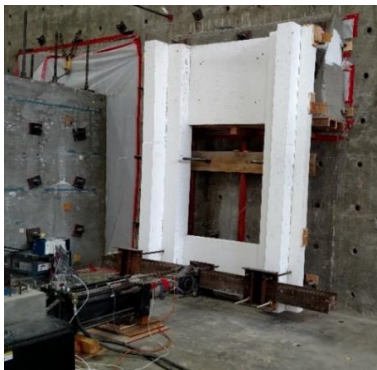
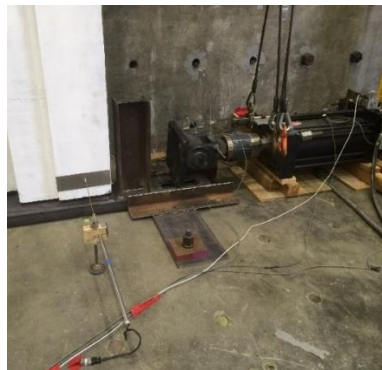
Setup for out-of-plane test

Setup for in-plane test with loading rail

1 TYPICAL PANEL TOP CONN. SCALE: 3/4"=1'-0"

Fig. 11 – Cyclical testing of 3/4-scale cladding panel specimens and top connection detail

For the testing, four 3/4-scale PC concrete panel specimens of various configurations matching the original PC panel shop drawings were constructed off-site, and then set in the testing laboratory. A typical panel testing setup is shown in Fig. 11. Panels were cast into the testing block top connection (Fig. 11 right) and mounted to the bottom loading rail (Fig. 11 middle). Two different testing-rig setups were developed. Out-of-plane cyclical displacement testing (Fig. 11 left) up to the BSE-2N drift level was performed first on each panel. Then, the loading ram was set in-line to the loading rail and bottom clips for the subsequent in-plane cyclical testing (Fig. 11 middle) with progressively increased displacement until connection failure. Slotted bottom clip angles permitted slip during the testing, though only the forces and displacements after binding were of importance in design as the available slip in each clip was accounted for separately.

As observed in the testing, warping and out-of-plane cracking at the vertical corners of the cladding

panels resulted in a notable softening of the effective stiffnesses that increased the out-of-plane and in-plane deformation capacity. All the tested panels reached the required out-of-plane drifts with only minor cracking, even in the binding (loading inward against the cast beam) direction. For the subsequent in-plane tests, the LS limit was observed to occur in two distinct variations. First, warping at the cladding corners under large cyclical displacements caused corner or edge spalls of concrete. In the other case, the panel vertical force couple associated with lateral binding caused one of the top connections to lose strength under large cyclical displacements. The component tests identified the potential limit states of the panel system and allowed the design team to target the real deficiencies of the system for mitigation.

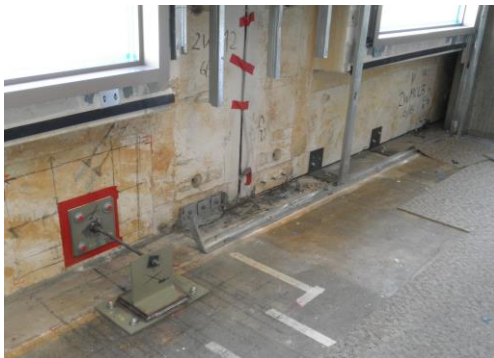
Fig. 12 Modified cladding panel bottom connection

As the component tests indicated that the existing panels would be better equipped to accommodate out-of-plane drifts, cladding panel retrofit consisted mainly of increasing the in-plane deformation capacity of the panels by resetting new slotted clips at the anchor bolts and widening mitered building corner joints using track-mounted saws. In some cases, the overhead support connections were improved using various support frames or by adding sleeved anchor bolts through the face at the window head. Bottom connection modifications entailed replacing existing clips with ones that have longer horizontal slots to allow proper fit-up at the existing connection bolts, and adding PFTE pads to permit sliding at both the vertical and horizontal clip angle legs, or by adding push-pull rods where architecturally possible (Fig. 12).

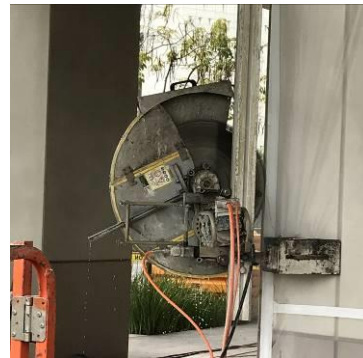
Fig. 13 corner joint widened by sawcut
