## RETROFITTING METHODS OF JAPANESE TRADITIONAL WOODEN BUILDINGS

S. Kita<sup>(1)</sup>

### **Abstract**

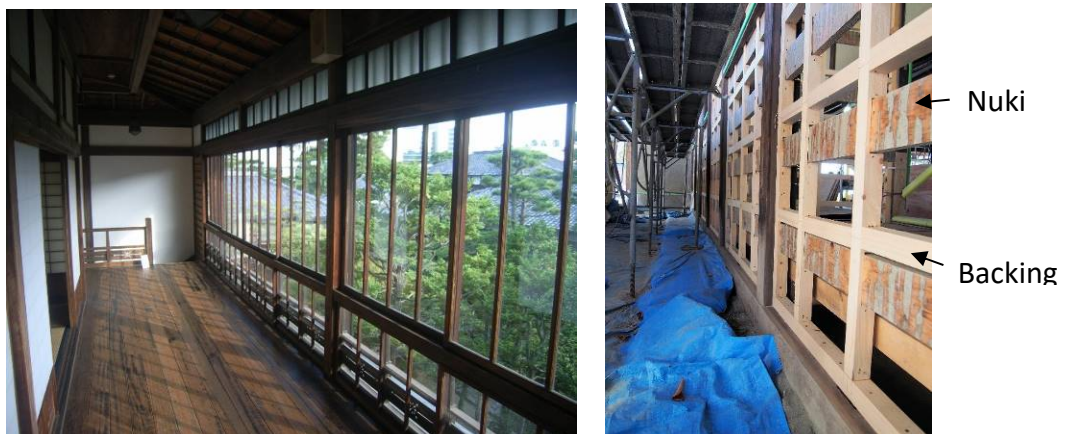
A common feature in Japanese traditional wooden buildings is their openness (Fig.2). Consequences of this, the number of walls that will be part of the earthquake resistant system is quite less, leading the seismic assessment to conclude that the seismic capacity of the building is insufficient. Furthermore, the connections between pillars and nuki (penetrating beams) or other beams contribute to the earthquake resistance performance, but unless the connection is between large elements, fulfill the lateral capacity demand with only these joints is of extreme difficulty.

Structural plywood is a very common material also used in modern wooden buildings. It is used to increase the lateral strength by using it as replacement for walls with low earthquake resistant properties such as earthen walls or lath and plaster walls. It is often used as a shin-kabe (wall with exposed timber pillars) because it does not greatly impair the appearance after replacement. At this time, it is required to leave the existing nuki as long as it is possible, so it is necessary to pay attention to the installation of backing material which is receiving structural plywood (Fig.3).

Fig.2-Openness of Japanese historical wooden buildings, Fig.3-Installation of backing material

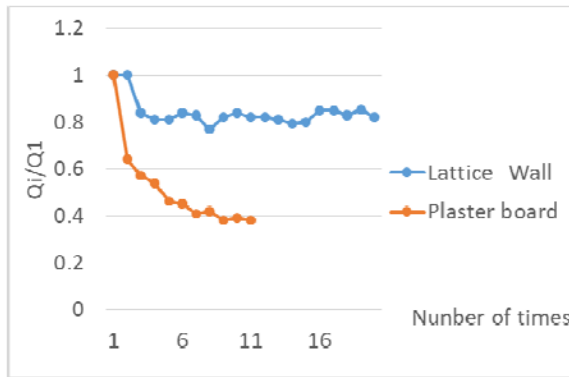
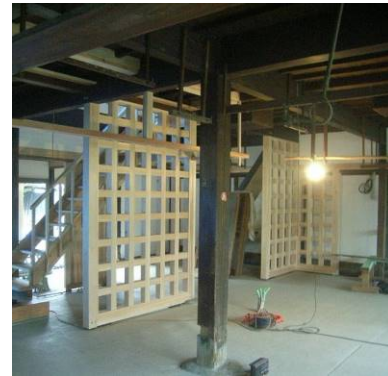
Lattice walls consist of many members connected through halving joint, each joint resists as the contact surface sinks during an earthquake. Although the initial rigidity is low, its toughness is extremely high, and the softening of its maximum shear strength when subject to repeated load is low, so its reliability as an earthquake resistant element is high (Fig.4-1)[1,2]. As a design aspect, the vertically and horizontally composed shape is easy to harmonize with traditional buildings, and since light and wind can pass through, it has been used in practical cases for seismic retrofitting (Fig.4-2).

Fig.4-1- Degrading of maximum shear strength, Fig.4-2-Example of lattice wall

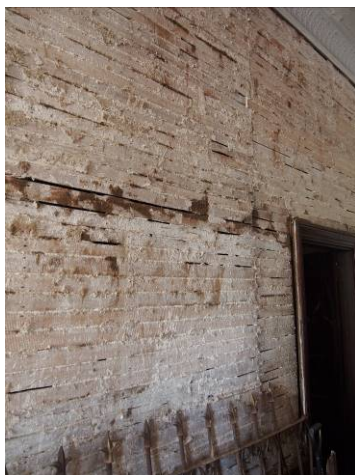
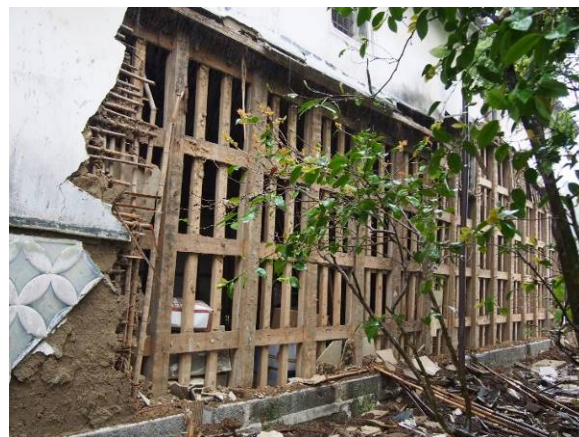
Wood lath is a material meant to accommodate plaster, it has around 30mm width and it is nailed 9mm apart each other. Lath installed horizontally or vertically are common, but improvement of strength can be expected by installing it in an oblique pattern. In addition, placing the planks in a densely manner, makes it easier for the plaster to peel off, which was also confirmed by the damage of the Kumamoto earthquake in 2016 (Fig.5).

According to Implementation Guidance for Basic Seismic Assessment of Important Cultural Properties (Buildings) [3], the ultimate strength of the earthen walls improves in proportion to its thickness, so it may be considered to increase the thickness as an earthquake resistant reinforcement, but as the weight also increases at the same time, efficiency is not so high. In addition, when the earthen wall is Oo-kabe (wall with no exposed pillars), the surroundings are not restrained by frames, leading to its performance not being the same as one confined by frames (shin-kabe portion). Furthermore, the Oo-kabe part easily peels off at the time of the earthquake if backing material of the wall is not constituted properly (Fig.6).

Fig.5-Plaster wall that is peeled off, Fig.6-Earthen wall that is peeled off

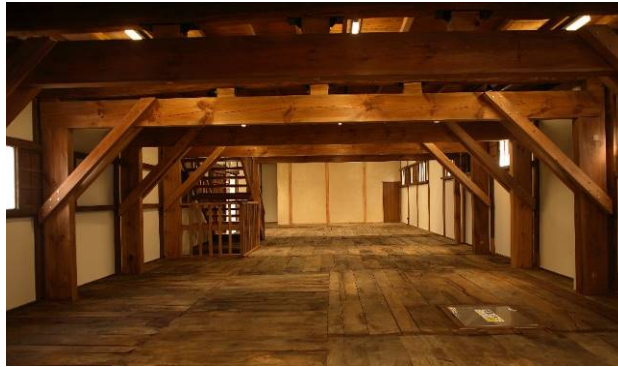
The earthquake resistant system is made by placing a knee brace on the pillar-beam corner and, by doing so, a rigid frame is formed (Fig.7). If the knee brace is placed directly in between the pillar and the beam, there is a possibility that the stiffness becomes too high and the balance with other parts becomes inappropriate. However, by placing the knee brace on the side surface of the pillar or beam and fixing it through bolts, the stiffness of the system can be adjusted. However, it is necessary to set the dimension of the

member so that the wood does not split-break before the bolt yields. In Fig.7, this type of frame is not only assuring seismic performance but also has the role of supporting the second floor where there was a large deflection. Furthermore, since the existing beam was not straight, a tenon was installed at the top and bottom of the packing material and it was inserted into both the existing beam and the new frame, achieving transmission of the shear force from the existing frame to the new frame at the time of the earthquake.

Fig.7-Rigid frame that is consisted of knee brace

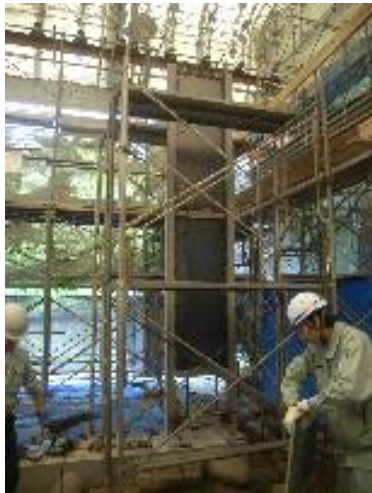
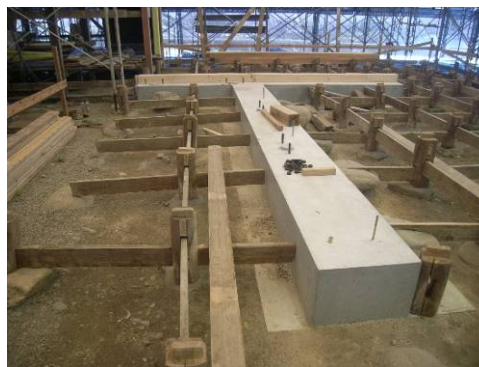
Steel frame is useful when high earthquake resistant seismic elements are required at extremely limited places. In the case of Fig.8-1, the vertical wall is made of a thin steel plate, and the rigidity and strength are adjusted by the length of the plates. In this case, a large pull-out force is generated at the bottom of the pillar, but its rising is prevented by the weight of the partial foundation (Fig.8-2). This foundation was needed to be minimised because this site was nominated as historic site and it is severely restricted to modify.

Fig.8-1- Installation of steel frame, Fig.8-2- Partial foundation

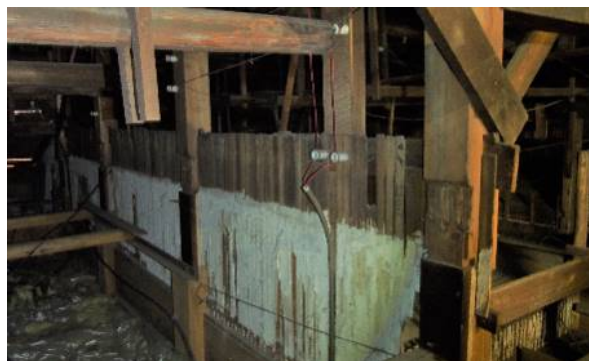
In some cases, weakening of the wall may be effective as to prevent the breakage of the pillars. As a method of weakening, changing the material of that over-hanging wall to a weaker specification or deliberately not to allow the beam to reach the above the ceiling, in order to lose the effect of restriction on the pillars (Fig.10).

Fig.10-Lath wall that is not reached to the beam

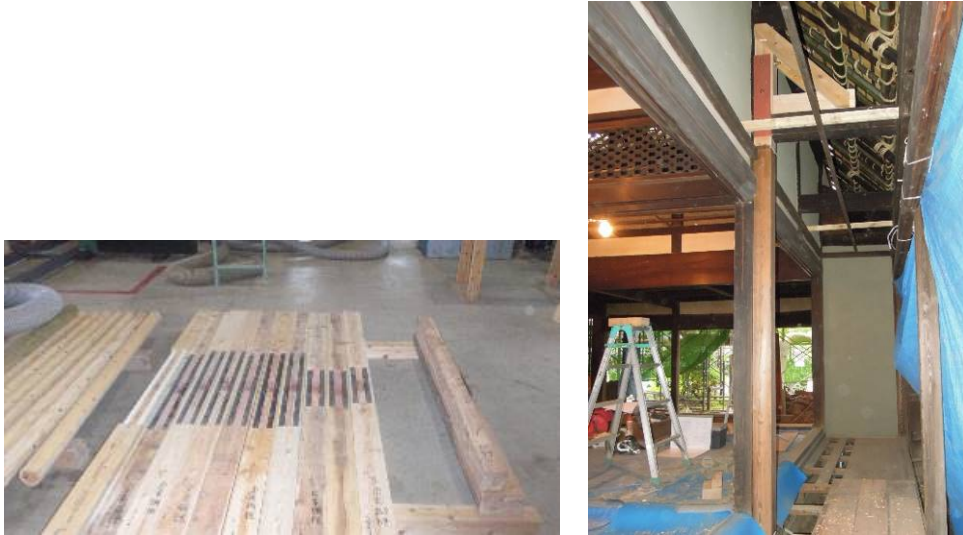
It is also effective to strengthen the pillar instead of weakening the over-hanging wall. For example, increasing the cross-sectional performance of the pillar by bonding carbon fiber [4]. In this case, a thin layer of timber is removed from the pillar and it is used to cover the reinforcement, after the carbon fiber has been added, because it is undesirable for the appearance of the carbon fibers to be seen. An experiment was conducted in order to confirm the reinforcement effect on 120mm section pillars by single point loading test (Fig.11).

Placing and fixing an additional pillar along an existing one that is likely to break will guarantee that the vertical load supporting capacity is maintained. However, special attention should be given at the time of installation, as the transverse members (nageshi: non-penetrating tie, kamo: rail of sliding door) will be an obstacle when attaching it to an existing pillar (Fig.12).

Fig.11- Specimens of reinforced columns, Fig.12-Attached additional pillar

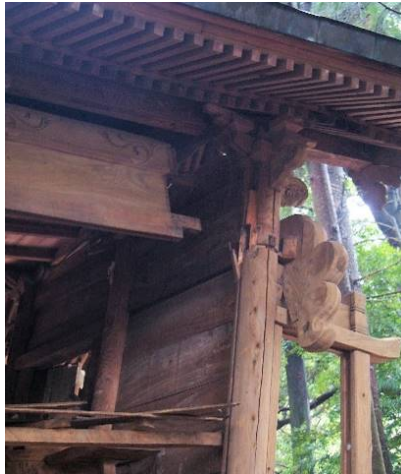
Seismic diagnosis is based on the premise that connectors and joints are not pulled out so that the forces can be transmitted. If this premise does not hold true, unexpected destruction may occur. For example, as shown

in Fig.14, when the connector pulls out, even if the building as a whole maintains sufficient seismic capacity, the earthquake will cause serious damage. It is difficult to judge the adequacy of the joint only from the appearance, but the existence of a wood pin or wedge should be checked (Fig.15), and if necessary, reinforce with a metal object.

Fig.14-Disengagement of connections, Fig.15- Pin and wedge of connections

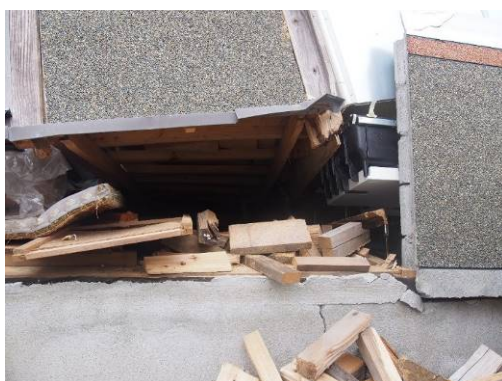
When the shear walls are resisting the horizontal force, pulling-out force is generated in the pillar on one of the corners. If the pillar is pulled out before the shear wall reaches the ultimate strength, the wall cannot reach the expected capacity (Fig.16). Therefore, measures to prevent pull out of the pillar are required. In a general wooden construction work, pillars are tightened by using a metal plate with bolts anchored to the foundation. However, since in Japanese traditional wooden buildings the pillars are mostly just placed on top of the stone foundation, it is impossible to prevent them to be pulled out. In that case, design method that reduces the allowable shear strength of the shear wall by allowing the pillar to be pulled out should be adopted. On the other hand, instead of allowing pull out of the pillars, installing a steel beam under the floor to resist the pulling-out force of the pillar through its flexural strength is also possible. At this time, since a large reaction force acts on the position that will become the support of the steel beam, it is necessary to properly fix it so that splitting of the bolts does not occur at the pillar-steel beam section (Fig.17).

Fig.16- Pull out of pillar leg, Fig.17-Installation of steel beam

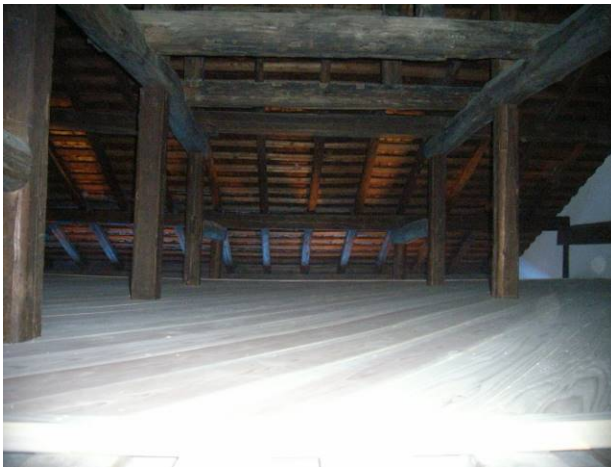
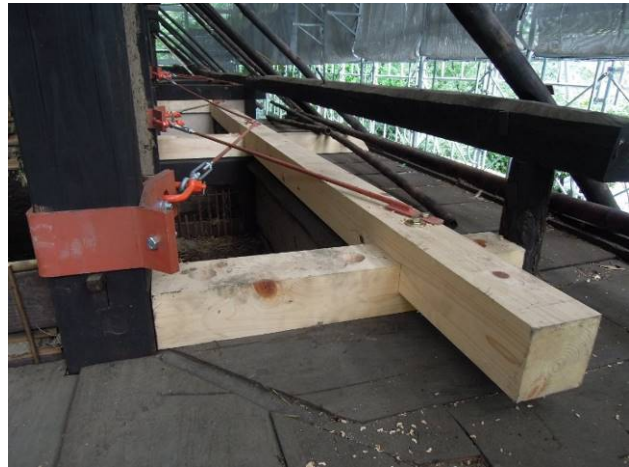
The first method is to reinforce the floor and the roof so that the rigid diaphragm assumption is accomplished. Methods to improve rigidity by nailing the floorboards obliquely (Fig.18), or reinforcement with steel bar brace (Fig.19). When strengthening the horizontal plane and bearing a large shear force, a large axial force acts on the boundary member. Therefore if there is a joint on the tension side, reinforcing with a metal plate becomes necessary (Fig.20).

Fig.18- Floorboards nailed obliquely, Fig.19- Steel bar brace for horizontal plane

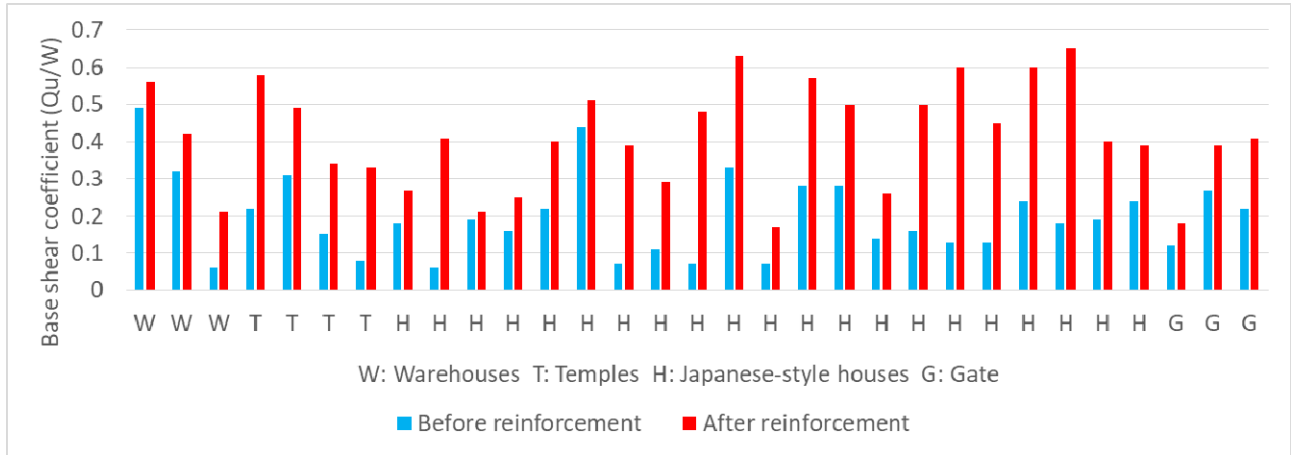
This paper showed that the seismic issue can be summarized into five points and it is necessary to install the reinforcement for them. The results of applying the reinforcement described above to the building indicated by Figure 1 are shown on Fig.22. It was confirmed that the seismic performance is effectively improved by these reinforcements.

Fig.22-Results of reinforcement
