LOW DAMAGE SEISMIC RETROFIT OF A HERITAGE URM BUILDING IN WELLINGTON, NZ

This paper discusses the unique approach taken in seismic retrofit of an existing four-storey URM building located at 97 The Terrace in Wellington, NZ and constructed in 1906. Listed as a Historic Place Category 2, it is one of the only domestic scale Edwardian townhouses remaining in the commercial zone of The Terrace.

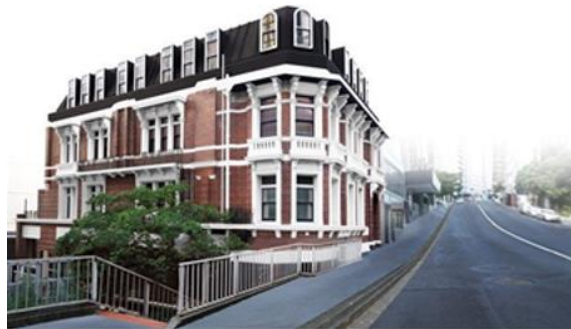
Fig. 1 – 97 The Terrace – View from The Terrace

The property is a four-storey plus basement URM building constructed in 1906. Listed as a Historic Place Category 2, it is one of the only domestic scale Edwardian townhouses remaining in the commercial zone of The Terrace. Fig. 1 shows the current day view of the building from The Terrace. A historic elevation of the building viewed from Woodward Street is shown in Fig. 2.

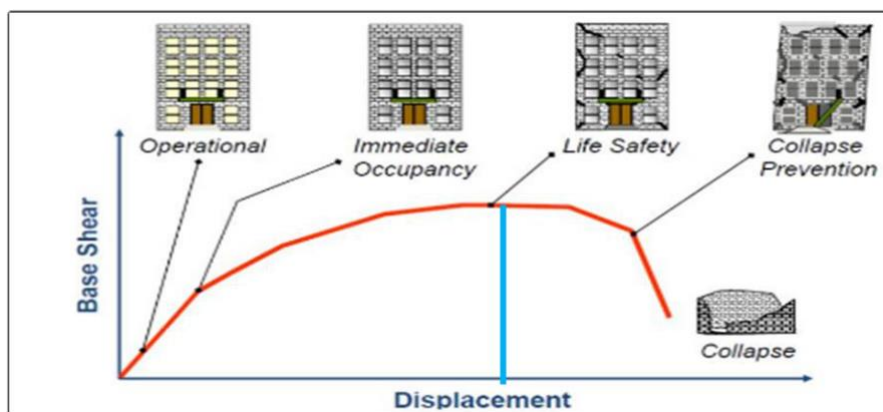
Fig. 7 – Force deformation diagram depicting different stages of building damage

The performance of the 97 The Terrace Building, based on our calculations obtained from DIANA analysis at 45%NBS seismic loads, sits between the “*Immediate Occupancy*” state and the “*Life Safety*” state as shown in Fig. 7. The blue line on the graph indicates the approximate location of the Building on this curve at 45%NBS loads. The global performance of the building was evaluated in accordance to the NZSEE Guidelines [2, 3, 4] and the ASCE 41-17 [5].
