SEISMIC SAFETY OF NON-STRUCTURAL COMPONENTS IN FULL-SCALE 10-STORY RC BUILDING SHAKING TABLE TEST

Keywords: E-defense; Full-scale shaking table test; RC building; Non-structural component; Seismic safety

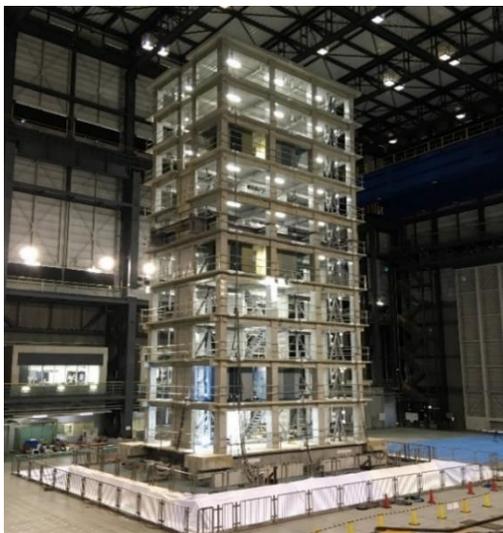
Fig. 1 – Full-scale ten-story RC building

The specifications of the ten-story RC building shown in Fig.1 are shown in Table 1 [2]. The test building consisted of a rigid-frame structure with the multi-story shear wall installed in the 1st to 7th floors in the short-side direction (wall direction) and a rigid-frame structure composed of columns and beams in the long-side direction (frame direction). The shaking table test was conducted on the structure using a free-standing base sliding system developed at the National Research Institute for Earth Science and Disaster Resilience and seismic resistance system on which a basis was fixed. This paper reports on the results of the test with the seismic resistance system.

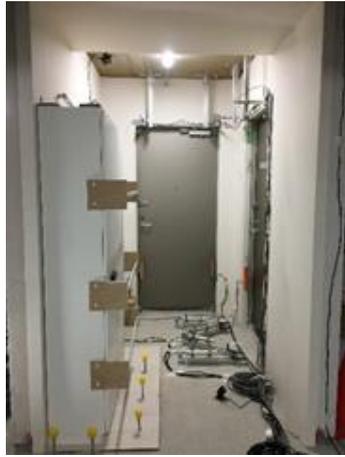
(a) Verification room A

(b) Verification room B

Fig. 4 – Setup of the verification rooms

The floor plan of the 2nd story is shown in Fig.2 and the rough plan of the verification rooms is shown in Fig.3, whereas the setup of the verification rooms is shown in Fig.4. The verification room with interior finish on the ALC panels and seismic resistance SDs (verification room A) and the verification room without interior finish on the ALC panels and non-seismic resistance SDs (verification room B) were located as shown in Fig.2. Furniture was also installed in verification room A. The cross sections of the SDs are shown in Fig.5, whereas the elevation view of the ALC panels are shown in Fig.6. The seismic resistance SD has a larger clearance between the door and the frame than the non-seismic resistance SD. In verification room A, the in-plane deformation angle of the seismic resistance SDs installed in the wall direction and the frame direction (as shown in Fig.3) were measured. In verification room B, the in-plane deformation angle of the non-seismic resistance SDs installed in the wall direction and the frame direction (as shown in Fig.3), and of the ALC panel installed continuously as the normal wall members (ALC (N)) and the ALC panel installed on the side of the non-seismic resistance SD (ALC (S)) in the frame direction (as shown in Fig.3 and Fig.6), were measured. Displacement meters were installed as shown in Fig.7 [3], and the in-plane deformation angle of the SDs, γ_{SD} , was calculated from the displacement data using Eq. (1). The installation of the displacement meters on the SD is shown in Fig.8.

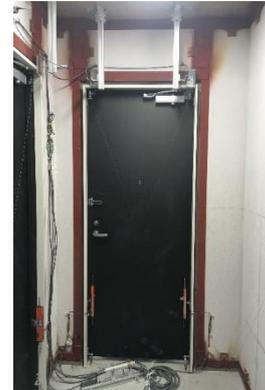
Fig. 8 – Installation of the displacement meters on the SD

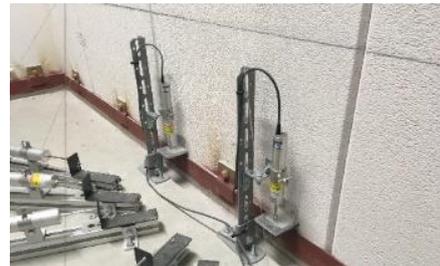
Fig. 10 – Installation of the displacement meters on the ALC panel

where Δ_{SD1} is the displacement measured by displacement meter 1, Δ_{SD2} is the displacement measured by displacement meter 2, L is the width of the SD, and H is the height of the SD. The displacement meters were installed as shown in Fig.9 and Fig.10 to measure the in-plane deformation angle of the ALC panels, and the in-plane deformation angle of the ALC panels, γ_{ALC} , was calculated from the displacement data using Eq. (2) [1].

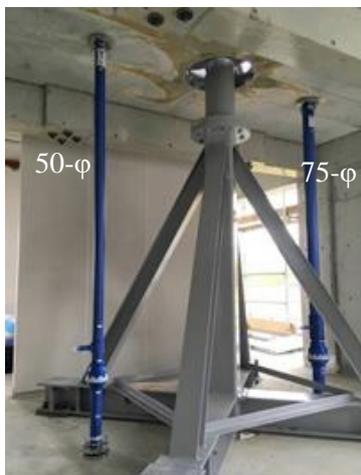
Fig. 11 – Installation situation of the water supply vertical pipes

where Δ_{ALC1} is the displacement measured by displacement meter 1, Δ_{ALC2} is the displacement measured by displacement meter 2, and B is the distance between the displacement meters. Furthermore, polyethylene vertical pipes for water supply with diameters of 50- ϕ and 75- ϕ were installed in the locations shown in Fig.2. The installation situation of the water supply vertical pipes is shown in Fig.11, whereas the installation method used for the water supply vertical pipes is shown in Fig.12 and Fig.13. Water supply vertical pipes are usually passed through the sleeves in the slab and fixed by filling with mortar. However, in this test, a stub flange was provided at the edge of the water supply vertical pipes and fixed to the slab with stainless flanges and anchor bolts. In addition, the water supply vertical pipes are provided with a fusionless joint. The strain gauges were attached to the water supply vertical pipes to assess their behavior during an earthquake. The locations of the strain gauges are shown in Fig.14. The strain gauges were placed at three locations on the pipe, and in four directions at each location.

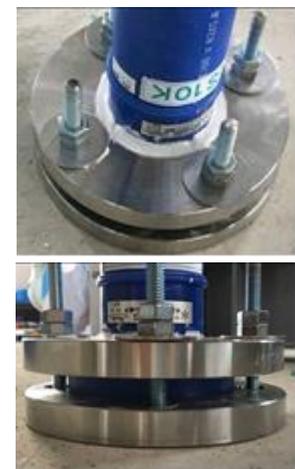
Fig. 13 – Installation part

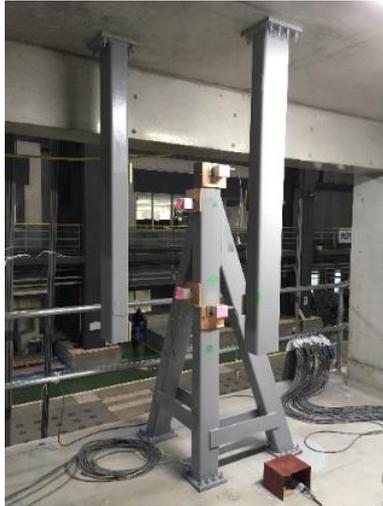
Fig. 17 – Displacement meters for measuring story drift angle Fig. 18 – Maximum story drift angle [2]

The maximum story drift angle of each story was measured by the displacement meters shown in Fig.17 [2]. The measured maximum values were 1/79 rad on the 4th floor in the wall direction, and 1/38 rad on the 7th floor in the frame direction (see Fig.18). The maximum story drift angles of the verified 2nd story were 1/103 rad in the wall direction, and 1/42 rad in the frame direction.

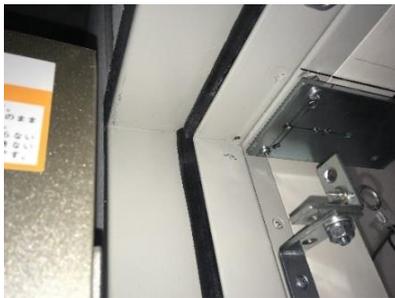
Fig. 22 – Scratches on the SDs after the test

The maximum story drift angle of the 2nd story and the maximum in-plane deformation angle of the SDs and ALC panels in each direction are shown in Fig.21, along with the overall maximum story drift and the maximum in-plane deformation. The maximum in-plane deformation angle of the seismic resistance SD was about 1.3 times, and that of the non-seismic resistance SD was about 1.2 times, the maximum story drift angle of the 2nd story in the frame direction. Additionally, the maximum in-plane deformation angle of the ALC panels and the maximum story drift angle of the 2nd story were comparable, and the rocking behavior of the ALC panels followed the behavior of the building. The maximum in-plane deformation angle of the seismic resistance SD was more than 3 times, and that of the non-seismic resistance SD was more than 2 times, the maximum story drift angle of the 2nd story in the wall direction. The maximum in-plane deformation angle of the SDs was larger than the maximum story drift angle of the 2nd story because of installation of the hanging wall on the SDs. However, comparing the maximum deformation of the SDs with the maximum story drift of the 2nd story, the maximum deformation of the SDs was larger in the wall direction, but smaller in the frame direction. The maximum in-plane deformation angle of the seismic resistance SD was larger than that of the non-seismic resistance SD in both the wall direction and the frame direction. A reason for this difference is that the seismic resistance SD has larger clearance between the door and the frame and therefore less confinement due to contact between the door and the frame. The scratches on the seismic resistance SD were larger than those on the non-seismic resistance SD [4], and the behavior of the frame was great even after the door contacted the frame. In addition, although both the seismic resistance SD and the non-seismic resistance SD sustained minor damage, as shown in Fig.22, all doors could be opened and closed after the tests. Additionally, there was some minor damage at the edges of the ALC panels, but no major damage, as shown in Fig.23.

- (3) Although both the seismic resistance SD and the non-seismic resistance SD showed minor damage, all doors could be opened and closed after the tests.

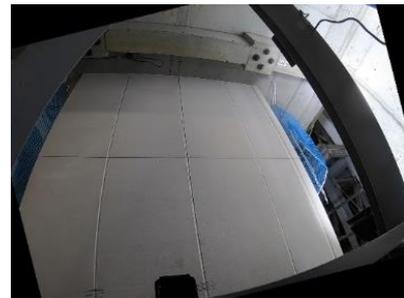
Fig. 23 – ALC panels after the tests

- (6) There was some minor damage at the edges of the ALC panels, but no major damage.
- (7) The strain of the water supply vertical pipes was less than the allowable strain for polyethylene pipe for water supply against earthquakes.
