## EXPERIMENTAL VERIFICATION OF INOVATIVE TECHNIQUE FOR SEISMIC RETROFITTING OF TRADITIONAL MASONRY BUILDINGS

V. Shendova<sup>(1)</sup>, A. Zlateski<sup>(2)</sup>, G. Jekic<sup>(3)</sup>

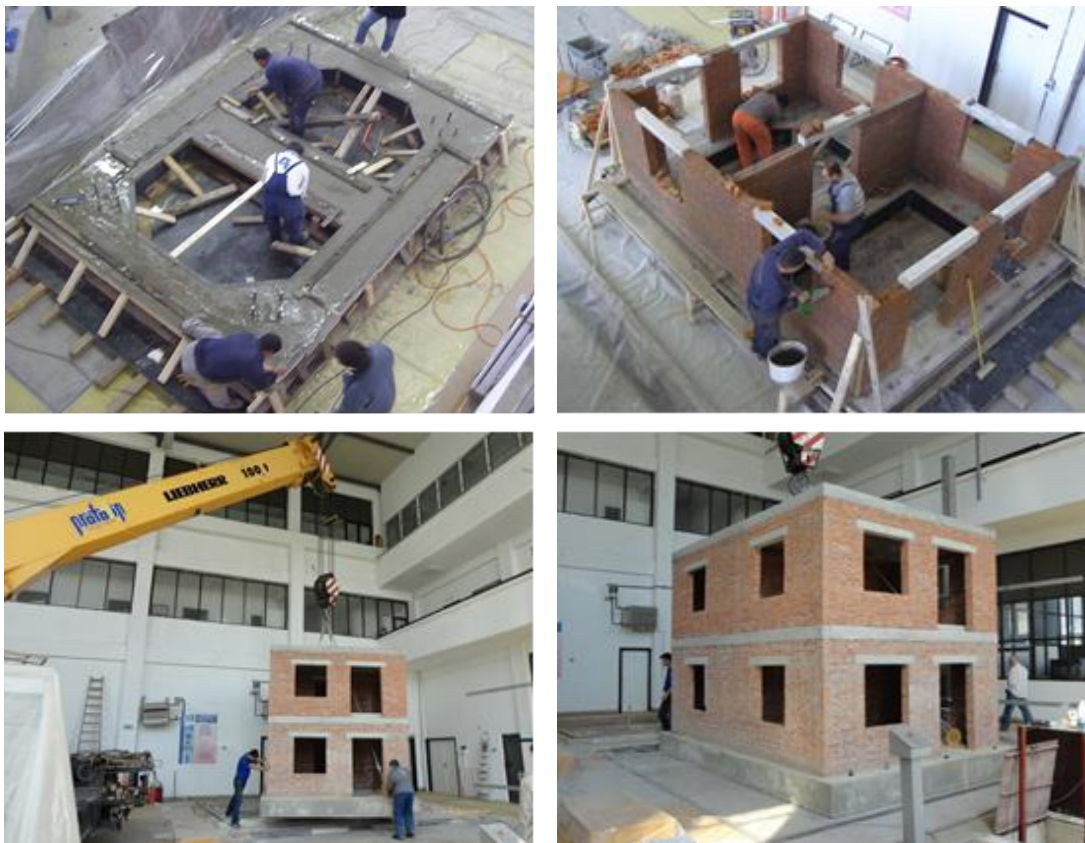
Fig. 2 - Construction and transportation of the brick masonry non-retrofitted model, BM

In accordance with the designed proportions, the model was constructed in the Dynamic Testing Laboratory of IZiIS using a traditional technology of construction of brick masonry structures. A reinforced concrete platform with proportions of 3.26 m x 4.76 m and a thickness of 0.30m was constructed as a foundation for the model for the purpose of its construction and transport, (Fig.2). Dimension of the model are length 4.24m, width 3.06m and height 3.30m. Structural system consists of five bearing walls, four facades and one middle wall. The walls were constructed in a running bond, with the thickness of 12.5 cm, while the thickness of the vertical and horizontal mortar layers is 0.5 cm. Bricks with designed proportions of 12.5 x 6 x 3.25 cm have been used for the construction of the walls. It was decided to procure the required number of bricks with standard dimensions, 25 x 12 x 6.5 cm, and prepared the bricks for model construction in the required dimensions by cutting. Preparation and baking of the bricks were performed mechanically, in the furnace of "Elenica" factory from Strumica, which has a long experience in production of bricks of standard and nonstandard proportions. Lime-cement mortar which is the main bonding material for the structures that represents the hypothetical structure has been prepared with lime: cement: sand ratio equal to 1: 1: 3. The river sand with fraction 0-2 cm was used as filler. Water from the water supply system was used.

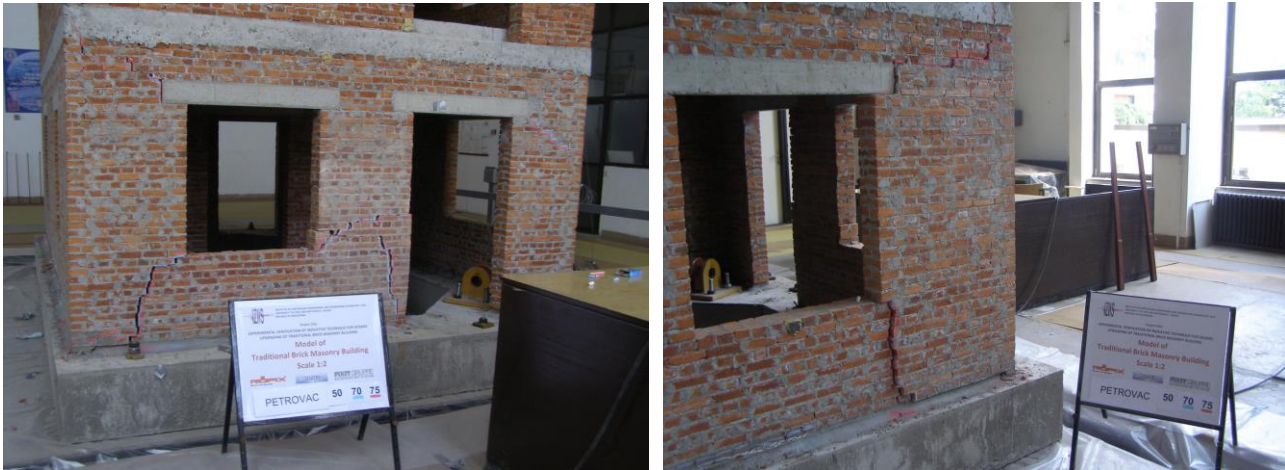
Fig. 4 – Damage to the model after final test ( $acc_{max}=0.35g$ )

earthquake was applied with an intensity of  $acc_{max}=0.22-0.35g$ , which resulted in heavy damages to the building, (Fig. 4). Analyzing the induced damages, it may be concluded the main failure mechanism is transferred in the lower zone and in the final stage it results in occurrence of typical shear cracks of the order of 0.5 - 2.5 cm due to dominant shear stresses. Damages are further on expanded to the bearing walls, mainly the north and the south, but also the middle wall, which are in the direction of the excitation. The stretching direction of cracks confirms the above stated facts about the type of failure.

Considering the general behaviour of the model under dynamic effects and under the last applied effect inducing considerably large cracks (Petrovac 75,  $acc_{max}=0.35g$ ), it is concluded that the building behaves as a rigid body in the elastic range. At the state of occurrence of the first shear cracks, the loads acting on the walls in the excitation direction are considerably increased which results in larger cracks occurring in these walls, (in plane failure mechanism) and development of damages up to a state close to failure. This was proved also by the decrease in natural frequency (stiffness degradation) from 10.95 to 8.7 Hz and from 17.0 to 12.2Hz for E-W and N-S direction, respectively, (Table 3).

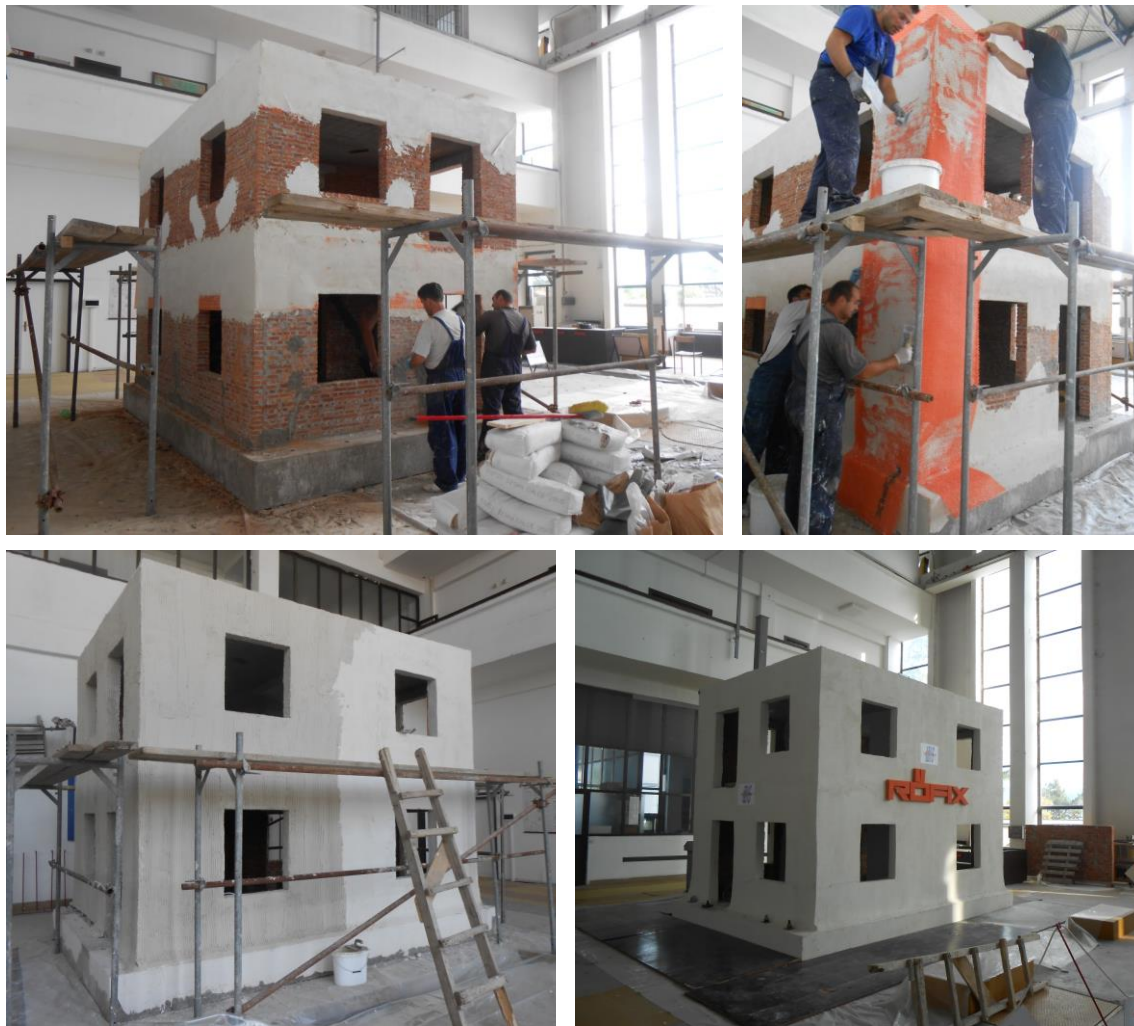
Fig. 5 – Retrofitting of the model using *System RÖFIX SismaCalce*

- applying of the layer of RÖFIX SismaCalce NHL- based mortar as primer,
- applying of RÖFIX SismaProtect anti seismic eq-grid on the outer side of the walls,
- applying of the RÖFIX SismaDur mortar for facade finishing.

The eq-grid was applied with 10-15 cm overlapping in the following order, (Fig. 5):

- around the roof and floor slab,
- above the window and door corners,
- around the foundation slab,
- from the top of the walls to the foundation with required overlapping.

For decreasing of the effect of rocking during seismic tests, additional detailing of retrofitting methodology was proposed to the specialists from the RÖFIX Company, providing anchoring of the eq-grid into the foundation by placing of steel profile (L) along the perimeter of the bottom of the facade walls and its anchoring by bolts under angle of  $45^\circ$  on regular distances of 15-20 cm.

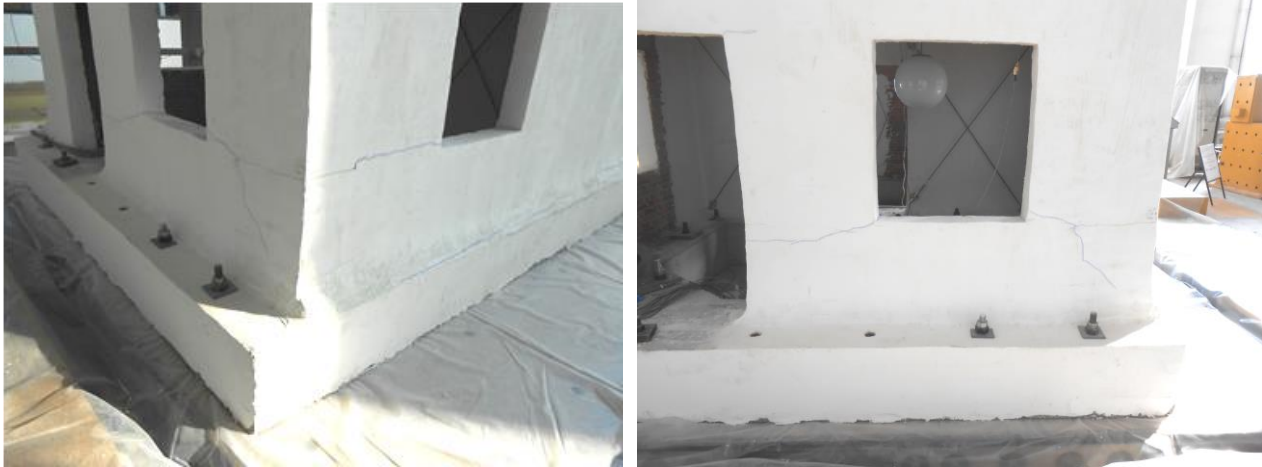
Fig. 6 - Damage of BM-SR model after final test, (left: S-E corner, right: South wall)

The first fine cracks occurred during the application of the Petrovac earthquake with  $acc_{max} = 0.35g$ . Visible horizontal crack occurred about 60 cm above the foundation, i.e. along the line of the bottom of the windows on first floor. This was characteristic for the N-E, S-E and N-W corners, (Fig. 6). With gradual increase of acceleration level of the Petrovac earthquake up to 0.50 g, it is concluded from the behaviour of the model BM-SR that the nonlinear state starts after this level. Compared to the effects of the same time histories of the earthquakes applied to model BM, it is concluded that the level of elasticity, that is the linearity limit is increased for about 100%.

In order to obtain the stages of nonlinear behaviour and estimate the damage level for higher expected earthquake intensities, the tests were carried out applying Petrovac earthquake with gradual amplitude of up to  $acc_{max} = 1.22g$ . For this very high acceleration level characteristic was further propagation of the initial cracks as well as occurring of additional cracks along the contact line of the walls with foundation (Fig. 6). However, stability of the complete building is preserved.
