## SEISMIC REINFORCEMENT OF TWO-STORY EARTHEN BUILDINGS USING A ROPE MESH: PRELIMINARY TABLE TEST RESULTS

*Keywords: earthen construction, seismic protection, rope mesh reinforcement*

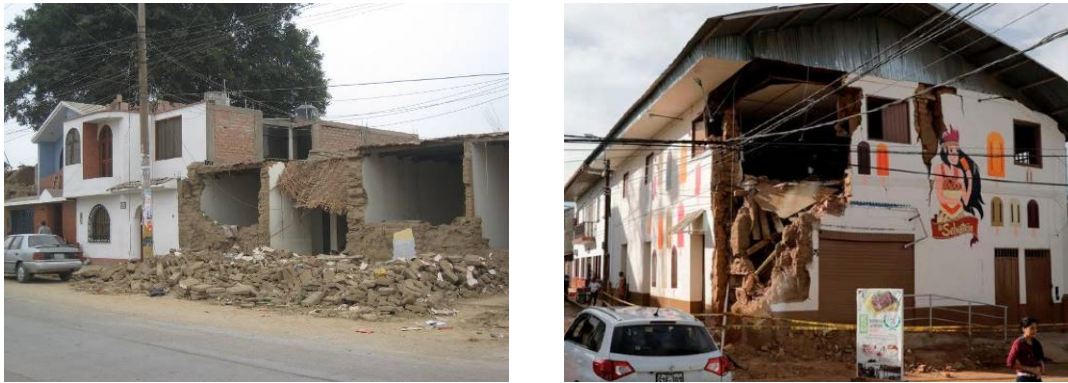
Fig. 1 – Adobe buildings heavily damaged by the Pisco, 2007 earthquake in Peru.

The collapse of earthen constructions is usually triggered by the progressive formation of cracks in the walls. First, a combination of in-plane diagonal cracks and vertical corner cracks occurs due to the low tensile strength of the adobe masonry. Then, exterior walls may overturn out-of-plane, sometimes dragging the roof with them [1]. Fig. 1 shows the partial collapse of adobe dwellings during the Pisco, 2007 earthquake in Peru. It is quite revealing to notice that the confined masonry house shown in the photo at the left did not suffer any damage, whereas the neighboring adobe houses lost their façade walls and most probably had to be demolished. Unfortunately, adobe is the only construction material available for a large portion of the population in Peru and many developing countries in seismic areas of the world.

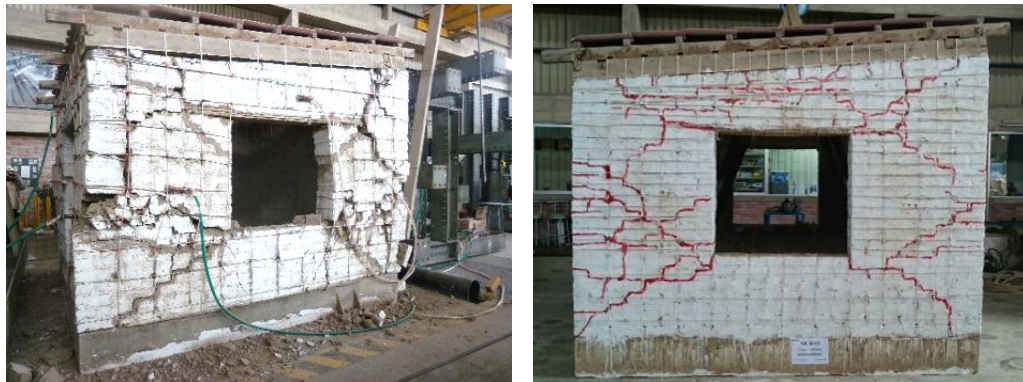
a) 1/2" nylon mesh reinforcement      b) 5/32" nylon mesh reinforcement

Fig. 2 – Cracking patterns on reinforced full-scale one-story adobe models after strong shaking table tests.

Two one-story adobe models were built, reinforced with nylon string meshes and tested at the shaking unidirectional table [2]. The first one-story model was first shaken in order to induce representative seismic damage. Then, the larger cracks were repaired via mud grout injection, and after the repaired cracks were suitably dry, the model was reinforced with a mesh made of 1/2" nylon ropes and tested again on the shaking table with a sequence of movements of increasing intensity (0.30 g, 0.71 g, 1.08 g and 1.53 g horizontal base acceleration). The model's seismic response was considered to be excellent because even during the strongest shaking the mesh reinforcement maintained the structural connection between roof and walls, controlled the excessive displacements of the walls and avoided partial collapses thus preserving the integrity of the structure Figure 2a shows the model after the whole testing campaign.

Based on the experimental results obtained, a design procedure was devised in order to be able to specify the rope mesh reinforcement required to provide seismic safety against collapse of any one-story earthen building. A second one-story model, was then built and reinforced with thinner 5/32" nylon ropes [3], which were tied by hand, thus avoiding the use of turnbuckles. This new reinforced model was subjected to a single strong base motion with 1.4 g peak acceleration, and its dynamic response was also considered to be excellent,

as the rope mesh was capable of preventing the overturning of the large wall portions which were cracked due to the strong shaking, as shown in Fig. 2b.

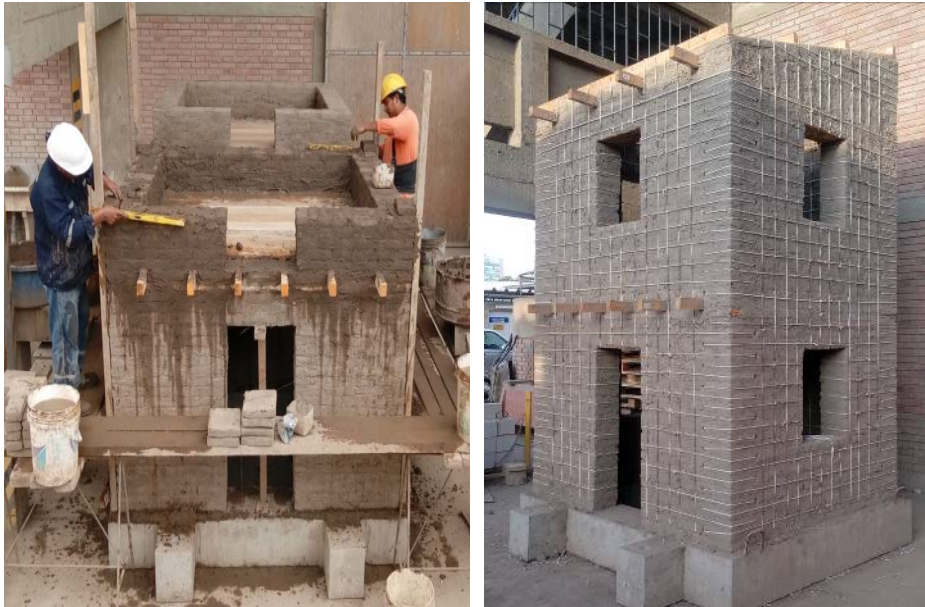
Fig. 4 – Construction of a half-scale reinforced adobe model.

The rope reinforcement consisted of 1/8" vertical and horizontal nylon strings placed on both faces of all walls. The horizontal strings were doubled. The reinforcement spacing was specified to be consistent with the masonry layout: every two rows horizontally and every block vertically. Holes were drilled on the mortar to allow passing the ropes through the walls. These perforations were carried out mainly in the vertical joints close to the wall corners for the placement of the horizontal ropes. Also, the horizontal joints located in lower areas were drilled for the placement of the vertical ropes. Additional holes were drilled in order to connect the internal and external meshes with pass-through ropes. The first story vertical ropes were placed first, passed over the wooden floor beams and tied to the second story ropes. Then, the horizontal ropes (which were doubled) were placed. The inner and outer meshes were joined with pass-through ropes. Figure 4 shows two stages of the construction of one reinforced adobe model.

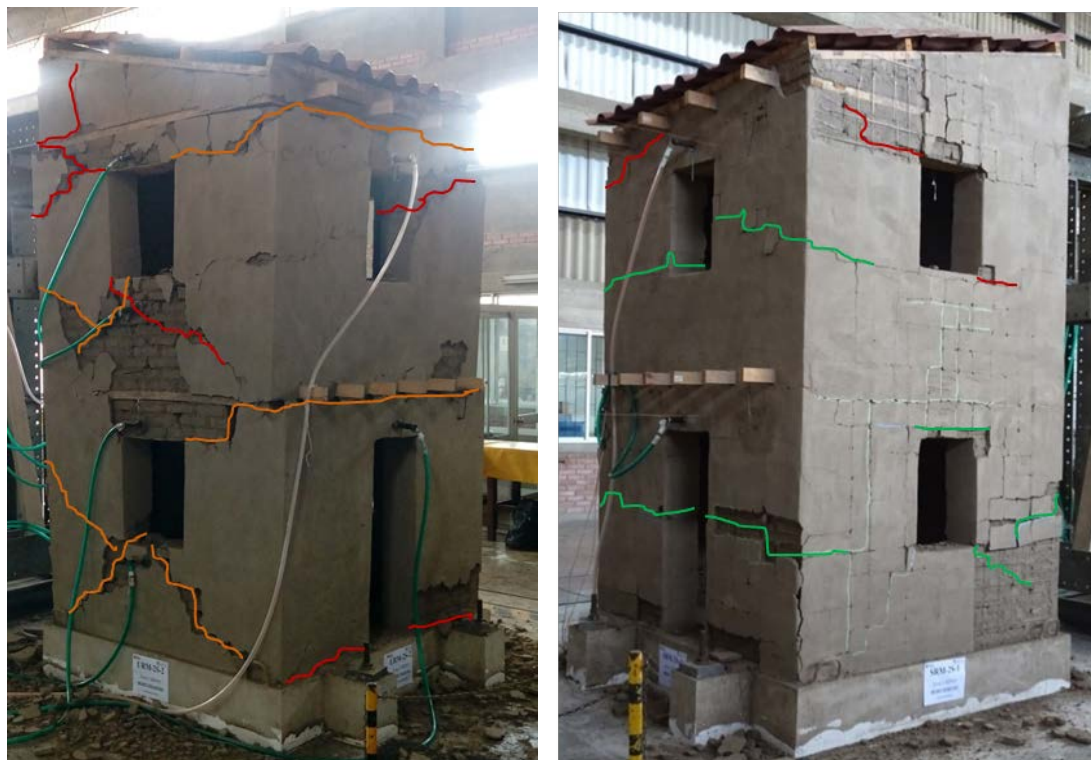
a) URM-2

b) SRM-1.

Fig. 8 – Damage of two models after strong shaking ( $D0_{max} = 60$  mm,  $A0_{max} = 1.67$ g).

motion with  $D0_{max} = 60$  mm and  $A0_{max} = 1.64$  g, the model was close to collapse: the front first story wall got separate from the floor beams, and thick diagonal cracks were formed on the second story back wall, across the full wall thickness (see orange and red lines in Fig. 8a). Also, there was a clear separation between the walls and the sloped roof. Fig. 8a shows the URM-2 after this test.

The first reinforced model was subjected to four shaking table motions. During the two firsts tests, with  $D0_{max}$  of 15 and 30 mm, some small horizontal cracks appeared at mid-height of the first floor front and back walls (see green lines in Fig. 8b). Then, two similar strong motions with  $D0_{max} = 60$  mm and  $A0_{max} = 1.67$  g were applied successively. During the first 60 mm shaking, diagonal cracks appeared near the openings of both levels, dividing the wall into several blocks (see green and red lines in Fig. 8b). In the second 60 mm tests all these fissures opened a little more and a slight relative movement between the different wall blocks was detected. The rope mesh reinforcement, however, was able to keep together all these wall portions. The reinforcement provided, therefore, allowed the structure to keep together in a stable manner, even though some walls were significantly damaged. None of the nylon strings failed during these tests. Fig. 8b shows the condition of the reinforced model after the second strong 60 mm, 1.67 g shaking.
