STRUCTURAL ASSESSMENT OF REINFORCED CONCRETE BEAMS RETROFITTED WITH CARBON FIBRES AND STEEL PLANKS SUBJECTED TO BENDING

This paper presents and discusses the structural behaviour of reinforced concrete beams subjected to bending with two retrofit systems, namely: (i) carbon fibre reinforcement and (ii) epoxy-bonded steel sheets. First, the beams were tested under four-point bending before repairing. In order to achieve a monolithic action, epoxy resin was used for adhering the retrofitting plates at the cracked zones and in the compression areas where the original concrete was replaced with construction grout. A total of 12 full-scale beam specimens were tested, 3 reinforced with carbon fibre and 3 reinforced with steel plates. The retrofitted results were compared against those of the 6 beams tested without reinforcement. All beams were tested in the Structural Laboratory of the Faculty of Civil Engineering at the UNSA (San Agustin National University from Arequipa) by applying 2 symmetric concentrated loads at mid-span. The structural retrofitting techniques examined herein were found to perform well and failure was not observed at the same repaired location due to adequate adhe

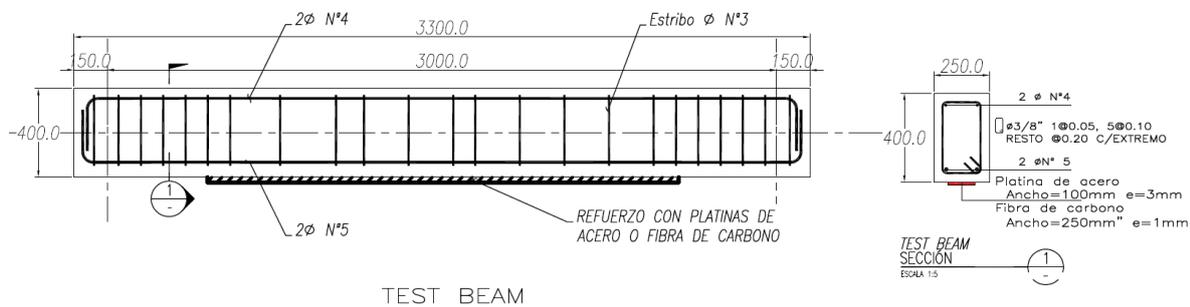
**Fig. 1.** Design detail of experimental beam

A total of six large-scale RC beams were manufactured and tested. The beams had a rectangular cross section of 250mm x 400mm with an effective length of 330mm. All the beams were provided with steel reinforcement of 2-5/8" diameter at bottom, 2-1/2" at the top and used 3/8" diameter stirrups along the beam length (See. Fig. 1). The beams were tested in a previous study and they attained loads from 9.52 ton to 15.61 ton and permanent plastic deflections in the range of 19.88mm to 80.93mm at midspan (See Table 2 and Fig. 2). Three beams were retrofitted using the externally bonded steel plate method and the other the three using the carbon fiber sheet bonding method. Additionally, two (2) U-shaped carbon fiber anchors were placed at each end of the beam in order to prevent rolling or premature take-off at the ends of the supplied reinforcement by bending.

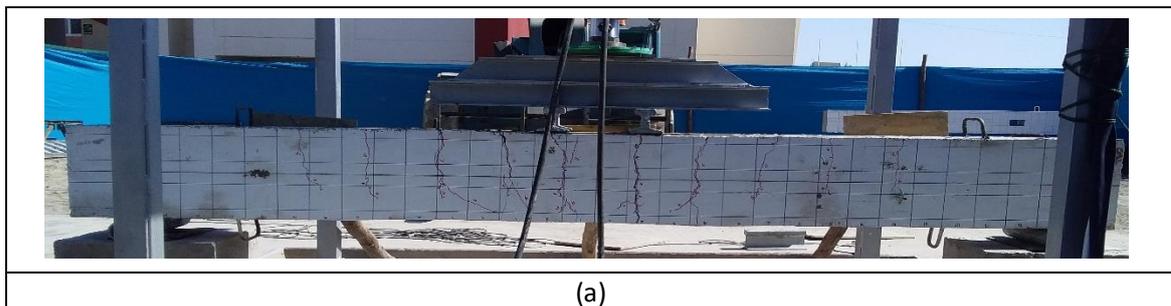
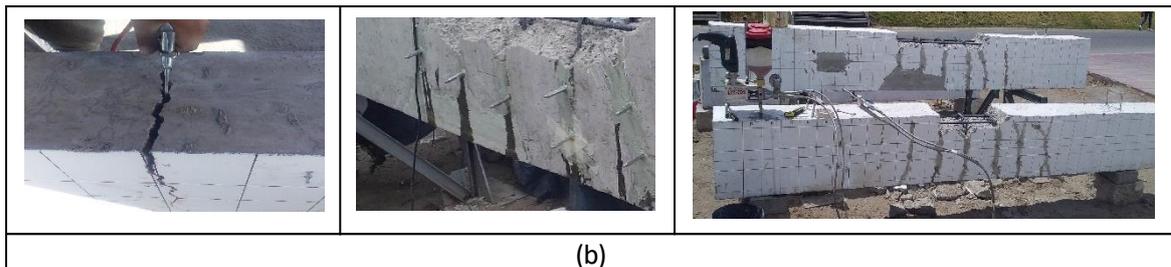
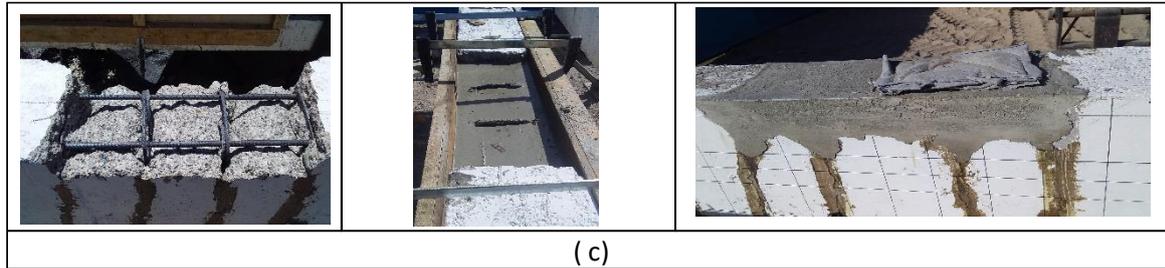
A typical retrofitted specimen is shown in Fig. 3. The following steps were undertaken:

- The original position of the specimen was recovered by means of a hydraulic jack.
- Cracks were cleaned with compressed air and sealed. Packers were placed with a fast curing epoxy adhesive (Sika Anchorfix -2).
- Main cracks were injected and filled using Sikadur 35- hi-Mod LV, a high strength, and low viscosity adhesive epoxy. The epoxy is injected using the specific pressure pump through the packers into the surface of the specimens.
- The heavily damaged concrete was removed.
- Cleaning of the specimen surface to be filled in using a metal brush and compressed air and application of bonding agent.
- Filling in with Sika 110 grout and curing.

Fig. 3 (a) Beam geometry recovery, (b) crack repair procedure, (c) concrete repair procedure.

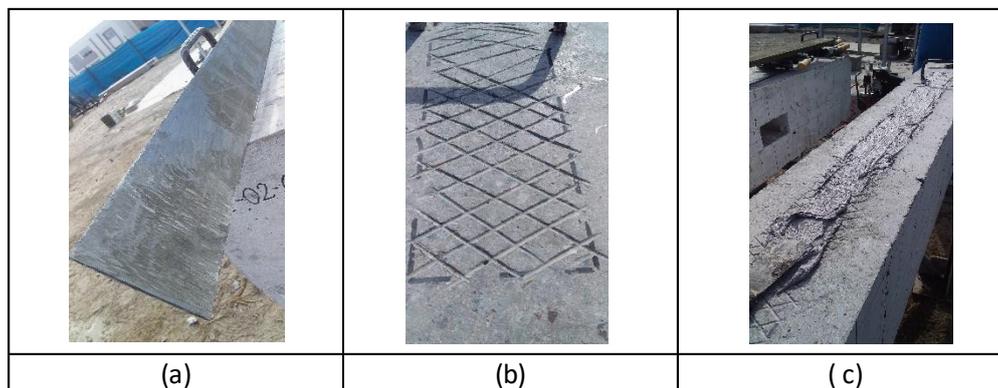
Fig. 4: Reinforcement procedure with steel plate

- Sandblasting or steel plate cleaning and texturing (See. Fig. 04 -a).
- Cleaning and texturing of concrete surface to be adhered to the steel plate (See. Fig. 4 -b).
- Apply the adhesive on both sides with a thickness of approximately 2mm. Apply uniform and sufficient pressure to leave a final adhesive thickness of 1mm.
- Keep pressure for 24 hours. Make sure the resulting adhesive thickness is as uniform as possible.

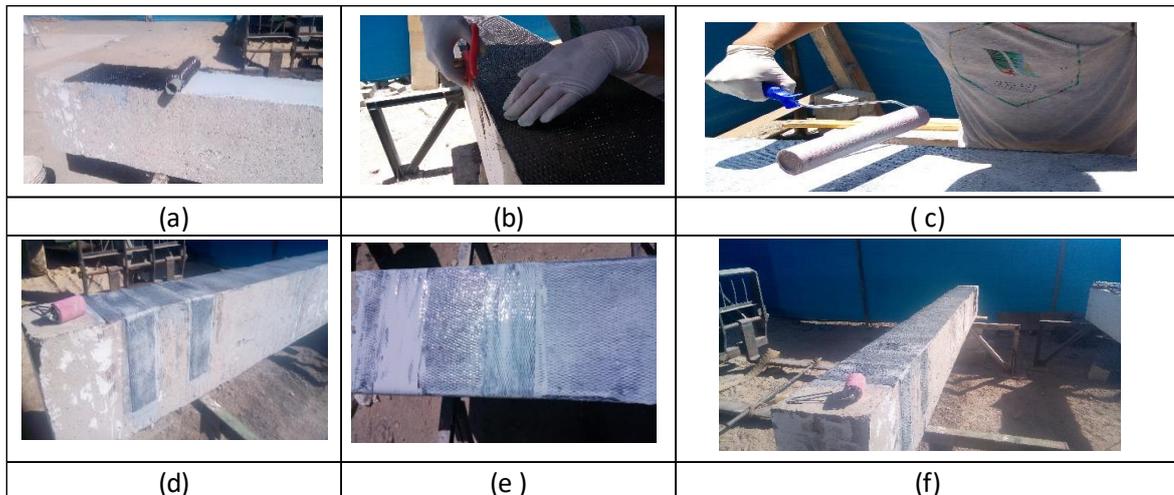
- The surface must be clean, free of oil, grease, dust, grout, paint, etc.
- The surface must be uniform (i.e. with irregularities of less than 15mm per 1mm length). If retrofitting is needed, the mortar or resins used for the repair must be completely cured before the application of the carbon fibre.
- Round off the corners to avoid stress concentration on the lower sharp edges of the beams.
- Cut the tissue with scissors or other cutting tools.
- Apply Sika-301 to the surface with a roller paint brush and carefully attach the carbon fibre tissue directly to
- The fibre is pressed with a special impregnation roller, only in one direction of the fibres. The overlap will be > 100mm (depending on the type of fabric) or whatever is specified in the project.

Fig. 5:(a) Placing carbon fiber fabric, (b) careful cutting of fabric, (c) pressure with roller, (d) placement of resin on fabric, (e) pressure with special roller, (f) finished specimen

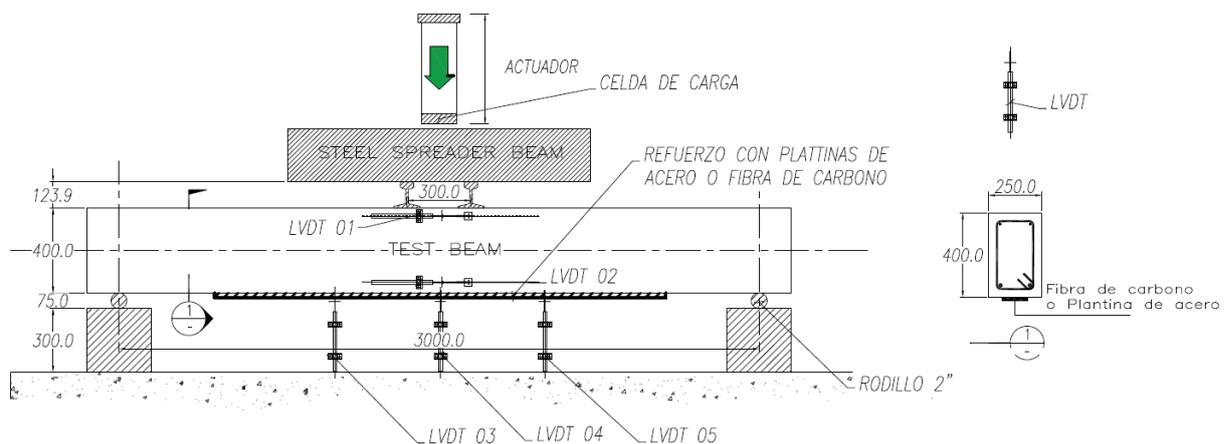
The experimental tests were performed under displacement-control conditions. The loading system had a capacity of 50 tonnes. The reinforced RC beams were simply supported in a 3000mm span and subjected to monotonous three points loads using a separate beam (See Fig. 6). The loads were applied using the 50 tonnes capacity beam testing machine with two loading systems of 300 mm. An internal loading distance from each other to create a constant moment region. Deflections at the midspan and supports were measured by means of displacement transducers (LVDT). Instrumentation was also placed in the tensile and compression zones at midspan.

Fig. 6: Configuración e instrumentación del ensayo (todas las medidas en mm)

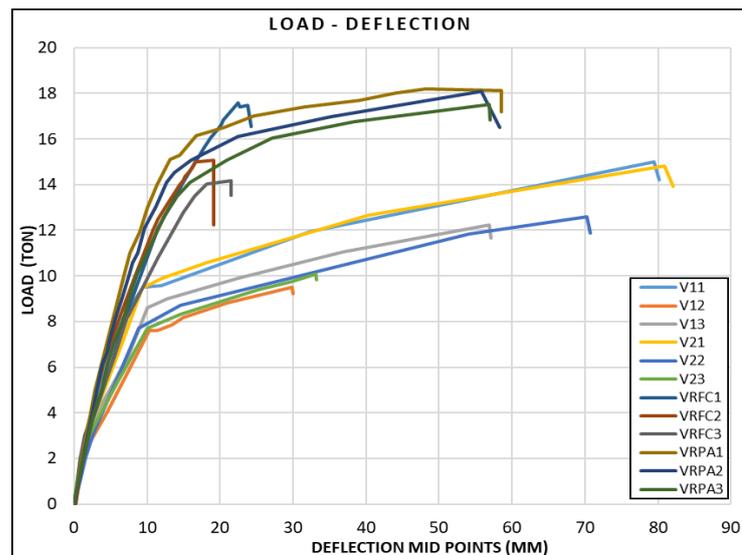
The total load versus midspan deflection curves of the repaired and original reinforced concrete beams are shown in Fig. 7. It can be appreciated from this figure that the repair and strengthening of the

damaged beams increased their initial stiffness and strength. The carbon fibre reinforced beams showed a fragile behaviour and the steel plate reinforced beams showed a ductile response.

The failure mode identified was delamination or reinforcement failure. The Control Beams experienced pure bending and related failure with severe vertical cracks propagating symmetrically from the soffit of the beam until crushing occurred between the load points.

Fig. 7. Gratic Load- Deflection mid points

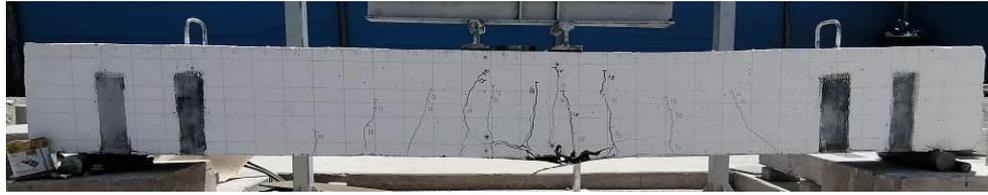
Fig. 9 Beam VRFC2

Beam reinforced with carbon fibre (VRFC2). The failure produced is by yielding of the internal reinforcement followed by fracture of the carbon fibre band due to bending stresses. Flexural cracks developed at midspan with widths in the order of 0.2 to 0.35mm. The load capacity was 15.12 ton and the ultimate midspan deformation was 19.12mm after which the carbon fibres fractured. The load achieved was 54% higher than the beam without external reinforcement.

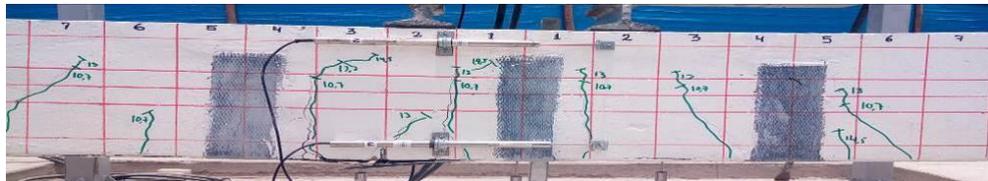
Fig. 10 Beam VRFC3

Carbon fibre reinforced beam (VRFC3). The failure mode observed in this beams was yielding of the internal reinforcement followed by fracture of the carbon fibre band due to bending stresses. The flexural cracks in the centre had widths of 0.20 to 0.30 mm. The peak load capacity was 14.17 ton at a midspan deformation of 21.48 mm. After which the carbon fibres fracture. The load achieved was 16% higher than the beam without external reinforcement.

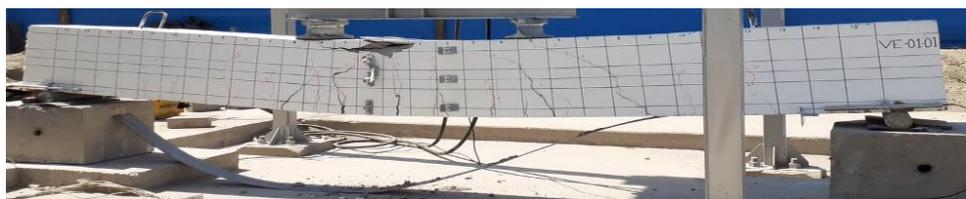
Fig. 11 Beam VRPA1

Beam reinforced with steel plates (VRPA1). The failure produced was yielding of the internal reinforcement followed by an incipient detachment of the steel plate at one end of the specimen due to bending stresses. Crack associated with bending were observed in the centre of the span, being in the order of 0.35 to 0.5 mm. The load capacity was 18.02 tons and deformation at midspan was 58.6 mm. After that, the steel plate at one end of the beam detached. The load achieved was 22% larger than the associated load of the beam without external reinforcement.

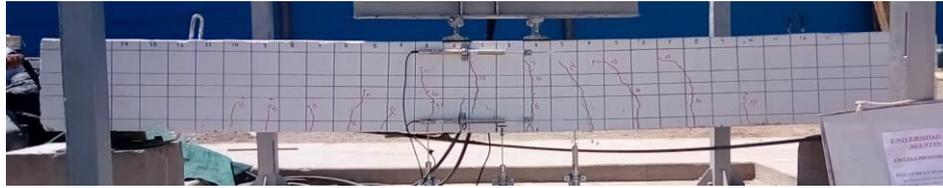
Fig. 12 Beam VRPA2

Beam reinforced with steel plate (VRPA2). The failure produced is by yielding of the internal reinforcement followed by an incipient detachment of the steel plate at one end of the specimen by bending stress. The bending cracks were exhibited at midspan, being in the order of 0.35 to 0.50 mm. The load capacity was 18.08 ton and deformation in the middle section was 55.81mm. The load achieved was 50% higher than the beam without external reinforcement.

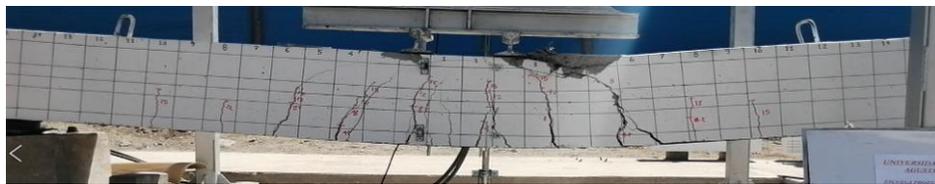
Fig. 13 Beam VRPA3

Beam reinforced with steel plate (VRPA3), the failure produced is by yield of the internal reinforcement followed by an incipient crushing of the concrete in the compression zone of the specimen by bending stress, the steel plate did not detach from the specimen. Bending cracks developed at midspan beam, which was in the order of 0.35 to 0.65 mm. The load capacity was 17.51 ton and deformation in the middle section was 56.68 mm. The load achieved was 84% larger than that of the beam without external reinforcement.

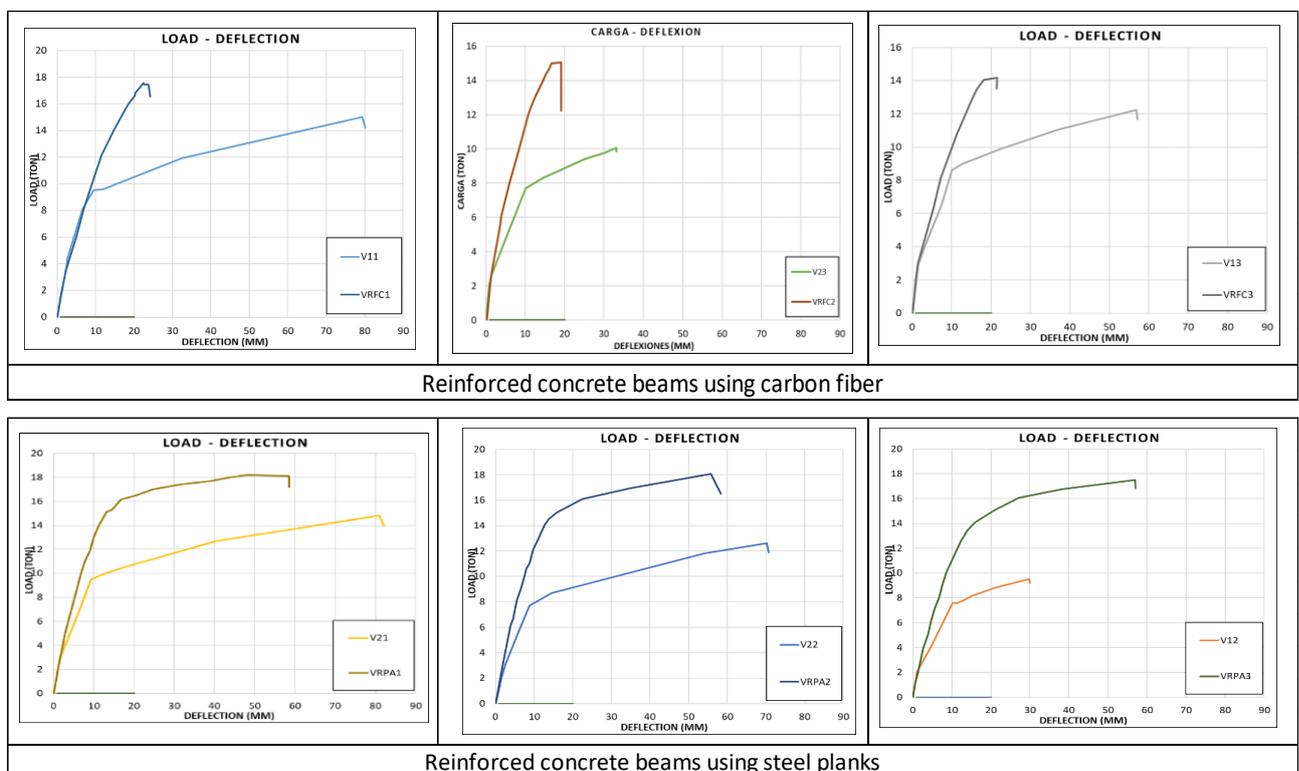
The recorded experimental results are presented in Fig. 14 in terms of load vs. deflection at midspan for all beams. Curves for beams with and without external reinforcement are represented.

Fig. 14 Load-midspan deflection relationships for beams VRFC, VRPA and beams without reinforcement
