INVESTIGATION ON THE COLUMN SHEAR FAILURE DUE TO THE LOCAL INTERACTION WITH MASONRY INFILLS IN RC FRAMES

Keywords: RC buildings; shear failure; local shear interaction; masonry infills; experimental results

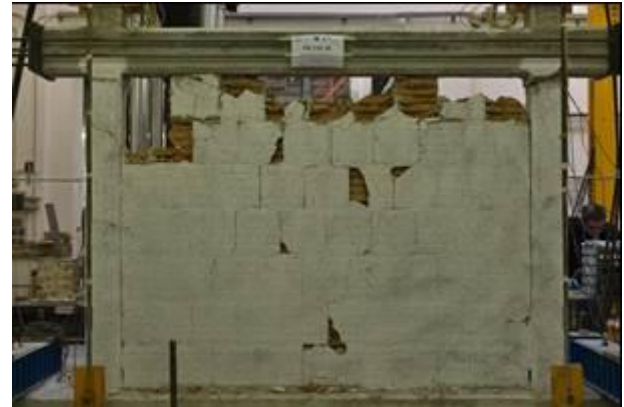
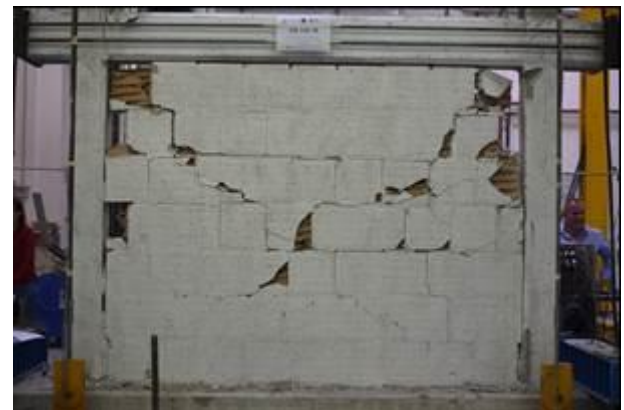
In this section, the main experimental results are shown and commented, in terms of base shear (V_{base})-drift cyclic response (see Fig. 3a and Fig. 4a) and damage evolution. The final damage state for each specimen is reported in Fig. 3b and Fig. 4b.

Fig. 3 – Experimental results for specimens with $t_w=120$ mm: base shear-drift cyclic response (a); final damage state (b)

During the very first steps of this test, until an actual applied drift level equal to 0.07% no significant cracks appeared, and only slight detachment of the infill panel from the surrounding frame was observed. At 0.15% drift, very slight cracks appeared in the infill top corner (close to M2 column), which became evident at the following cycle (at 0.32% drift). At 0.32% drift, additionally, first horizontal sliding between the panel and the top beam were observed, slight diagonal cracks developed in the infill panel, with about 60° inclination with respect to the horizontal direction, starting from the top corners, and hairline cracks occurred in the top M1 column, with about 30° inclination with respect to the horizontal direction. In the following cycle, the peak load was reached, namely $V_{base} = V_{max,+} = +116.5$ kN at +0.66% and $V_{base} = V_{max,-} = -108.5$ kN at -0.57%. At this stage, existing diagonal cracks in the panel and inclined cracks at the top columns became more evident; an additional crack occurred in column M2 (where the third stirrup was located, at about 32 cm from the column-beam interface) with about 45° inclination. Such cracks in top columns appeared in the ascending phase of the global response, proving the existence of a shear interaction due to the lateral infill action on the columns. In the following cycle, at drift = 1.1%, additional cracks developed in the panel, parallel to the first ones, and corner crushing at both the infill top corners occurred, with the detachment and the overturning of some external bricks' tiles; shear cracks in top column became wider. In the following sub-cycles at the same drift level, additional tiles overturned from the whole last row of bricks. When the drift level equal to about 1.5% is intended to be applied, in the positive (pushing) direction, a

sudden strength drop was observed at 1.1% drift (see red star in Fig. 3a), followed by a clear intra-cycle softening until the imposed drift level (1.5%). At this sub-cycle, an evident sliding along the crack surface was observed at the top of M1 column, together with a sudden elongation of the hydraulic jack located on that column (see section 4), thus highlighting the born of a shear failure and the subsequent losing of column axial load carrying capacity. A last sub-cycle in the negative direction was performed and the test was stopped, when the maximum strength decay with respect to the maximum achieved V_{base} was equal to 57%.

drift = +0.5%, and a hairline inclined crack occurred at the top M1 column; a slight inclined crack also appeared in column M2 (in pulling direction) at about 30 cm from the beam-to-column interface. The maximum V_{base} was achieved at +0.5% drift in the positive direction ($V_{max,+} = 97.7$ kN). In the negative loading direction, the maximum base shear was achieved at -0.94% drift. At this stage, in the pull-direction, a clear crack was born along the panel diagonal, together with the a slight crack in top column M2, and a significant strength drop was observed also in this direction (see Fig. 3b). Vice-versa, in the push-direction at the same applied drift level, the widening of the existing diagonal crack in the infill was observed, with some bricks crushing in the center of the panel and in the top corner in contact with the column M1, where a clear (diagonal) shear crack was observed (with about 60° inclination with respect to the horizontal direction).

In the following cycles, exiting cracks in the infill progressively became wider, clearly isolating a roughly triangular portion of infill in the upper portion of the panel, which became free to move rotating around the infill central point and, thus nullifying the increment of its horizontal action on the adjacent columns. Therefore, in the columns' ends mainly horizontal cracks increased their width, whereas, no further development of diagonal shear cracks was observed or measured, thus producing a preeminent flexural behavior of the RC frame (with the flexural hinging of columns highlighted by horizontal cracks along the columns base side) from 1.6% drift to the end of the test (at about 4% drift). Obviously in this case, due to the contact length between the bottom portion of the infill and the column, the column clear length resulted lower than its total length. An almost constant residual strength was reached of about 40 kN, namely less than 50% of the maximum achieved base shear, and more than the expected plastic shear of the frame in the hypothesis of plastic hinging at the columns (weaker than beam)' ends.

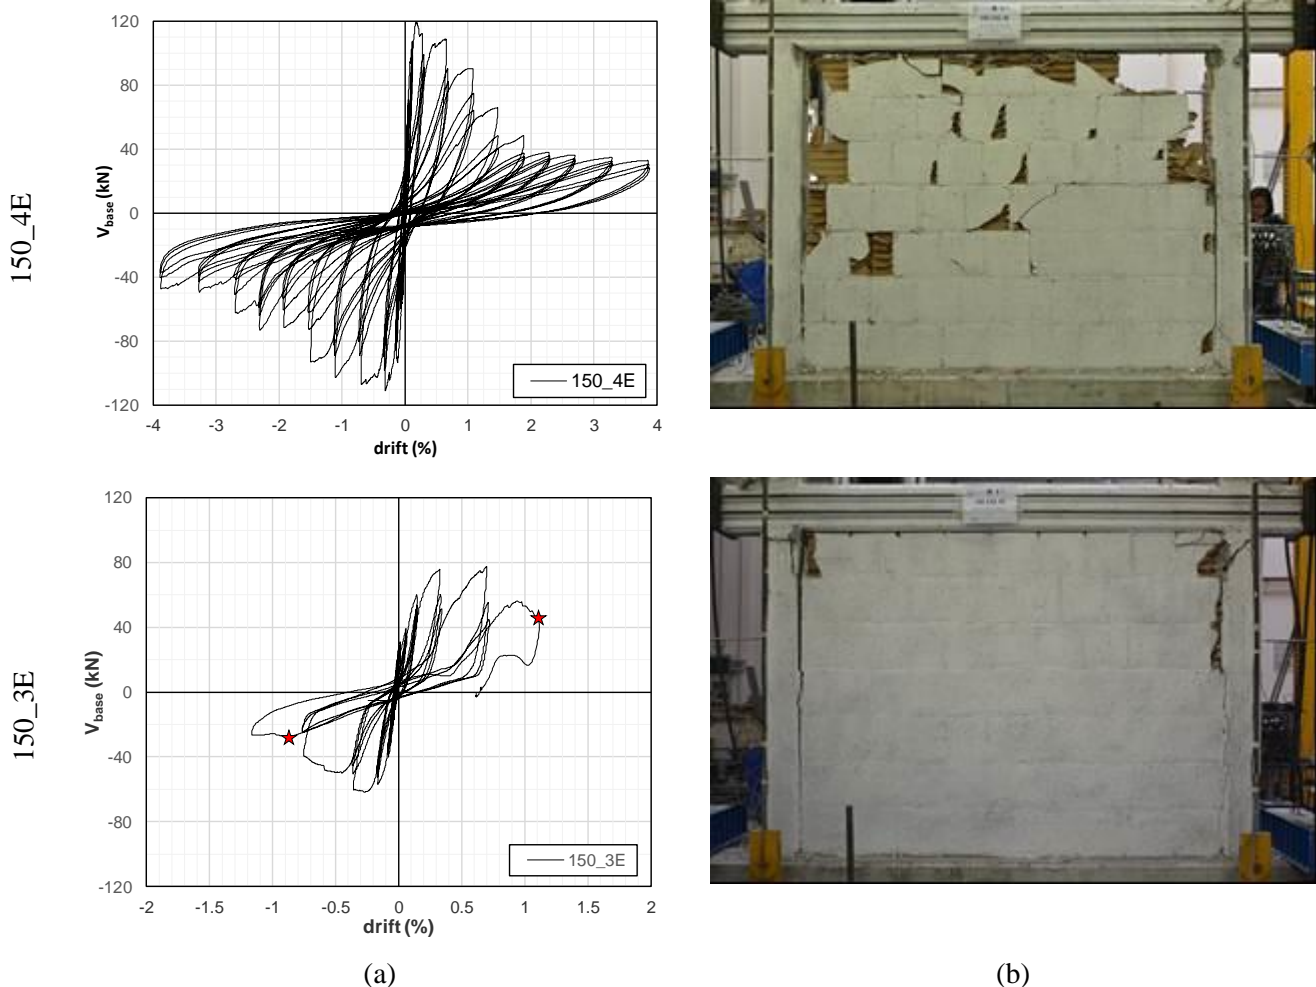
Fig. 4 – Experimental results for specimens with $t_w = 150$ mm: base shear-drift cyclic response (a); final damage state (b)

At the end of the test, the infill panel appears only slightly cracked, with some crushing in the top corners, and totally detached from the surrounding columns; whereas the initial top gap between the infill

and the top beam is almost totally closed (see Fig. 4b) due to the sliding of the top beam with respect to the lower portion of the M1 column, along the main identified shear crack. The final global response results clearly asymmetric, due to the described evolution of shear cracking and failure in columns, and maximum achieved lateral load significantly lower (about 60%) than the maximum load achieved in the 150_4E specimen, as discussed in the next section.

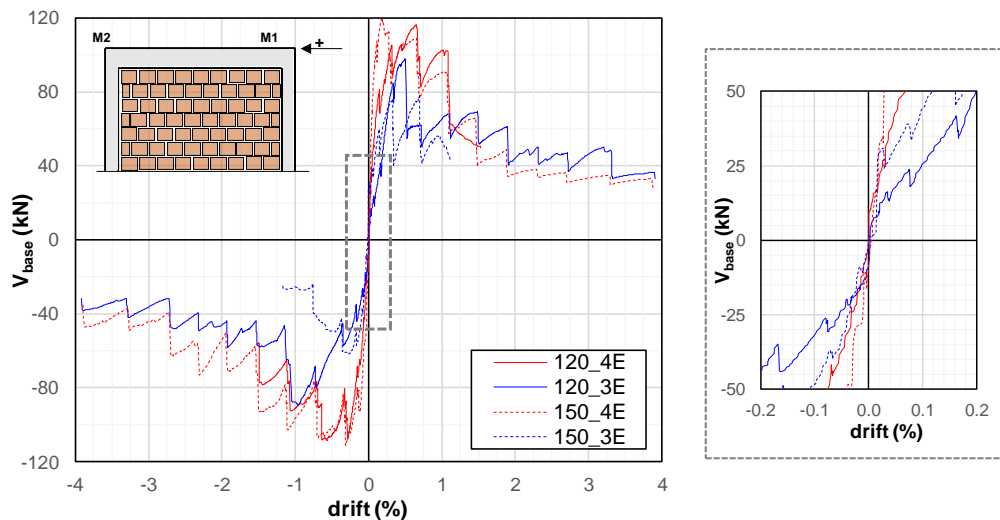
The experimental results described above are compared to each other in this section. A first comparison can be carried out in terms of V_{base} -drift envelopes (as shown in Fig. 5), maximum base shear in both loading directions and related drift levels (as reported in Table 3).

It can be noted that the initial lateral stiffness of specimens infilled with thicker bricks (150 mm) is higher than the corresponding frames infilled with 120 mm bricks. Additionally, when infills are well connected along all the four edges with the frame (cases “4E”), the initial stiffness is higher than the corresponding cases “3E”, as expected. On the other hand, for the “4E” specimens, the maximum achieved lateral load is almost the same for both the infill thickness, mainly due to the lower compressive strength (about 40%) of the thicker bricks (150 mm) with respect to the thinner bricks (120 mm), as shown in Table 1, which compensates for the higher thickness (and, consequently, the higher infill resisting area). If the cases “3E” are considered, the specimen with the higher bricks thickness shows even lower maximum base shear with respect to the case of 120 mm infill thickness, likely due to the very different behavior (ductile versus brittle) which characterized these two specimens, as described in the previous section.

Fig. 5 – Comparison of experimental envelopes
