## SEISMIC FRAGILITY ANALYSIS OF A FOUR-STORY MASONRY BUILDING WITH RETROFIT TECHNIQUES

### **Abstract**

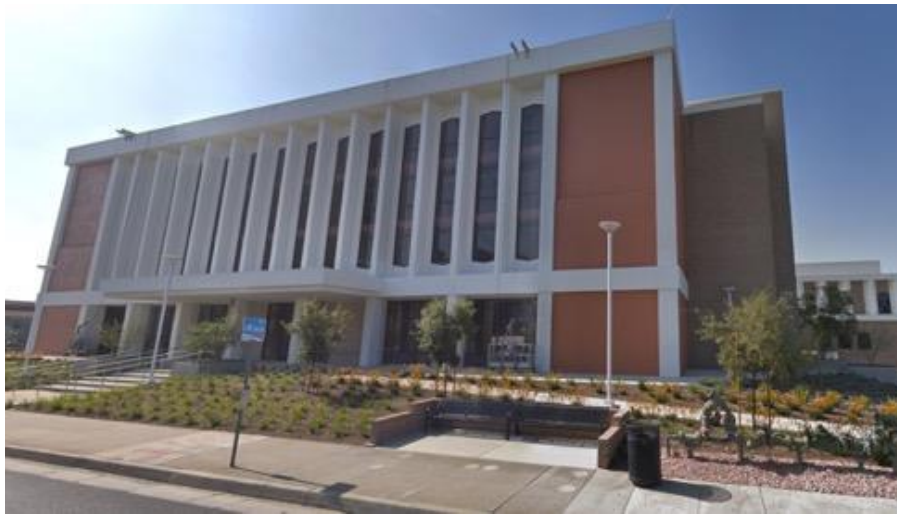
Fig. 1 – Present State of the Case-Study Building

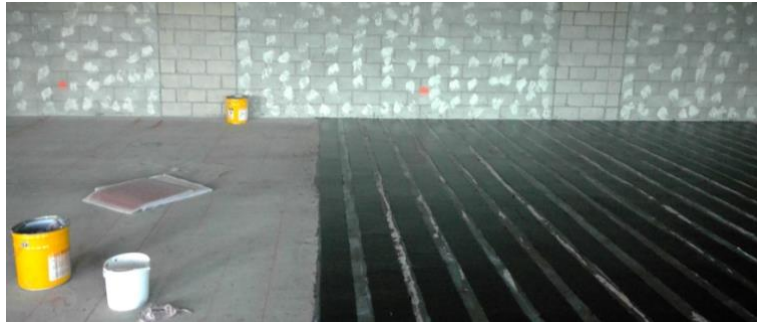
Fig. 2 – Unidirectional CFRP Placement

The objective of this study is two-fold. The first is to determine fragility analysis of the case study building prior to the seismic retrofit compared to the current retrofitted building. Meaning, this research is looking at one individual case study building, but a before and after snapshot--producing two curves. Also, this research will determine if the building could have been made stronger with a different pattern of CFRP. The building implemented a unidirectional placement.

The seismic retrofit for the building in question was completed in 2017. The use of Carbon Fiber Reinforced Polymer (CFRP) was included in the seismic retrofit. The increased strength was proven in Can [12] by placing CFRP in three different directions. Can's research proved that the full wrapping of the structure was the best approach. Because the building underwent a voluntary seismic retrofit, the restrictions were not high as to how the building had to be reinforced. The seismic retrofit on the case study building has implemented the process of CFRP strips being placed running the width of the building and vertically on the shear walls. This unidirectional placement is specific to the building and was deemed to have enough stability for the retrofit.

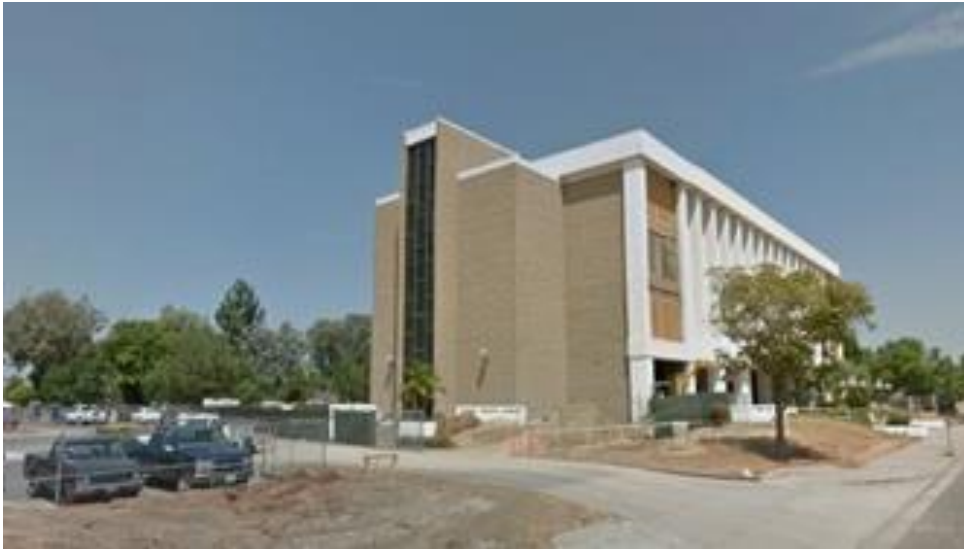
Fig. 3 – Case-Study Building during construction

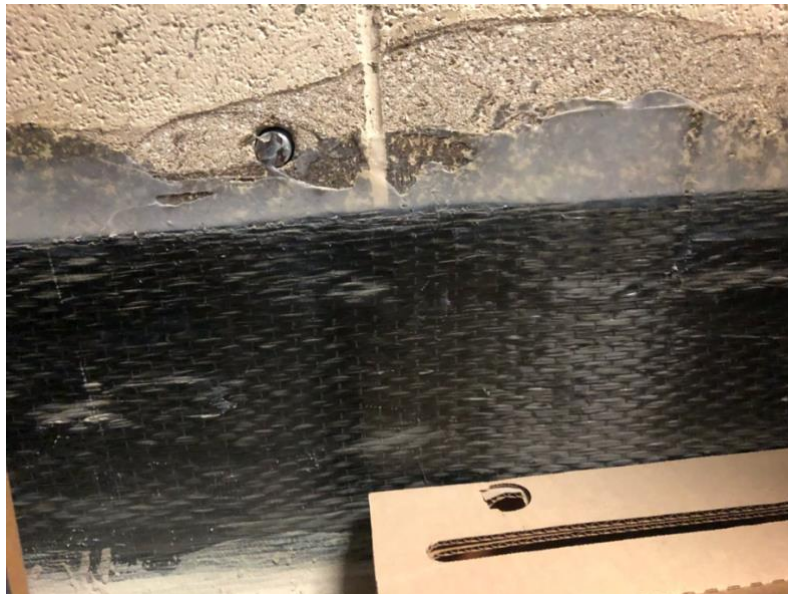
Fig. 4 – CFRP placement in the Case-Study Building

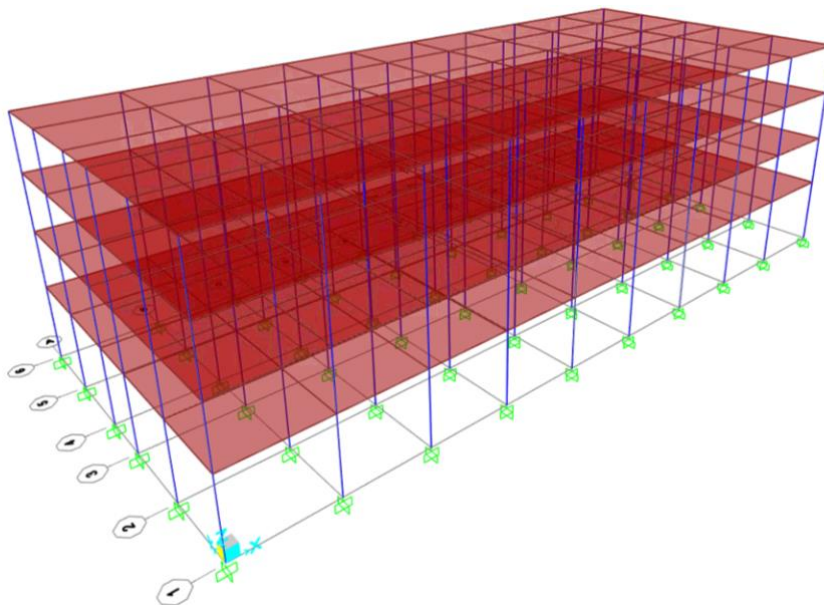
Fig. 5 – SAP2000 model used during the research

For the model used in this paper, the authors took advantage of some assumptions. The first assumption is that the geotechnical aspects of the location are all perfect. The soil characterizes are deemed best case scenario. This assumption allows the authors to ignore the foundational components and simply analyze the structural components of the case-study building. Another assumption made in this modeling process was to ignore the structural integrity of the elevator pit and shaft. This assumption is simple to apply, because the elevator components do not add a large amount of structural integrity for low-rise buildings. The model was generated by creating a 3D model of the case-study building. This model took into account the reinforced concrete beams and columns along with the masonry infill. A second model was made; this model was built from the original model, but then was updated to reflect the CFRP that was added during the retrofit.

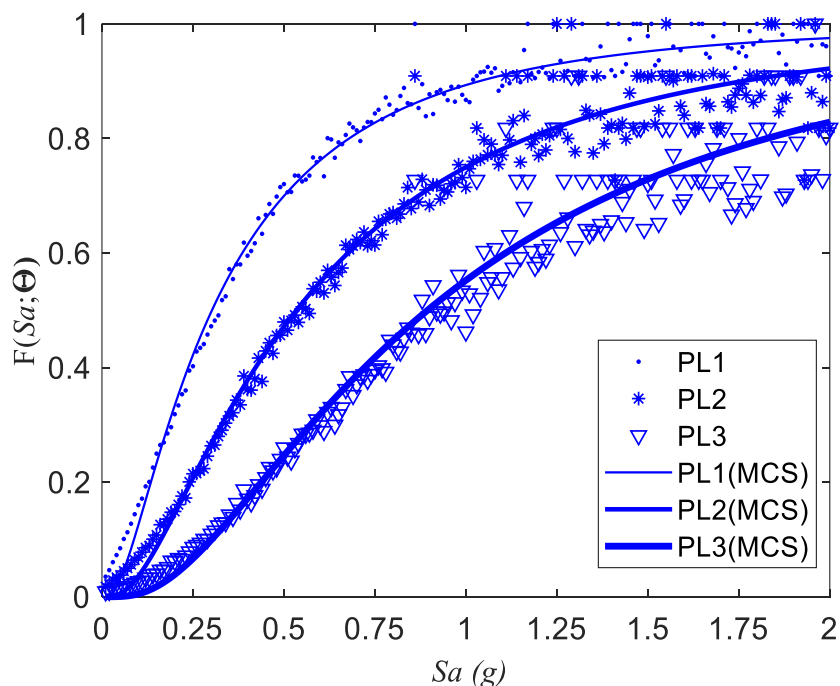
Fig. 6 – Fragility Curve for the Pre-retrofitted Building

Figure 6 provides a graphical representation of how the original building performed once the ground motion was applied. The X axis is the spectral acceleration in g-force. The Y axis is the probability of exceeding the performance levels or in other words—the probability of failure. PL1 is Performance Level 1, which is known as Immediate Occupancy according to ASCE 41. PL2 is equivalent to Life Safety, and PL3 is likened to Collapse Prevention.

It can be identified that the original building performed poorly when the ground motion was applied. The curve demonstrated how the increase in spectral acceleration caused a drastic increase in failure probability. The production of this curve could provide an additional justification that a retrofit was needed and had the potential to greatly eliminate risk of failure.

Figure 6 and Figure 7 are set up in the identical manner in order to a meaningful comparison to be made. After looking at both the original and retrofitted curves, it becomes apparent that the CFRP did in fact decrease the probability of failure. When looking at a spectral acceleration of 1g, the original building had over an 80% chance of failing at PL1. At the same acceleration, the retrofitted building decreased its failure probability by over 20%. This decrease did come at a cost to the owner, but the cost provided the potential to save more lives in the case of a building collapse due to seismic activity.

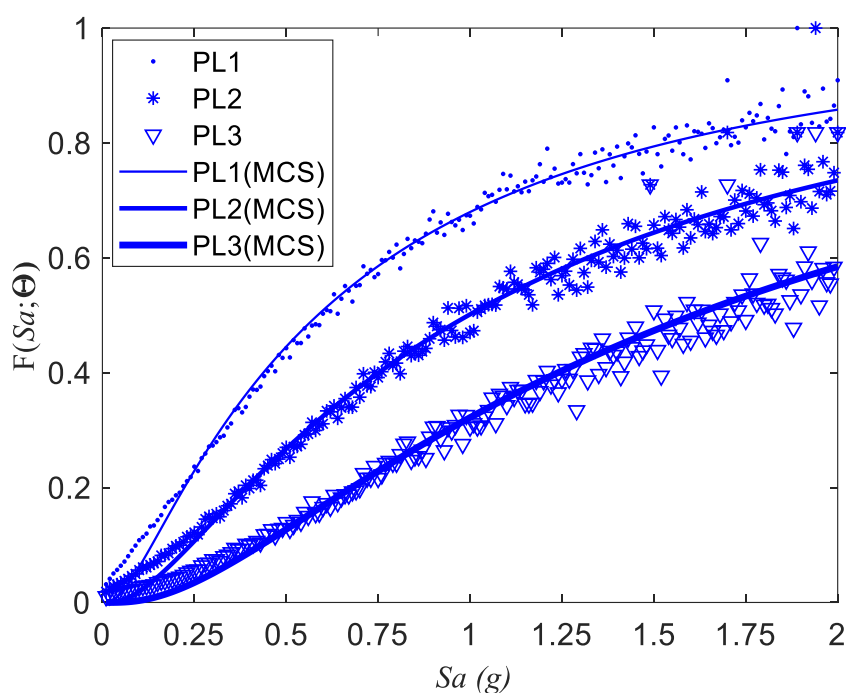
Fig. 7 – Fragility Curve for the Retrofitted Building

The retrofitted structure was also modeled in SAP2000 and the same suite of ground motion was applied to the retrofitted model. The research required the users to understand how the CFRP application created a stronger case-study building and then apply these concepts into the model in SAP2000. The intent of this retrofitted model is to also generate the fragility curve and accurately analysis if and how the retrofit increased the integrity of the building. Below is the resulting fragility curve for the retrofitted structure.
