DISSIPATION PANELS FOR SEISMIC RETROFITTING OF BUILDINGS

Abstract

Keywords: Dissipation Panels; energy dissipation; damper; seismic retrofitting; low intrusive solution.

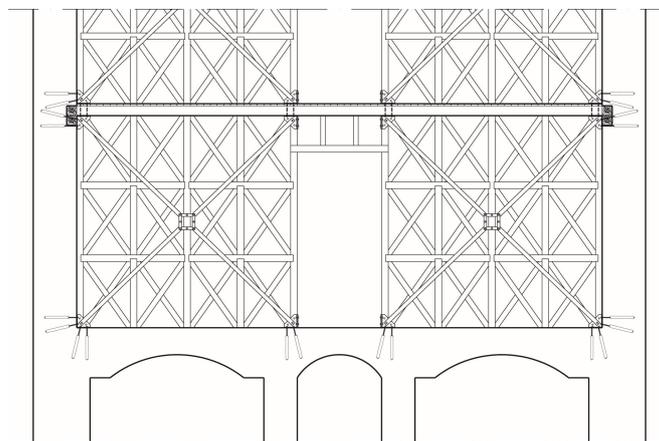
Basic conception of the Dissipation Panels corresponds to an articulated supporting frame with an embodied replaceable central damper. The frame is formed by two columns, a top and a bottom beam, and diagonal braces. The Panels are positioned like an interior wall between two consecutive floors of the building as schematically represented in Fig. 1.

Fig. 1 – Schematic representation of the installation of the Dissipation Panels in an old structure.

causing damage to the original existing structure. Therefore, the technology corresponds to a low intrusive solution. This advantage can be particularly interesting for old/historic buildings. For example, as it is shown in Fig. 1, the Dissipation Panels can be integrated within/in respect of an existing structure that includes the notable *Pombalino* timber framed walls as part of its original structure [1].

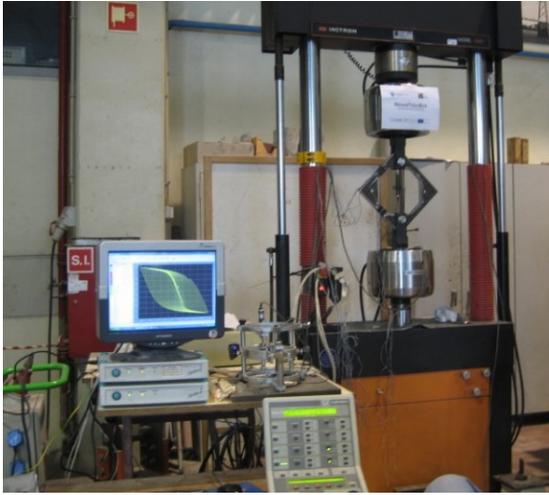
The cyclic tests of the Dampers were carried out in a universal Instron testing machine as shown in Fig. 2. Displacement along the direction of the force was measured with a linear transducer. In some specimens, extensometers and photogrammetry were also part of the instrumentation.

Fig. 2 – Experimental setup for testing the Dampers.

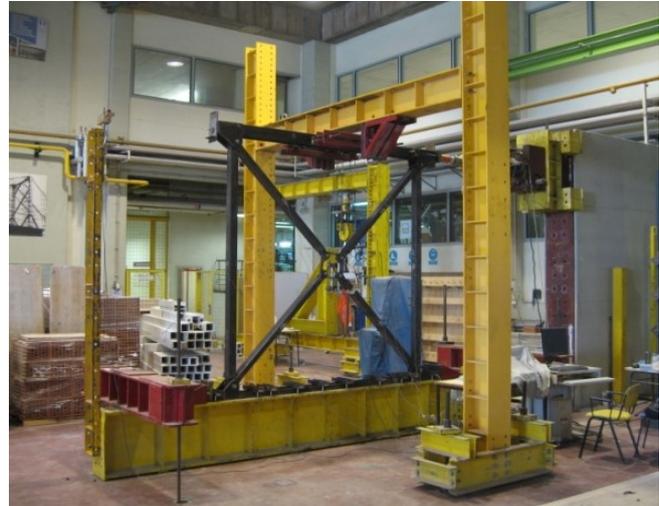
The Panels were subjected to cyclic quasi-static tests performed in the reaction wall of the LERM/IST as presented in Fig. 3. The tests involved the application of controlled in-plane horizontal cyclic displacements at the top of the models by a 400mm stroke mechanical actuator with 1000kN capacity that incorporated a load cell in order to measure the applied load. The bottom horizontal component of the Panels was fixed to an auxiliary steel beam of the laboratory. The displacements of this beam were restrained through its connection to the floor of the laboratory. In order to guarantee the stability of the Panel during the test, a top guiding system that restrained its transversal displacement was used as it can be observed in Fig. 3.

Fig. 3 – Experimental setup for testing the Dissipation Panels.

The Panels were subjected to cyclic quasi-static tests performed in the reaction wall at the Laboratory of Structures and Strength of Materials at Instituto Superior Técnico (IST) as shown in Fig. 3. The main results correspond to the hysteretic diagrams of the Dissipation Panels presented in Figures 9 to 11. In these Figures is shown, in the left side, the horizontal force-displacement curve (F_h , d_h , measured at the top of the Panel) and in the right, the diagonal force-displacement diagram (as per the diagonals directions of the Damper, D1 and D2). From the experimental horizontal force-displacement curves, it is possible to determine relevant data such as ultimate displacement, stiffness and dissipated energy. The results of the Damper allow to measure its dynamic behavior when incorporated in the Dissipation Panel and to relate them with the data obtained in the tests of the Dampers alone.

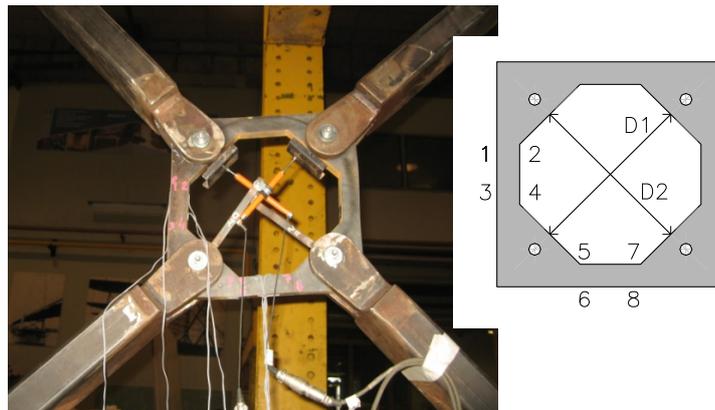
The instrumentation of each Dissipation Panel consisted of: 2 extensometers in each diagonal member of the Panel; 2 extensometers in each vertical element of the Panel; 1 draw wire transducer at the top of the Panel with a maximum measuring capacity of 500mm. The control of the amplitude of the displacement cycles (δ_h) was done through this latter measuring device. Figure 4 shows a detail of the instrumentation of the central Damper device belonging to the Panels tests: 2 Linear Variable Differential Transducers (LVDTs) (with 25mm course), D1 and D2, and 8 extensometers (for this second set of tests, extensometers in the central damper were only used for the model P5DHW2). In specimen P6DHF2, photogrammetry was also used as an additional method of instrumentation to obtain the displacements of the Panel along the cycles.

Fig. 4 – Instrumentation of the damper of Panel P5DHW2. Transducers D1 e D2 and extensometers 1 to 8.

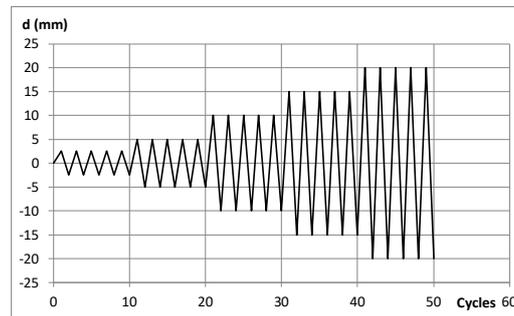
The scheme of the horizontal displacements (d) imposed to the prototypes of the Panels during the cyclic tests is displayed in Fig. 5. For each model, the imposed horizontal displacements corresponded to increasing amplitudes at each cycle. The horizontal displacement history was defined based upon the specifications of the standard EN 15129:2009 – Anti-seismic devices [4]. The tests were performed until the complete failure of the specimens.

Fig. 5 – Imposed horizontal displacements in the tests of the Panels.

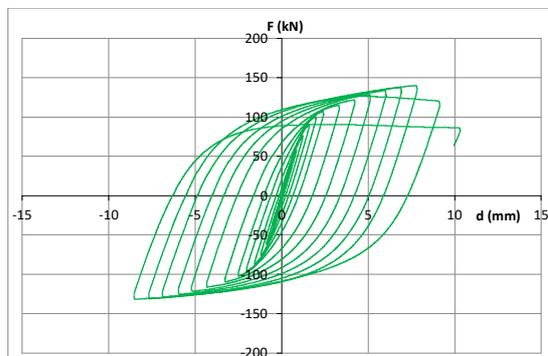
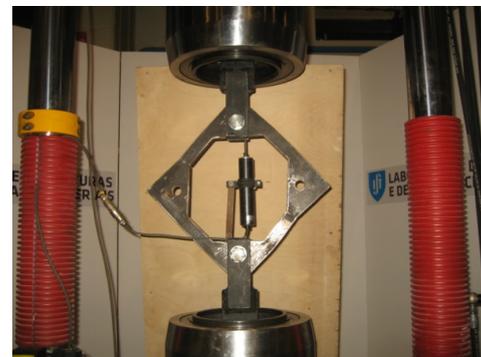
Force-Displacement Diagram

Failure of specimen

Fig. 6 – Cyclic test results of DHJ1 specimen.

The experimental diagrams of the cyclic tests of the Dampers are presented in Figures 6 to 8. For the three specimens, the curves show similar hysteretic stable behavior, without any sign of degradation of both stiffness and strength, and a good dissipation energy capacity. Comparing the diagrams of the three models, the highest post yield stiffness was obtained in the DHF1 model and the lowest value of this property corresponded to the DHW1.

Throughout each test it was possible to observe the deformation of the Damper and the formation of plastic hinges in the interior angles, where the rupture occurred, as shown in Figures 6 to 8. All the specimens exhibited an identical behavior.

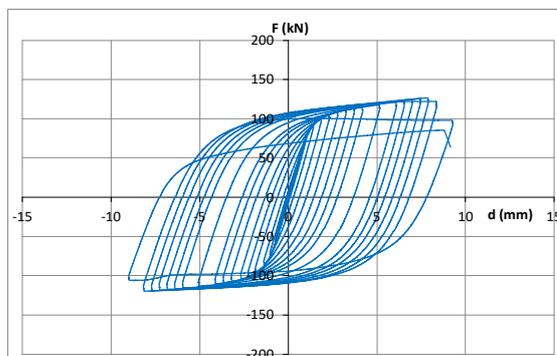
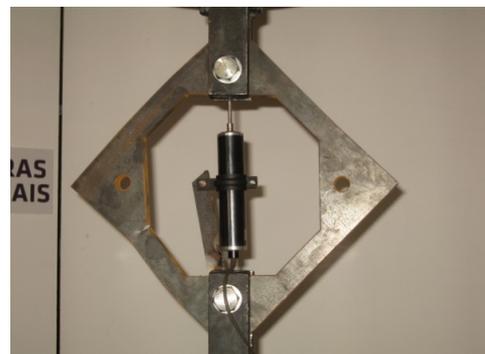
Force-Displacement Diagram

Failure of specimen

Fig. 7 – Cyclic test results of DHW1 specimen.

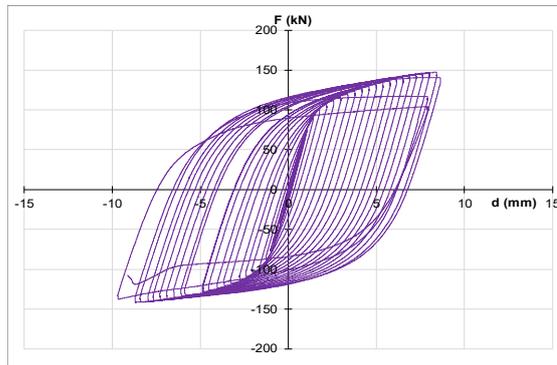
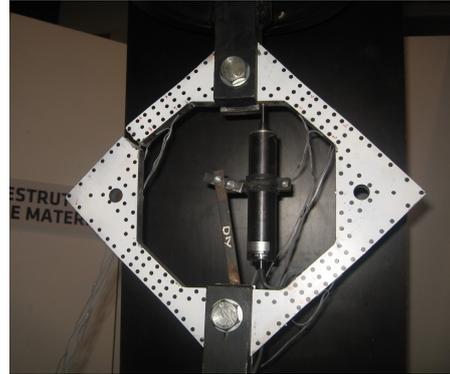
Force-Displacement Diagram

Failure of specimen

Fig. 8 – Cyclic test results of DHF1 specimen.

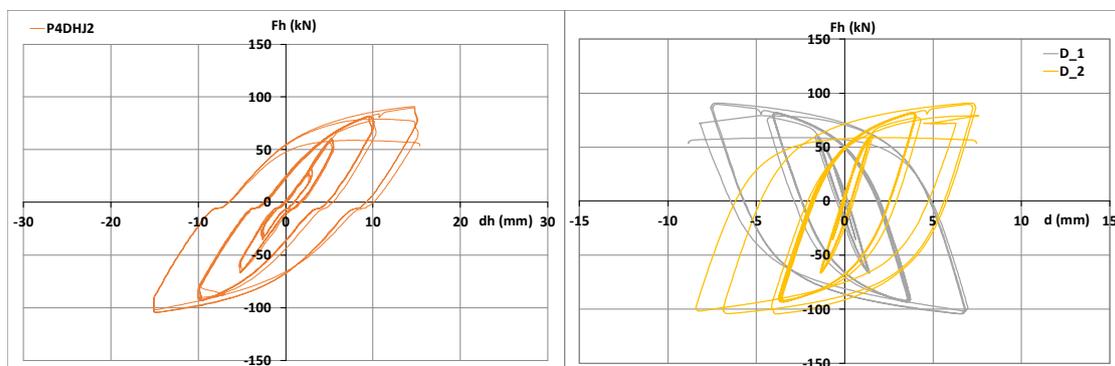
Fig. 9 - P4DHJ2 model test results. Horizontal Force-Displacement curve of the Panel. Horizontal Force-Diagonal Displacement curve of the Damper.

Similar main results were obtained for the here presented tested specimens. The experimental load-displacement diagrams show a good and stable cyclic behavior, with growing load-displacements amplitudes from one cycle to the next. The model P6DHF2 suffered rupture in a cycle of greater amplitude ($d_h = 20\text{mm}$) than in the case of models P4DHJ2 and P5DHW2 ($d_h = 15\text{mm}$). However, the P6DHF2 model only supported a full 20mm cycle. Note that it was not possible to obtain the values of the transducers of the damper of Panel P6DHF2 until the end of the test, because during the test, the transducers got out from the correct measurement position.

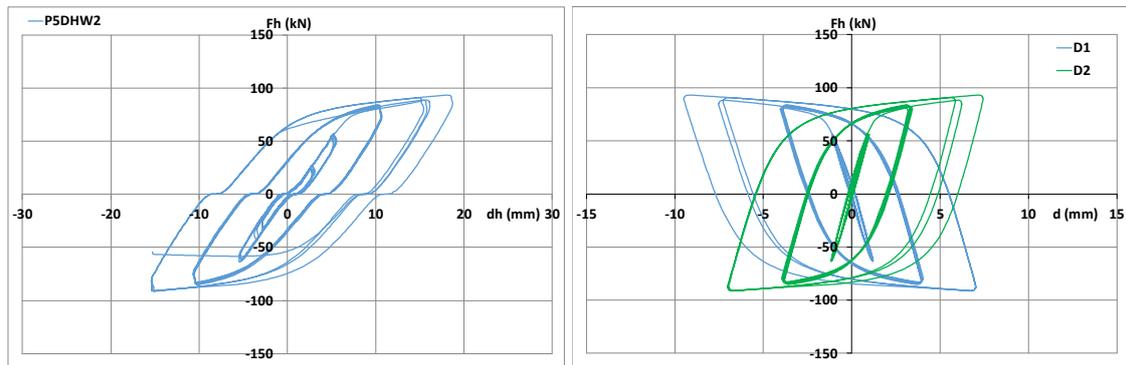
Fig. 10 – P5DHW2 model test results. Horizontal Force-Displacement curve of the Panel. Horizontal Force-Diagonal Displacement curve of the Damper.

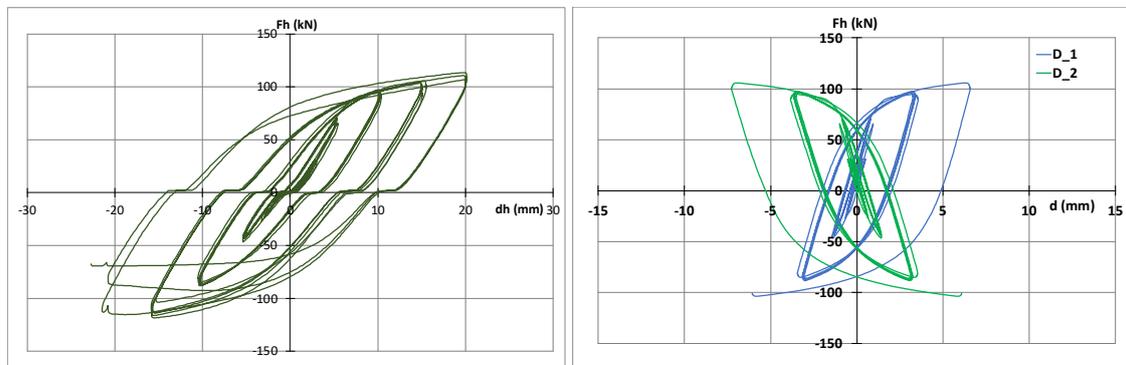
Fig. 11 – P6DHF2 model test results. Horizontal Force-Displacement curve of the Panel. Horizontal Force-Diagonal Displacement curve of the Damper. (Note: in this test, the transducers of the Damper were positioned in a symmetric way in relation to Fig. 4)

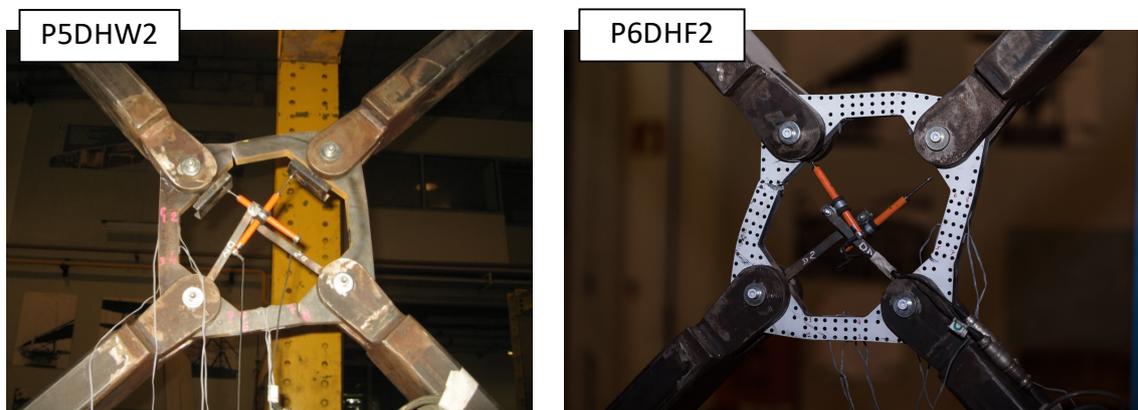
During the tests it was possible to observe the deformations of the dampers in each cycle and its growing amplitude until failure. The failure modes of the P5DHW2 and P6DHF2 specimens are shown in Fig. 12. For the three tested models, failure occurred due to rupture of the central dampers, which happened at the interior angles of the cross section. All of the others elements that formed the Panels exhibited a clear elastic response, below the yield limit of steel, as from the data collected from the strain gauges installed in the referred elements. As expected, damage was concentrated in the dampers, which could be easily replaceable after each test.

Fig. 12 – Failure of models P5DHW2 and P6DHF2.

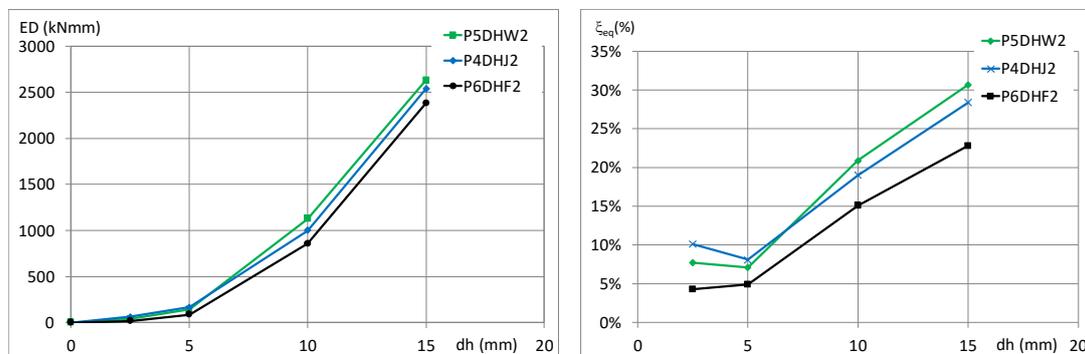
where ED is the dissipated hysteretic energy, F_{max} is the peak force and d_{max} is the maximum displacement [6]. The energy dissipated in each cycle and the equivalent damping that resulted from the tests of the Panels are presented in Fig. 13. It can be observed that the energy dissipation evidenced a considerable increase throughout each cycle. This trend is also noticeable for the equivalent damping ratio, since it also increases from the beginning of the loading until the Panels reach its ultimate lateral strength.

Fig. 13 – Dissipated energy and equivalent damping.

Results of P4DHJ2 e P5DHW2 tests do not significantly differ in terms of the principal parameters evaluated, such as ultimate displacement, energy dissipation and equivalent damping ratio. In the case of the P6DHF2 specimen, the values of dissipated energy and equivalent damping are lower than the results of the models P4DHJ2 and P5DHW2. This difference is mainly attributed to the higher rigidity of the model P6DHF2 in relation to the other two models.

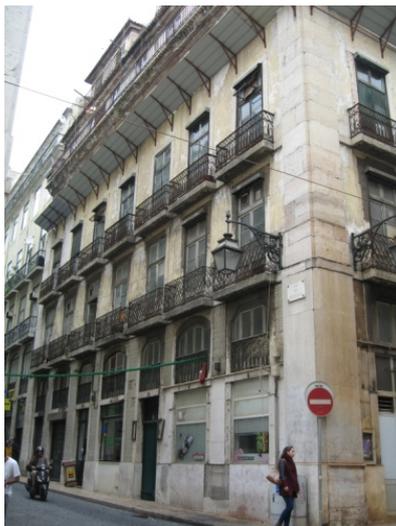
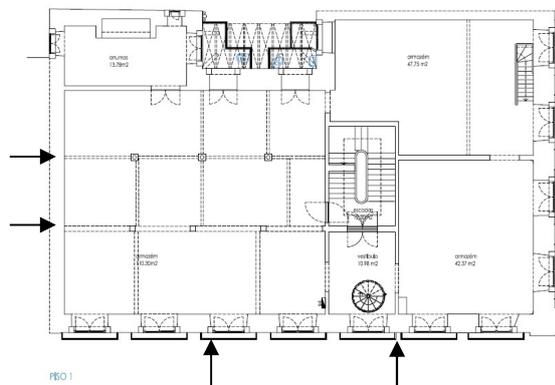
The case study building has a rectangular plan layout of about 14m×21m and has five elevated stories and an attic (Fig. 14). The building is located at the corner of the block, so the main resistant masonry walls are composed of two principal facades (with openings that define the geometry of the masonry structural elements) and two party walls parallel to the facades. In the longest direction of the building, the party wall only corresponds to approximately half of its length. The other half of the masonry wall of the building is not shared with other buildings of the block. The thickness of the masonry external walls ranges between 40cm and 100cm, decreasing with the elevation of the building. Timber beams of the floor have sectional dimensions of 10-12cm×16-18cm, spaced about 40cm in plan.

Fig. 14 – View of the case study building. Plan of Floor 1. Original location of the timber framed walls (frontal walls).

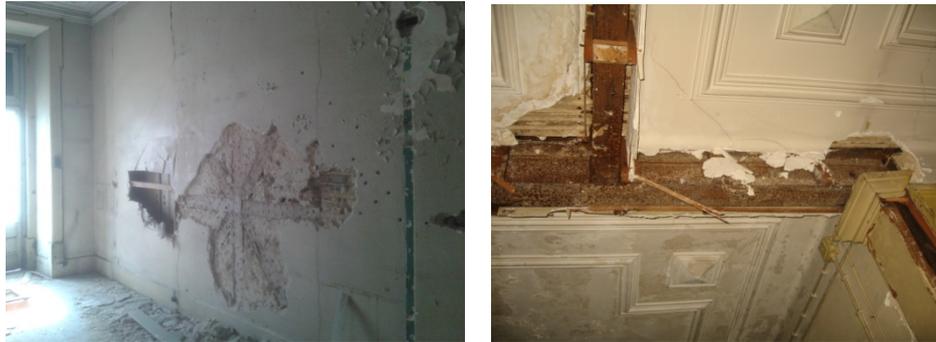
A survey of the actual condition of the building indicated that it had undergone considerable modifications with time. Major changes detected in the building were related to the significant removal (partly or totally) of most of the supporting interior frontal walls and addition of steel elements in some cases – Fig. 15. Other observed anomalies were localized timber decay, corrosion of steel elements and cracking of diverse elements.

Fig. 15 – Modification of the original structure. Incomplete frontal wall. Total removal of frontal wall and addition of steel elements.

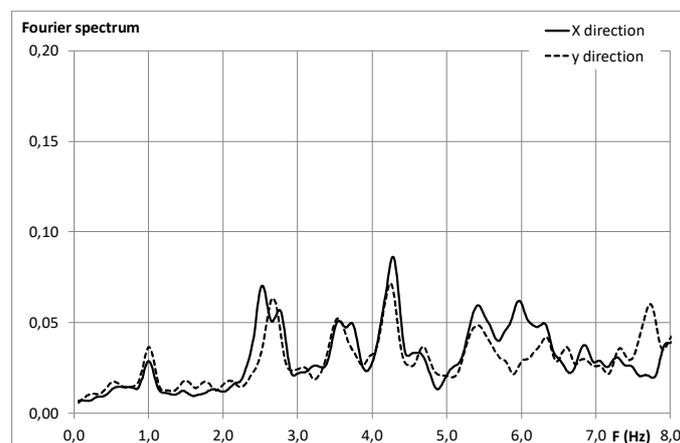
The dynamic identification experimental campaign was performed in the second and fourth floors of the building. The natural frequencies that were identified related to the first modes were approximately equal to 1.0Hz, in both X (longest direction of the building) and Y (perpendicular to X) directions – Fig. 16. Other modes were also detected for frequencies between 2,5 and 2,7Hz, in X and Y directions, respectively. After the complete definition and calibration of the model, a seismic analysis was performed. Seismic action was defined by means of an acceleration response spectrum.

Fig. 16 – Dynamic identification test. Fourier spectrum result. 4th Floor.

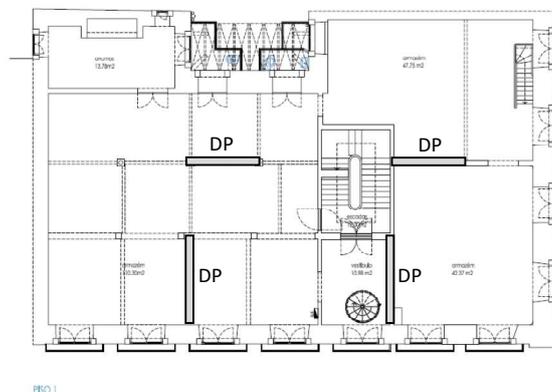
As part of the seismic retrofitting strategy, it is proposed to install the Dissipation Panels. These elements are installed as interior walls, perpendicular to the main exterior masonry walls and adequately connected to them. The Dissipation Panels are supposed to be located in the same alignments where the original frontal walls (that had once been an important part of the structure) were originally positioned and from where they have been removed – Fig. 17. This should allow the reestablishment of the original structural concept but with a more seismic strengthening effective system. The panels are planned to be installed along the two principal directions of the building, parallel to the X direction and to the Y direction.

Fig. 17 – Plan of floor 1. Possible locations of the Dissipation Panels (DP).
