DISSIPATION PANELS FOR SEISMIC RETROFITTING OF BUILDINGS

Keywords: Dissipation Panels; energy dissipation; damper; seismic retrofitting; low intrusive solution.

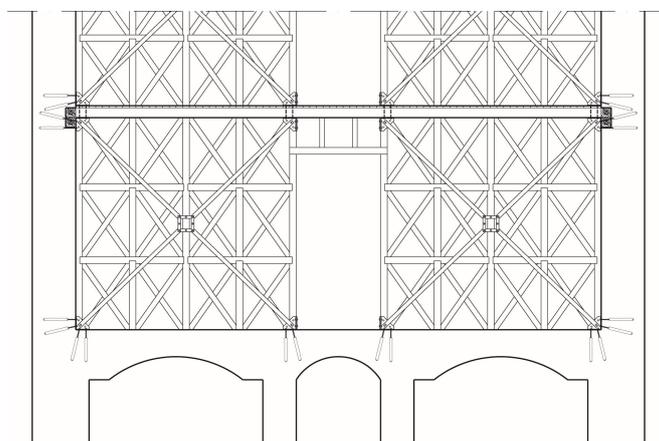
Fig. 1 – Schematic representation of the installation of the Dissipation Panels in an old structure.

Basic conception of the Dissipation Panels corresponds to an articulated supporting frame with an embodied replaceable central damper. The frame is formed by two columns, a top and a bottom beam, and diagonal braces. The Panels are positioned like an interior wall between two consecutive floors of the building as schematically represented in Fig. 1.

causing damage to the original existing structure. Therefore, the technology corresponds to a low intrusive solution. This advantage can be particularly interesting for old/historic buildings. For example, as it is shown in Fig. 1, the Dissipation Panels can be integrated within/in respect of an existing structure that includes the notable *Pombalino* timber framed walls as part of its original structure [1].

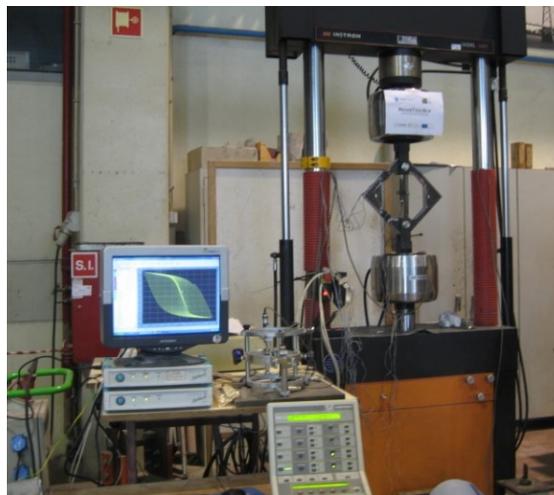
Fig. 2 – Experimental setup for testing the Dampers.

The cyclic tests of the Dampers were carried out in a universal Instron testing machine as shown in Fig. 2. Displacement along the direction of the force was measured with a linear transducer. In some specimens, extensometers and photogrammetry were also part of the instrumentation.

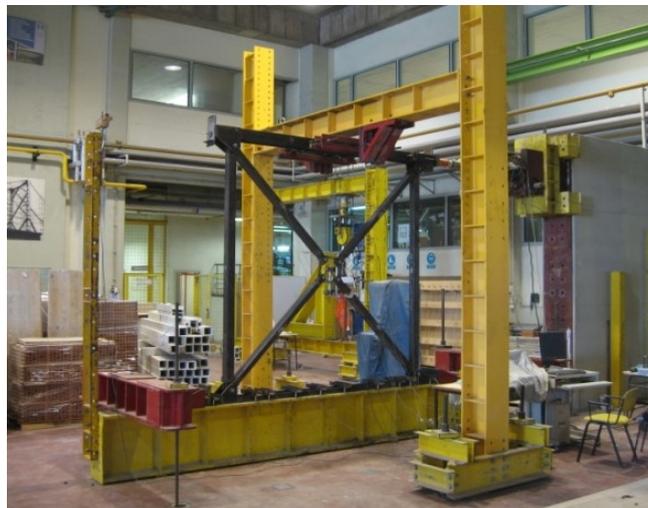
Fig. 3 – Experimental setup for testing the Dissipation Panels.

The Panels were subjected to cyclic quasi-static tests performed in the reaction wall of the LERM/IST as presented in Fig. 3. The tests involved the application of controlled in-plane horizontal cyclic displacements at the top of the models by a 400mm stroke mechanical actuator with 1000kN capacity that incorporated a load cell in order to measure the applied load. The bottom horizontal component of the Panels was fixed to an auxiliary steel beam of the laboratory. The displacements of this beam were restrained through its connection to the floor of the laboratory. In order to guarantee the stability of the Panel during the test, a top guiding system that restrained its transversal displacement was used as it can be observed in Fig. 3.

The Panels were subjected to cyclic quasi-static tests performed in the reaction wall at the Laboratory of Structures and Strength of Materials at Instituto Superior Técnico (IST) as shown in Fig. 3. The main results correspond to the hysteretic diagrams of the Dissipation Panels presented in Figures 9 to 11. In these Figures is shown, in the left side, the horizontal force-displacement curve (F_h , d_h , measured at the top of the Panel) and in the right, the diagonal force-displacement diagram (as per the diagonals directions of the Damper, D1 and D2). From the experimental horizontal force-displacement curves, it is possible to determine relevant data such as ultimate displacement, stiffness and dissipated energy. The results of the Damper allow to measure its dynamic behavior when incorporated in the Dissipation Panel and to relate them with the data obtained in the tests of the Dampers alone.

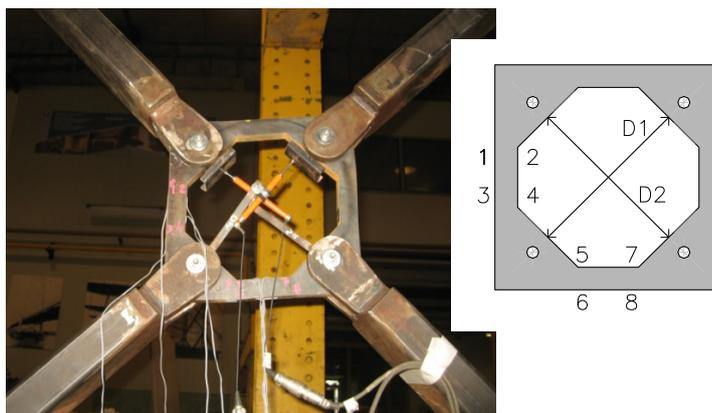
Fig. 4 – Instrumentation of the damper of Panel P5DHW2. Transducers D1 e D2 and extensometers 1 to 8.

Fig. 11 – P6DHF2 model test results. Horizontal Force-Displacement curve of the Panel. Horizontal Force-Diagonal Displacement curve of the Damper. (Note: in this test, the transducers of the Damper were positioned in a symmetric way in relation to Fig. 4)

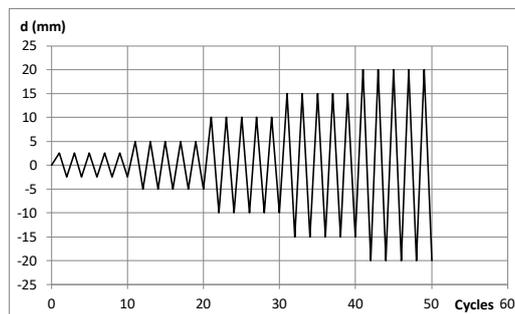
Fig. 5 – Imposed horizontal displacements in the tests of the Panels.

The scheme of the horizontal displacements (d) imposed to the prototypes of the Panels during the cyclic tests is displayed in Fig. 5. For each model, the imposed horizontal displacements corresponded to increasing amplitudes at each cycle. The horizontal displacement history was defined based upon the specifications of the standard EN 15129:2009 – Anti-seismic devices [4]. The tests were performed until the complete failure of the specimens.

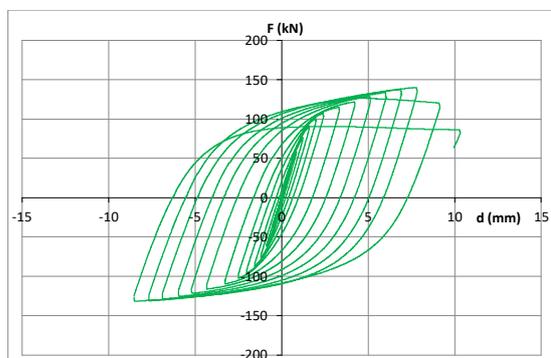
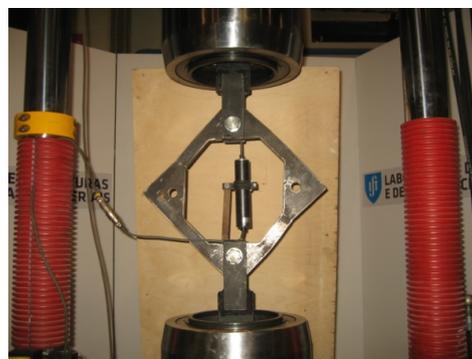
Force-Displacement Diagram

Failure of specimen

Fig. 6 – Cyclic test results of DHJ1 specimen.

The experimental diagrams of the cyclic tests of the Dampers are presented in Figures 6 to 8. For the three specimens, the curves show similar hysteretic stable behavior, without any sign of degradation of both stiffness and strength, and a good dissipation energy capacity. Comparing the diagrams of the three models, the highest post yield stiffness was obtained in the DHF1 model and the lowest value of this property corresponded to the DHW1.

Throughout each test it was possible to observe the deformation of the Damper and the formation of plastic hinges in the interior angles, where the rupture occurred, as shown in Figures 6 to 8. All the specimens exhibited an identical behavior.

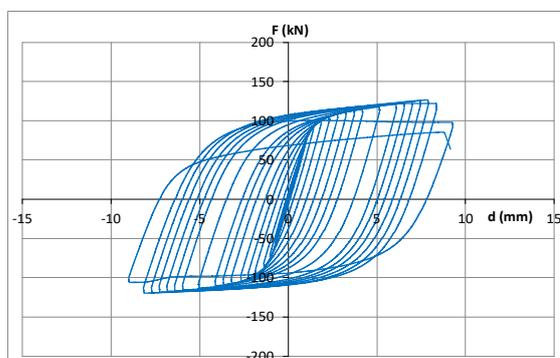
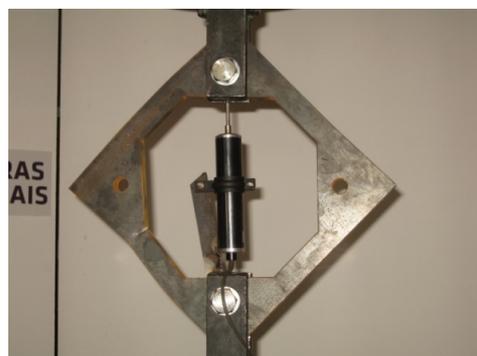
Force-Displacement Diagram

Failure of specimen

Fig. 7 – Cyclic test results of DHW1 specimen.

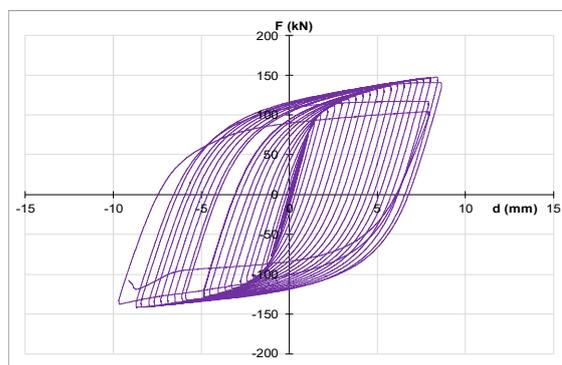
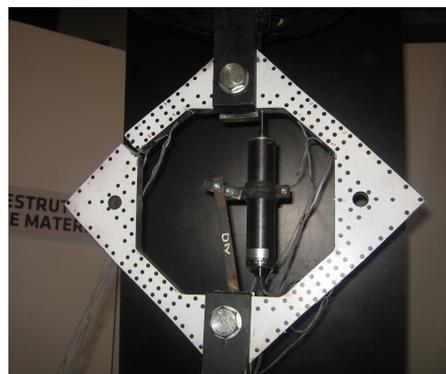
Force-Displacement Diagram

Failure of specimen

Fig. 8 – Cyclic test results of DHF1 specimen.

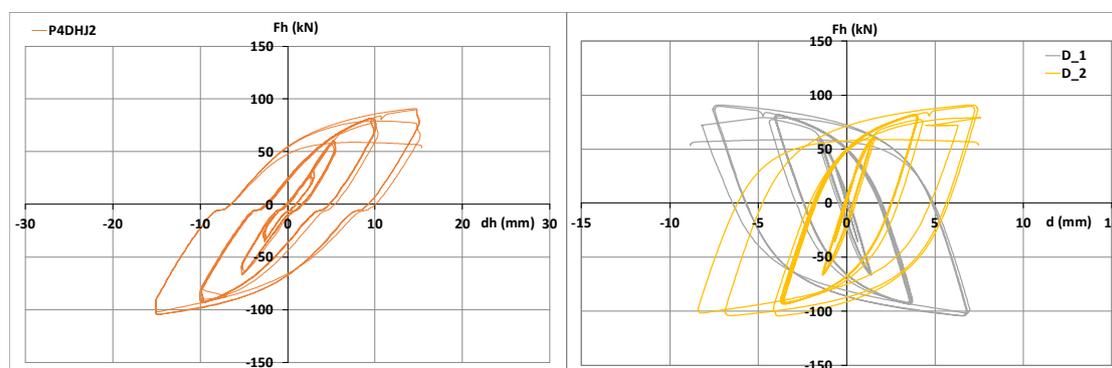
Fig. 9 - P4DHJ2 model test results. Horizontal Force-Displacement curve of the Panel. Horizontal Force-Diagonal Displacement curve of the Damper.

Similar main results were obtained for the here presented tested specimens. The experimental load-displacement diagrams show a good and stable cyclic behavior, with growing load-displacements amplitudes from one cycle to the next. The model P6DHF2 suffered rupture in a cycle of greater amplitude ($d_h = 20\text{mm}$) than in the case of models P4DHJ2 and P5DHW2 ($d_h = 15\text{mm}$). However, the P6DHF2 model only supported a full 20mm cycle. Note that it was not possible to obtain the values of the transducers of the damper of Panel P6DHF2 until the end of the test, because during the test, the transducers got out from the correct measurement position.

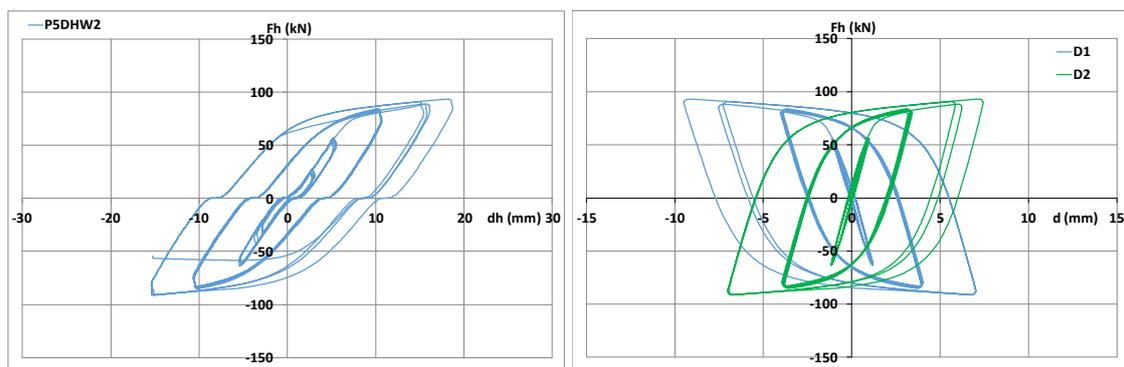
Fig. 10 – P5DHW2 model test results. Horizontal Force-Displacement curve of the Panel. Horizontal Force-Diagonal Displacement curve of the Damper.

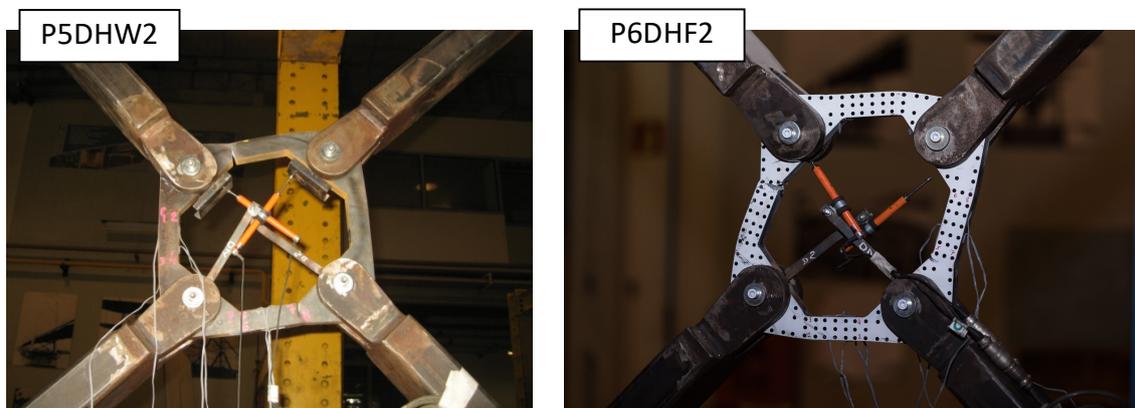
Fig. 12 – Failure of models P5DHW2 and P6DHF2.

During the tests it was possible to observe the deformations of the dampers in each cycle and its growing amplitude until failure. The failure modes of the P5DHW2 and P6DHF2 specimens are shown in Fig. 12. For the three tested models, failure occurred due to rupture of the central dampers, which happened at the interior angles of the cross section. All of the others elements that formed the Panels exhibited a clear elastic response, below the yield limit of steel, as from the data collected from the strain gauges installed in the referred elements. As expected, damage was concentrated in the dampers, which could be easily replaceable after each test.

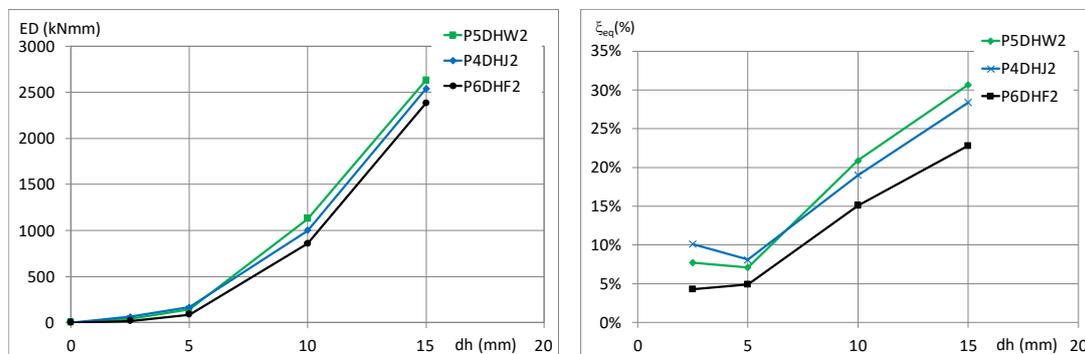
Fig. 13 – Dissipated energy and equivalent damping.

where ED is the dissipated hysteretic energy, F_{max} is the peak force and d_{max} is the maximum displacement [6]. The energy dissipated in each cycle and the equivalent damping that resulted from the tests of the Panels are presented in Fig. 13. It can be observed that the energy dissipation evidenced a considerable increase throughout each cycle. This trend is also noticeable for the equivalent damping ratio, since it also increases from the beginning of the loading until the Panels reach its ultimate lateral strength.

Results of P4DHJ2 e P5DHW2 tests do not significantly differ in terms of the principal parameters evaluated, such as ultimate displacement, energy dissipation and equivalent damping ratio. In the case of the P6DHF2 specimen, the values of dissipated energy and equivalent damping are lower than the results of the models P4DHJ2 and P5DHW2. This difference is mainly attributed to the higher rigidity of the model P6DHF2 in relation to the other two models.

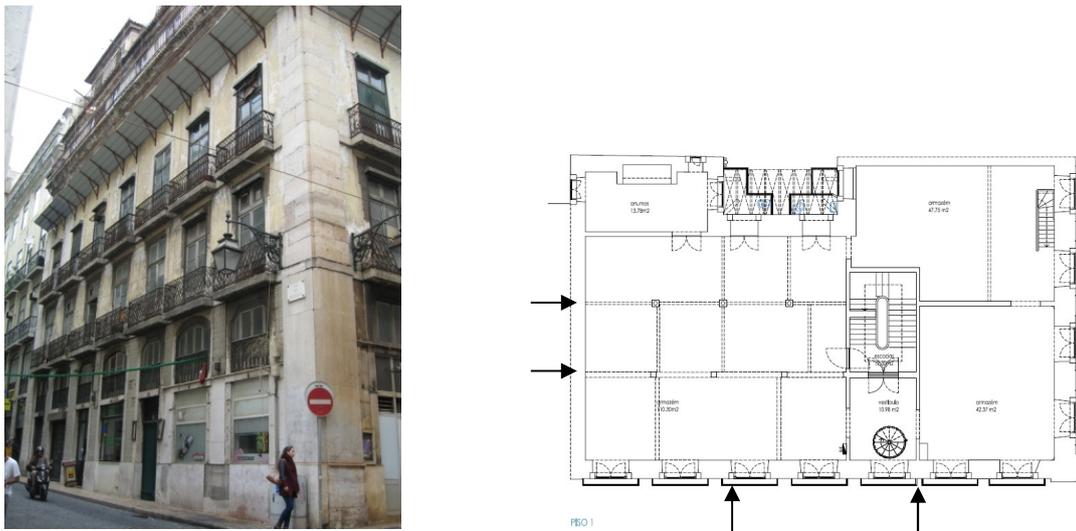
Fig. 14 – View of the case study building. Plan of Floor 1. Original location of the timber framed walls (frontal walls).

The case study building has a rectangular plan layout of about 14m×21m and has five elevated stories and an attic (Fig. 14). The building is located at the corner of the block, so the main resistant masonry walls are composed of two principal facades (with openings that define the geometry of the masonry structural elements) and two party walls parallel to the facades. In the longest direction of the building, the party wall only corresponds to approximately half of its length. The other half of the masonry wall of the building is not shared with other buildings of the block. The thickness of the masonry external walls ranges between 40cm and 100cm, decreasing with the elevation of the building. Timber beams of the floor have sectional dimensions of 10-12cm×16-18cm, spaced about 40cm in plan.

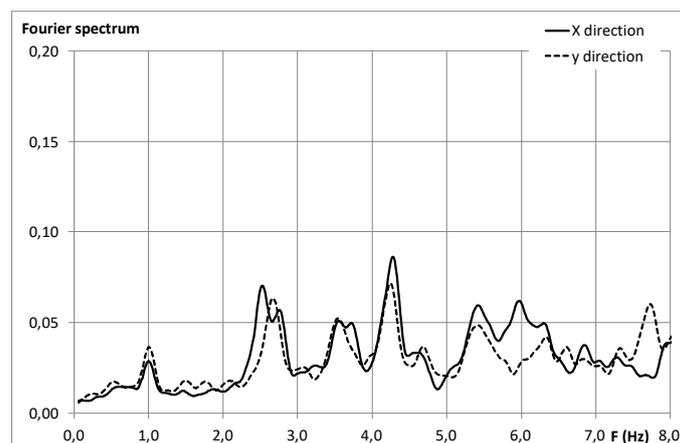
Fig. 16 – Dynamic identification test. Fourier spectrum result. 4th Floor.

The dynamic identification experimental campaign was performed in the second and fourth floors of the building. The natural frequencies that were identified related to the first modes were approximately equal to 1.0Hz, in both X (longest direction of the building) and Y (perpendicular to X) directions – Fig. 16. Other modes were also detected for frequencies between 2,5 and 2,7Hz, in X and Y directions, respectively. After the complete definition and calibration of the model, a seismic analysis was performed. Seismic action was defined by means of an acceleration response spectrum.

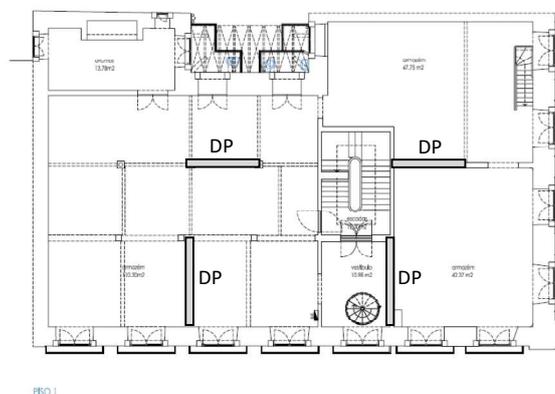
Fig. 17 – Plan of floor 1. Possible locations of the Dissipation Panels (DP).

As part of the seismic retrofitting strategy, it is proposed to install the Dissipation Panels. These elements are installed as interior walls, perpendicular to the main exterior masonry walls and adequately connected to them. The Dissipation Panels are supposed to be located in the same alignments where the original frontal walls (that had once been an important part of the structure) were originally positioned and from where they have been removed – Fig. 17. This should allow the reestablishment of the original structural concept but with a more seismic strengthening effective system. The panels are planned to be installed along the two principal directions of the building, parallel to the X direction and to the Y direction.
