AN EXPERIENCE OF USING DYNAMIC CONE TEST TO EVALUATE LIQUEFACTION POTENTIAL OF LIQUEFIED SUBSOIL LAYERS

S. Sethabouppha⁽¹⁾

Abstract

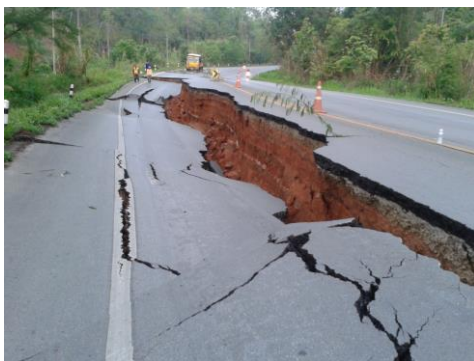
Fig.1- Failure of a highway embankment

In 2014, a 6.3 M_L earthquake and hundreds of aftershocks struck the southern area of Chiang Rai Province in northern Thailand. The main shock and, probably, a few strong aftershocks induced soil liquefaction at several locations within the area of approximately 30 kilometers around the epicenter. The liquefaction caused quite significant damages including cracks on ground and highway pavement, failure of highway embankment, settlement and collapsing of several houses such as shown in Fig.1 and Fig.2.

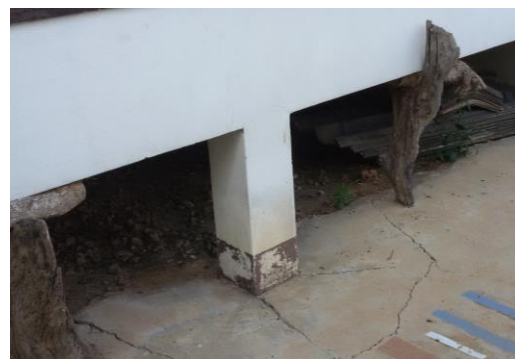
Fig.2 - Settlement of a shallow foundation

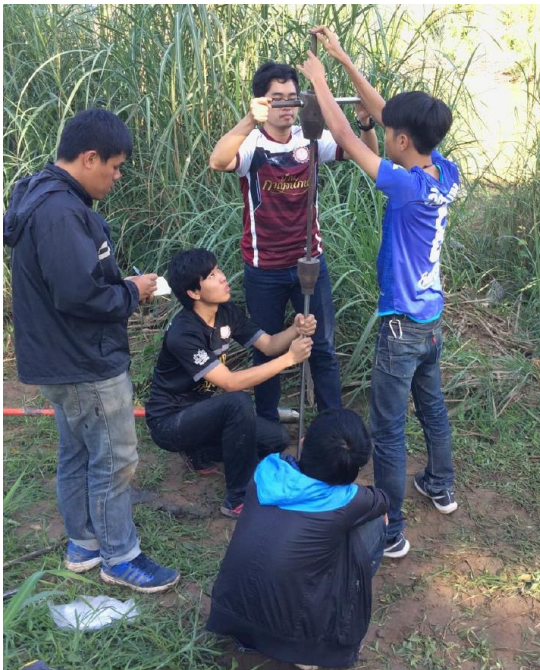
Fig.4 - Performing KPT

Kunzelstab Penetration Test or KPT is a test for resistance of soil layers to the penetration of a steel rod with a cone-shaped driving head attached to the tip and an anvil attached to the top of the rod as illustrated in Fig.3. They are driven into the ground by dropping a 10-kg hammer on the anvil from a high of 50 centimeters. However, unlike SPT, KPT’s driving head cannot collect any soil sample during the penetration. Therefore, another tool such as hand auger is required to collect soil samples. Therefore, groundwater table can be observed in the auger hole. Fig.4 and Fig.5 show KPT operation and using a hand auger to collect soil samples, respectively.

KPT records number of the blows required to drive the rod and the attached head 20 centimeters in the ground. The blow counts are called N_{KPT} and it can be retrieved continuously through the depth of the investigation. Groundwater table can be observed in the hole left by the auger operation.

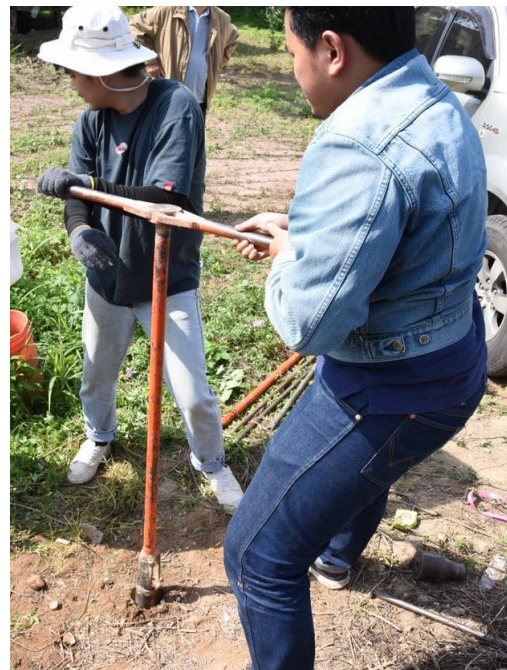
Fig.5 - Collecting soil samples by a hand auger

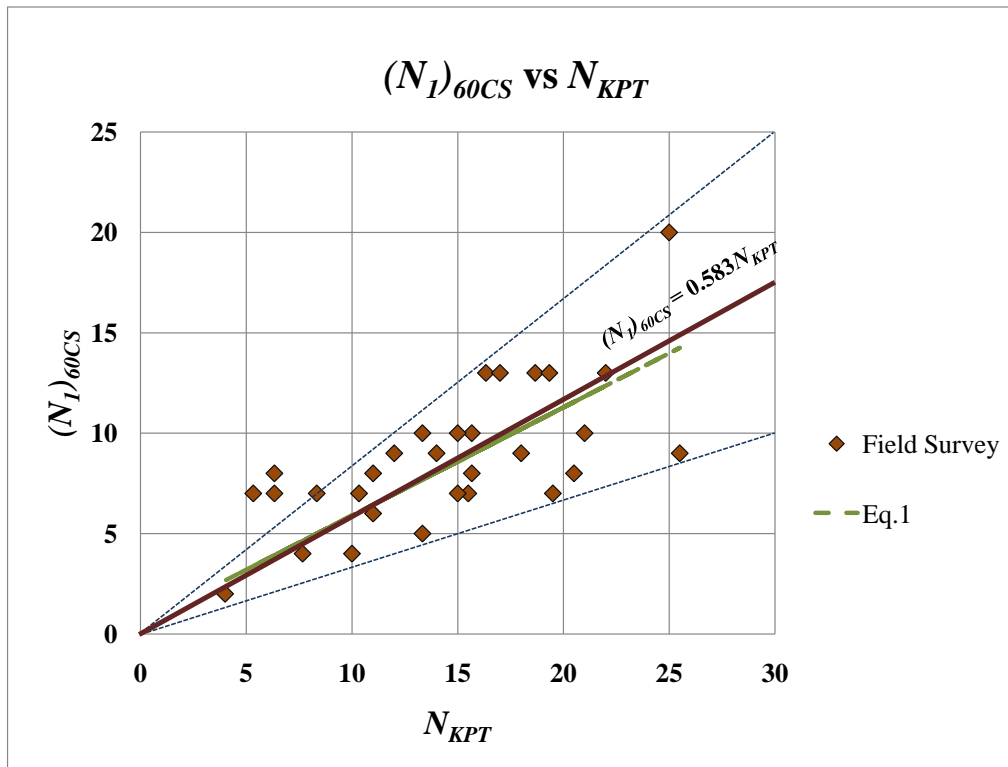
It was not clear that Eq.1 was suitable for which type of soils. Therefore, an experiment was conducted to investigate the relationship between $(N_I)_{60CS}$ and N_{KPT} by running KPT investigation near 6 SPT boreholes with sandy soils. By averaging 3 or 4 of N_{KPT} at the same depth where SPT N-values were measured, the values of $(N_I)_{60CS}$ and N_{KPT} can be plotted as shown in Fig.6.

Fig.6 - Observation of $(N_I)_{60CS}$ values and N_{KPT} values in sandy soils

From Fig.5, Eq.1 seems reasonable with the data points. However, this research preferred an equation yielding the origin, therefore another relationship between $(N_I)_{60CS}$ and N_{KPT} may be approximated as shown in the following equation.

$$(N_I)_{60CS} = 0.583 N_{KPT} \quad (2)$$

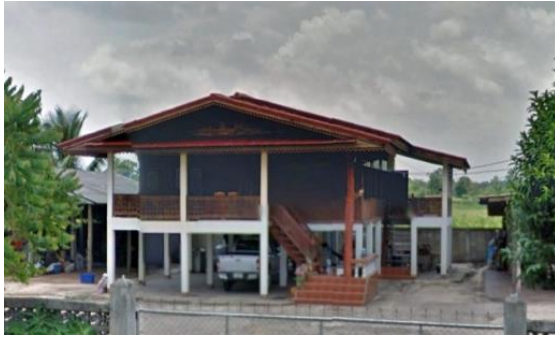
Fig.8 - The house before the earthquake

The case at Location 4 is presented here as a demonstration of the investigation and analysis. At Tha Ma-O Village, locating just approximately 1.5-2.0 km from the epicenter, some houses were damaged by the earthquake vibration and/or liquefaction. However, the case that gained a lot of interest was collapsing of a house as shown in Fig.8 and 9.

Fig.9 - The house after the earthquake

As shown in Fig.9, some large cracks can be observed on the ground. This was probably a sign of liquefaction occurring in the subsoil layers. This house was built on an approximately 1-meter fill. Therefore, investigation by KPT and obtaining soil samples by hand auger were made on the original ground off the fence in order to obtain information of the subsoil as much as possible. Fig.10 shows the grain size distribution curves of those soil samples plotted in the liquefiable range suggested by the Japanese Seismic Code for Harbor Structures [6].

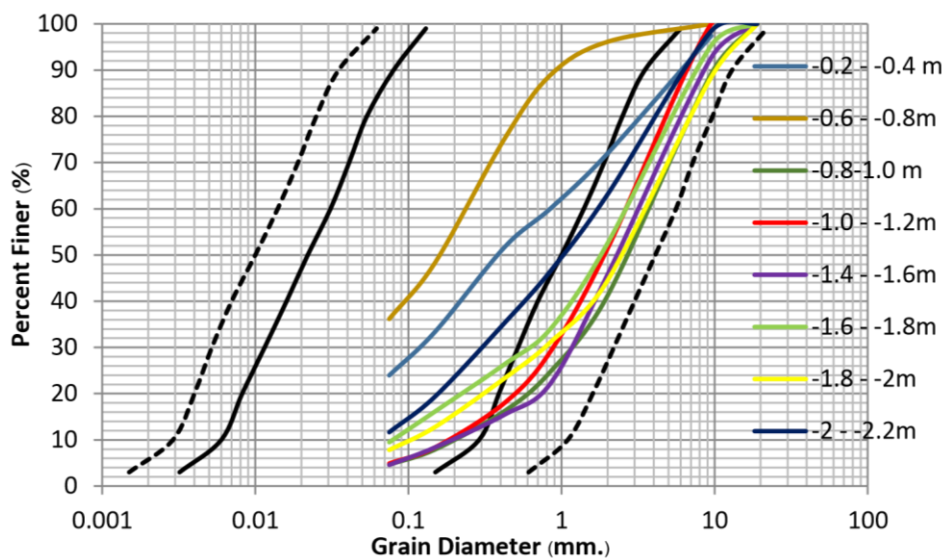
Fig.10 Grain size distribution of the soil samples from Tha Ma-O Village

The soil samples were mostly clayey sand in loose condition. With groundwater at approximately 0.8 m below the original ground surface, *FSL* values were calculated and summarized as shown in Table 1.
