Model tests on the deformation and collapse processes of small earth dams due to earthquakes and rainfall

Keywords: small earth dam, rainfall, earthquake, model test, residual deformation

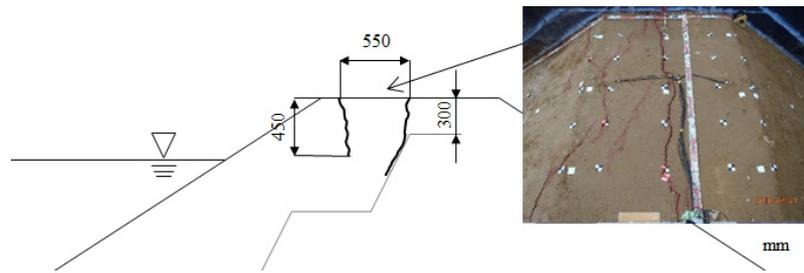
Fig. 1 – Cracks observed after a full-scale model experiment [5]

There have been many studies that have sought to estimate the impact of rainfall on the seismic resistance of soil structures, such as reservoirs. Recent studies of the seismic performance of small earth dam embankments by Sawada et al. and Nakazawa et al. comprised a series of full-scale experiments [5–7]. Traditionally, a small earth dam with a sloping core zone is adopted as the water leakage method from a reservoir. However, in cases where the quantity of impermeable materials required for this method is insufficient, the use of geosynthetic clay liner (GCL) and bentonite as a water barrier is increasing. Based on this background, the earthquake resistance of an embankment to which GCLs had been applied, its permeability after an earthquake, and the effectiveness of installation methods for GCL sheets were examined. As shown in Fig. 1, although cracks occurred at the crest of the embankment, there was no confirmed water leakage on the downstream side, suggesting that the impermeable sheet remained functional after a shake table test.

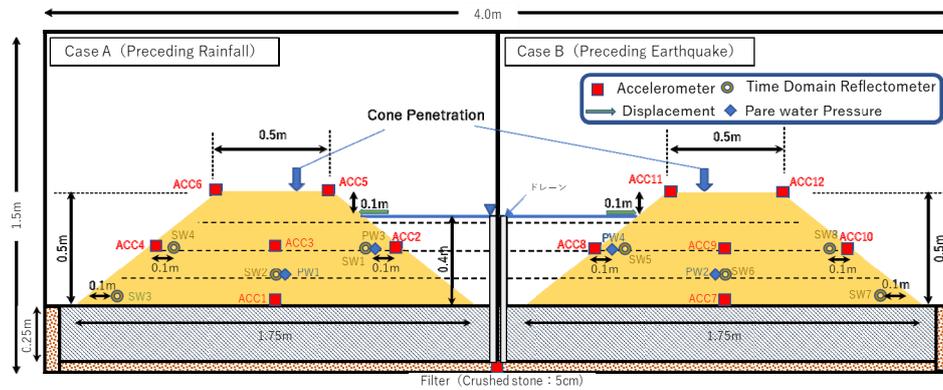
In a series of experiments, two identical embankment models with reservoirs were constructed in 1.5-m high, 1.0-m wide, and 4.0-m long rigid soil containers. The model on the left in Fig. 2 details the effects of preceding rainfall (Case A), whereas the model on the right illustrates the effects of a preceding earthquake (Case B). The model was scaled down to one-fifth of a full-scale experimental model with reference to experiments by Sawada et al. (2016; 2018). Drainpipes were installed in each section so that the water level in the reservoir was kept constant during rainfall experiments. Measurement sensors, including

Fig. 2 – Cross section of embankment models with reservoirs

As shown in Fig. 2, the embankment on the foundation, which was 0.25-m thick using the same ground material as the model, was designed to have a shape 0.5 m in height, 0.5 m in width at the top with a slope of 1.25:1. By dividing the embankment into four layers such that the density of each layer was uniform to control the density of the embankment model, two embankments with the same cross section were constructed. In this experiment, modeling of the sloping core of a standard earth dam was omitted to simplify the experimental conditions. After the construction of the two models, water was injected into the center space of both models to form a reservoir with a depth of 0.4 m. In addition, a filter layer made of crushed stone corresponding to gravel was installed at the bottom of the soil container, as shown in the cross section. PVC pipes adjusted to the water surface height were connected to the filter layer to provide drainage, preventing water level changes during rainfall.

As described in the next section, the model on the left side in Fig. 2 represents the case of preceding rainfall (Case A) and the model on the right side represents the case of a preceding earthquake (Case B). The

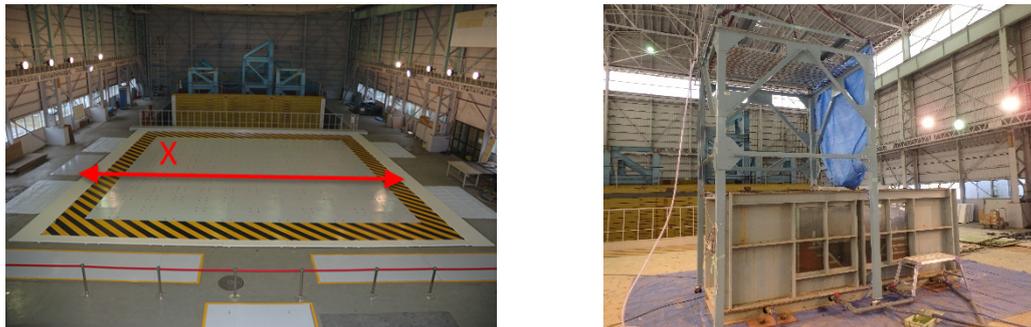
(a) Complete view of the shake table (b) Rainfall sprinkler device and soil container

Fig. 3 – The shake table and experimental situation

A series of experiments were performed in the large-scale earthquake simulator at the National Research Institute for Earth Science and Disaster Resilience, Tsukuba, Japan. The features of this facility are presented in Table 1. Fig. 3 shows the shake table arrangement. As indicated in Table 1, the shake table measures 14.5 × 15.0 m (with a load area of 12.0 × 12.0 m), the maximum load capacity is 4,900 kN, the acceleration is approximately 0.5 G (490 Gal) with a load of 4,900 kN and approximately 0.8 G (784 Gal) with load of 2,450 kN, and the stroke is ±22 cm.

Photo 3 shows the appearance of the sprinkler for the rainfall test. This device has a structure that straddles the outer shape of the soil container used in the experiment and can generate uniform rainfall within an area of 1 × 1.8 m. The watering mechanism is a system in which 500 rain needles are vibrated by a motor, generating rain from a height of 2.0 m above the soil container. The raindrop diameter is variable in the range of φ1.7 to 3.0 mm, and the rainfall intensity can be controlled in the range of 10 to 80 mm/h.

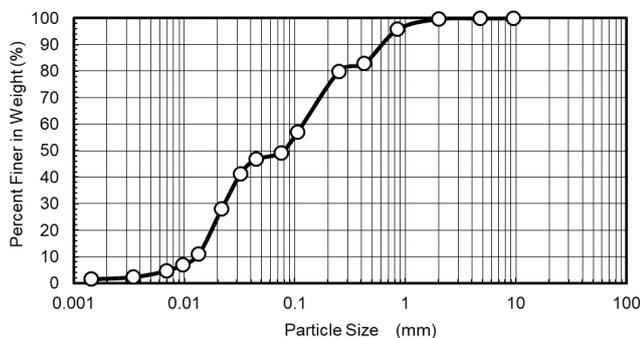
The geotechnical material used in this experiment was cultivated soil, sampled from Ibaraki Prefecture, Japan, and classified as a volcanic ash. Fig. 4 illustrates the particle-size distribution curve and Table 2 presents the physical properties of the soil. The soil was mostly composed of sand and silt, and the plasticity index, I_p , was 9.9, which indicates low plasticity. Before the construction of the embankment model, this material was in a highly heterogeneous state. The natural water content, w_c , was 45.3% in the silt and 4.4% in the sand mass where the sand content was considered to be dominant.

Fig. 4 – Grain size distribution

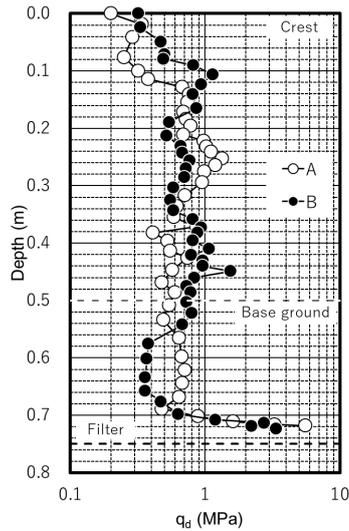
homogeneity of the embankment models in both cases was confirmed by a lightweight dynamic cone penetration test [12]. According to the results shown in Fig. 5, although the cone resistance q_d in the surface layer at 10 cm is slightly lower, the entire embankment model indicates a uniform q_d distribution in both cases. Table 3 shows the conditions of the embankment models after construction. It was determined that the wet densities ρ_t of the embankment models should be set at a low level to allow for easy reproduction of the damage in the experiment. Consequently, ρ_t values after construction were 1.53 t/m³ for Case A and 1.48 t/m³ for Case B.

Fig. 5 – Results of lightweight dynamic cone penetration tests

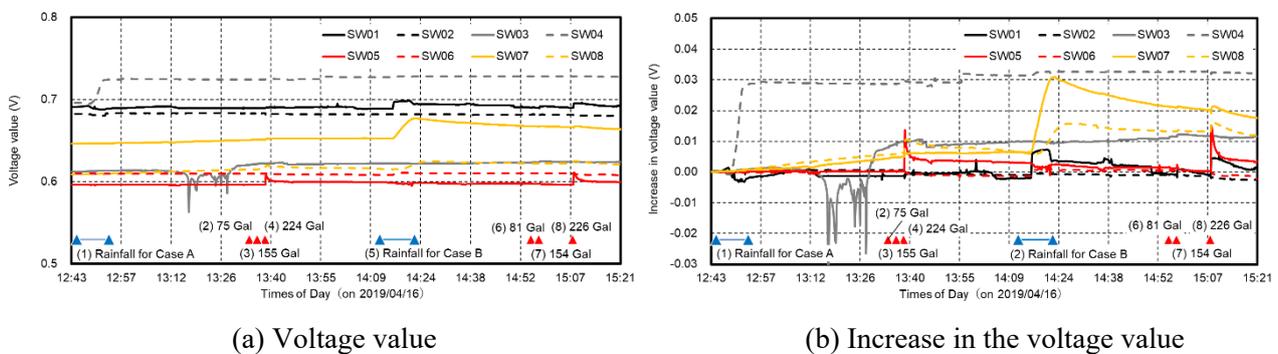
Fig. 5(a) and (b) show the timing of each test from the start to the end of the series of experiments and the changes in data obtained by the soil moisture meter shown in Fig. 2. Because the data measured by the soil moisture meter are displayed as voltage values, not saturation degrees, they only show permeation characteristics. A positive change in this data means that the degree of saturation inside the embankment model has increased.

Fig. 5 – Progress of voltage values

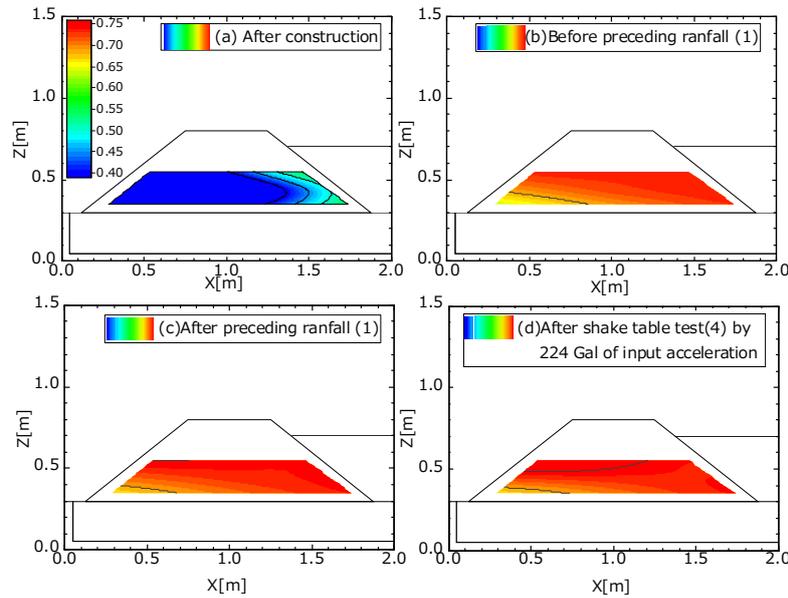
Based on each time segment shown on the horizontal axis of Fig. 6, the contour diagrams of voltage value of Case A are shown as an example. At 12:42, which is the display start time in the figure, water was injected into each reservoir until filled as planned. In Case A, during the preceding rainfall indicated at (1), it was confirmed that the voltage values of SW 1 to 3 did not change because the seepage line had already been formed on the upstream side. However, the increased in the voltage value due to rainfall infiltration in SW4 installed in unsaturated layer on the downstream side can be confirmed. Then, until the shake table tests were started, the voltage values of both Case A and B were almost constant, and there was little change in the degree of saturation in the embankment models. After that, in a series of shake table tests indicated at (2) to (4), the voltage increase in Case B was more than that in Case A after the test (4) by the acceleration of 224 Gal at (4). The remarkable increase in SW5 voltage on the upstream side suggests that the absence of rainfall infiltration promotes the change in water content in the embankment model.

Fig. 6 – Contour diagrams of voltage values in Case A

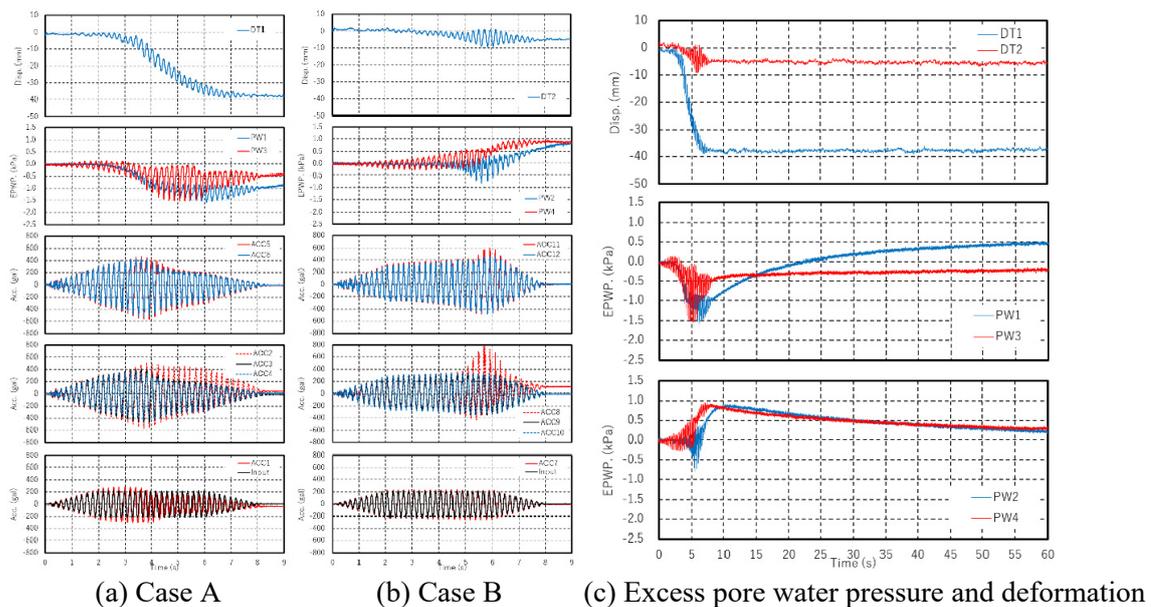
In Case A with preceding rainfall, a series of shake table tests (2 to 4, as shown in Table 4) were performed without any deformation of the embankment model because of factors other than rainfall erosion. Under acceleration between 75 and 155 Gal, no deformation of the embankment models was observed, and the acceleration responses differed little between Cases A and B regardless of the preceding rainfall. In the shake table test with an acceleration of 224 Gal, serious damage occurred as shown in Fig. 7(a) to (c), especially the horizontal displacement of the embankment model of Case A increased with shaking. In relation to pore water pressure, though Case A showed negative pressure, it can be confirmed that excess pore water pressure was generated at the same time as shaking in both cases.

Fig. 7 – Time histories of shake table tests at 224 Gal after preceding rainfall experiments

Looking at ACC5 and 6 in Case A and ACC11 and 12 in Case B, shown in Fig. 2, installed at the shoulders of the embankments, the acceleration response in Case A was amplified until $t = 4$ s and then attenuated. On the contrary, in Case B, it was amplified with a peak indicated at $t = 6$ s and then shifted. This tendency of Case B was remarkable in ACC8. Therefore, it is believed that a crack occurred in the crest of the embankment model at this point and a sliding failure occurred toward the downstream side, as shown in Fig. 8. In addition, although no cracks were observed in Case A, a large deformation occurred below the water level of the reservoir. Fig. 7(c) shows changes in the horizontal displacement of the embankment model and the excess pore water pressure after shaking. It can be seen that the dissipation of excess pore water pressure recovered slowly after shaking. However, horizontal displacement occurred during shaking and changed little after the shaking test.

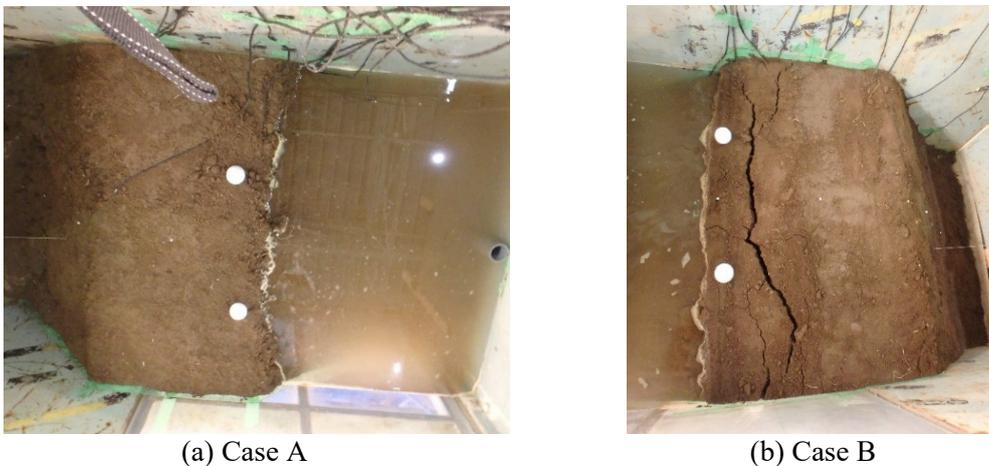
Fig. 8 – Situations at the crests of the embankment models after 224-Gal shaking

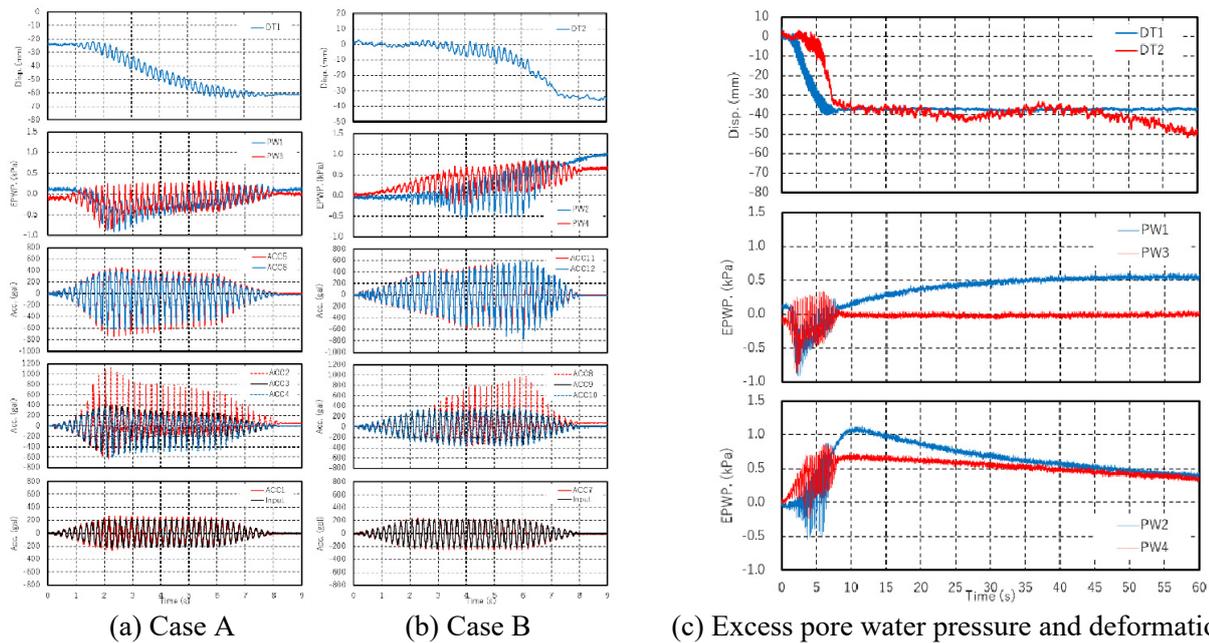
Subsequently, in the tests 6 to 8, as shown in Table 4, it was confirmed that excessive pore water pressure combined with shaking at 154 Gal was different each other between Case A and B, although dynamic behaviors in both cases indicated almost no difference under shaking at 81 Gal. Focusing on the results at 226 Gal shown in Fig. 9(a) to (c), the acceleration response of ACC2 installed on the upstream side shows a peak at $t = 2$ s in Case A and at $t = 6$ s at ACC8 in Case B. The tendency of the excess pore water pressure was similar to the results in tests 2 to 4 shown in Table 4. In both cases, the excess pore water pressure was generated simultaneously with shaking, and Case A showed negative pressure. Regarding the horizontal displacement of the embankment models, displacement only occurred during shaking and no deformation or no progress of deformation could be observed after shaking regardless of the excess pore water pressure, according to Fig. 9(c).

Fig. 9 – Time histories of shake table tests at 226 Gal after shake table tests and rainfall experiments

Based on these results, we found that the dynamic response characteristics of an embankment model differ depending on the preceding event (earthquake or rainfall), although the failure mechanisms are different in Cases A and B. If an earthquake occurs after saturation of the embankment, or the seepage line rises due to preceding rainfall, it is thought that the deformation of the embankment model occurs due to a decrease in shear resistance. Conversely, if an earthquake precedes rainfall, it is suggested that the shear strain and cracks generated due to the earthquake make it easy for rainfall to penetrate the embankment model. Consequently, it is thought that this phenomenon causes a collapse of the embankment slope toward the upstream side.

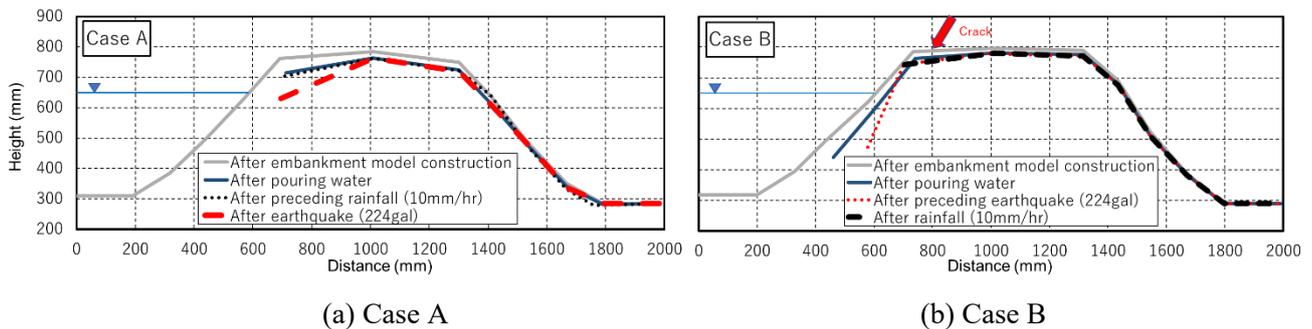
Fig. 10 shows the deformation of embankments after preceding rainfall and subsequent shaking in Case A and after a preceding earthquake and the rainfall experiment in Case B, containing the initial shape after embankment construction and after water injection into each reservoir part. To compare the deformation in both cases easily, the Case A illustration is reversed left to right in Fig. 10(a). Although it is difficult to observe the slope shape on the upstream side after water injection, in Case A, which was subject to preceding rainfall, a wide range of deformation were seen from the center of the crest and shoulder of the embankment model on the upstream side. On the contrary, in Case B, which was affected by a preceding earthquake, cracks near the front shoulder on the upstream side were caused by shaking before the rainfall experiment. This damage suggests the occurrence of a local sliding failure toward the upstream side. However, the effect of subsequent rainfall was not noticeable.

Fig. 10 – Deformation caused by both shaking and rainfall

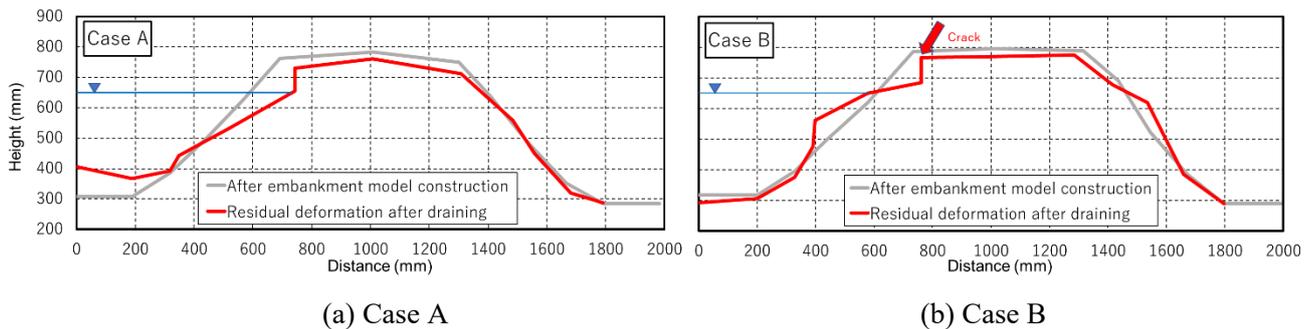
Fig. 11 shows the residual deformation after drainage from the reservoir sections in both cases and indicates that the deformation shown in Fig. 10 became even more noticeable. Fig. 12 shows the residual deformation photographed at the crest of the embankments after final drainage. In Case A, because fine tension cracks were observed at the crest, it is suggested that extensive deformation occurred throughout the embankment. On the contrary, according to the residual deformation in Case B, it is probable that the initial slip soil mass, which had already been generated by the preceding earthquake, was moved further toward the upstream side by the final shake table tests after the rainfall experiment.

Fig. 11 – Residual deformation

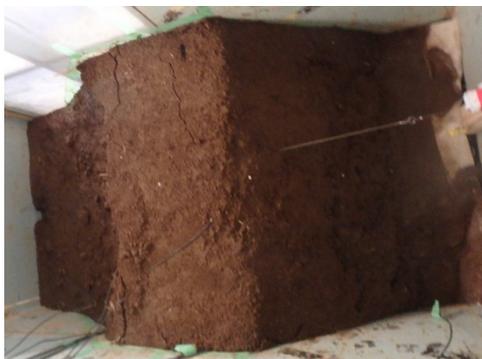
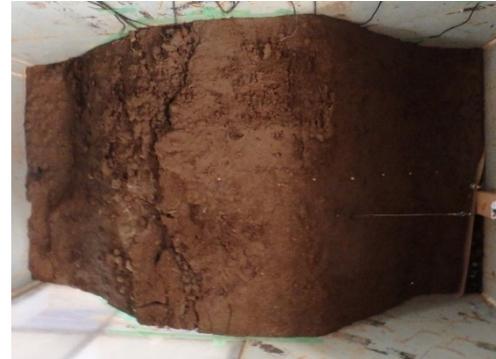
(a) Case A

(b) Case B

Fig. 12 – State of the embankments after drainage (with the reservoir sections on the left side)
