Seismic stability of masonry retaining wall in centrifuge tilting tests

K. Sano⁽¹⁾, K. Itoh⁽²⁾, T. Tanaka⁽³⁾, N. Suemasa⁽⁴⁾, T. Konami⁽⁵⁾

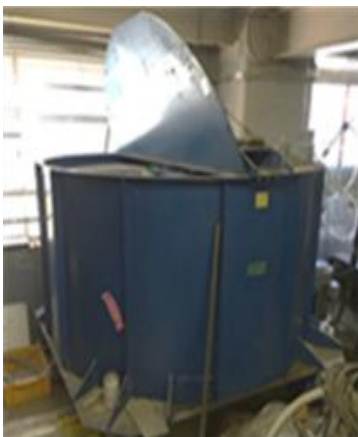
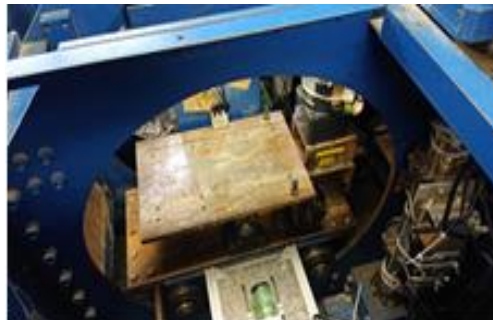
Fig.1, Small centrifugal experimental device

In this experiment, a geotechnical centrifuge device owned by Tokyo City University, was used. The photo of the device and performance values are shown in Fig.1, and Table 1, respectively.

1) Outside of device

2) Platform inside of device

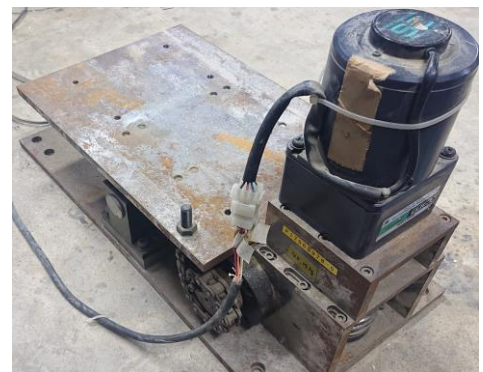
Fig.2, Tilting table device

A tilting table device used for the experiment is shown in Fig.2. We can tilt the table from 0 to 30 degree and load horizontal seismic force $k_h = \tan\theta$ (k_h =horizontal seismic force, θ =tilting angle) on the modelled retaining wall.

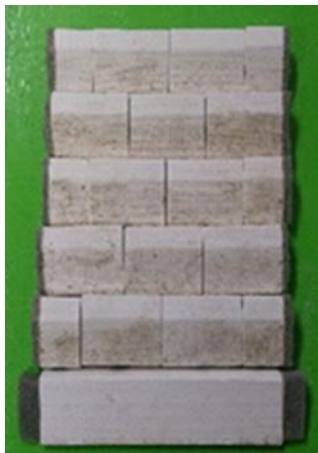
Fig.3, Retaining wall blocks on base

wall blocks and base were reproduced with plaster on 1/20 scale by a 3D printer. Two types of retaining wall blocks with 20mm in height and 19mm or 38mm in width and a retaining wall base with 20mm in height and 114mm in width were used for this experiment. Sponge tape was attached between the retaining wall surface and the soil container for reducing the friction. The retaining wall blocks and the base used for this experiment are shown in Fig.3. Blocks were subsequently stacked in five layers on the base to make the retaining wall with 110mm in height and then the retaining wall was tilted with 75 degree. as shown in Fig.4. The backfill was made with silica No. 7 by air pluviation to achieve a relative density of 60%. The schematic diagram of the modelling retaining wall ground is shown in Fig.5. In order to make conditions similar to actual conditions, modelled micropiles with rough surface made of MC nylon were used for the reinforcement as shown in Fig.6. As a reinforcement method, seven micropiles were put in the backfill at the point of 47mm away from the top of slope, and four micropiles were tilted 5 degree toward the wall and three were tilted 15° degree backward. In addition, the bottom of the micropiles were fixed in a zigzag with a intervals of 15mm to the bottom of the soil container with 120mm in width, and the top of the micropiles were integrated by PVC footing. The schematic diagram of the modelling reinforced retaining wall is shown in Fig.7. In addition, the photos of modelled air retaining wall (Case1) and modelled reinforced retaining wall (Case2) are shown in Fig8 and Fig9, respectively.

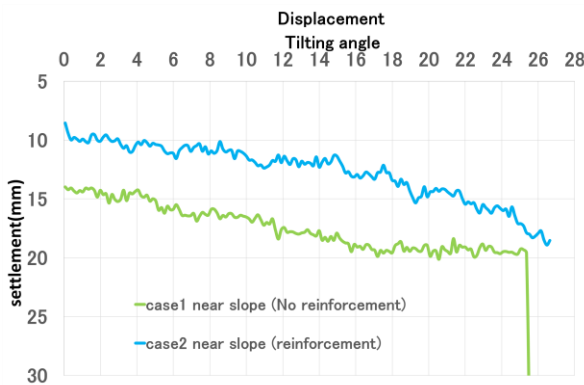
Fig.13, Relationship between tilting angle and settlement near slope

The relationship between tilting angle and displacement amount obtained from displacement sensors located at two measuring points are shown in Fig.11 and 12. As for Case1 both in Fig.11 and 12, after the displacement amount gradually increased according as the tilting angle increased, sudden rise was observed when the tilting angle turned to approximately 25 degree and which means the collapse of the retaining wall. As for Case2, on the other hand, the displacement amount was smaller than Case1 as the tilting angle increased, and the displacement amount had increased more significantly since the tilting angle became 18 degree, however, a collapse didn't occur when the tilting angle turned to 25 degree. From the results, the reinforcement effect in Case2 was confirmed.
