# FEATURES OF TSUNAMI EVACUATION OF ORGANIZATIONS AND INDIVIDUALS AT THE GREAT EAST JAPAN EARTHQUAKE TSUNAMI

Y. Goto

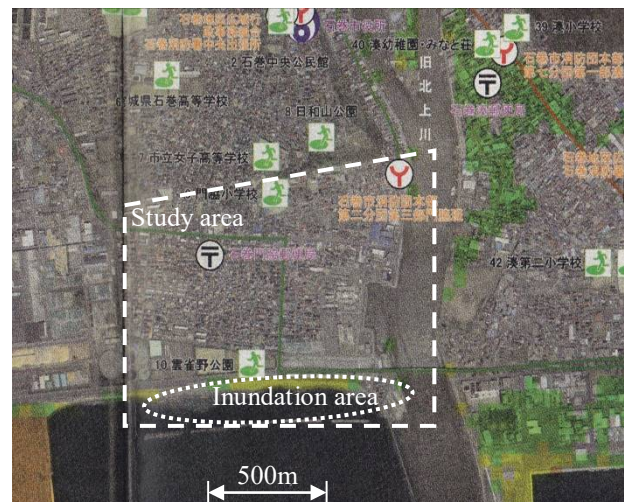
Ishinomaki City Office prepared a disaster prevention guide and hazard map booklet having several tens pages in A4 color printing, in March 2009 and distributed it to all houses. It included basic explanations, an evacuation site list, a disaster relief facilities list and hazard maps of flood risks, geological disaster, earthquake, tsunami and nuclear accident. A copy of the tsunami hazard map of the study area is shown in Fig.5. It did not indicate the possibility of tsunami inundation except for a part of Hibarino. It is obvious that the map greatly underestimated the tsunami inundation when it was compared with Fig.3 and Fig.4.

Fig.5 – Partial copy of hazard map published by Ishinomaki City Office

It has already been mentioned that the hazard map created by Ishinomaki City Office underestimated the flooded area. Even if a majority of people would not look at the hazard map, if the inundation area is upgraded, the disaster prevention information that the Ishinomaki City Office sends to residents and the content of disaster prevention drills in inundation-prone areas would need to be changed, and local mutual assistance systems to support for vulnerable evacuees, would need to be developed.

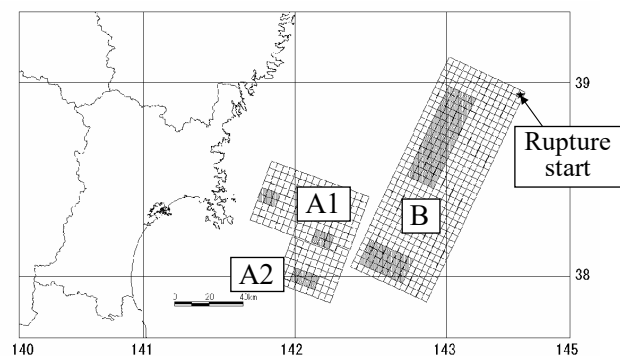
Ishinomaki City Office created a hazard map based on the tsunami inundation area prediction map prepared by Miyagi Prefecture in March 2004. According to the report on the Miyagi Prefecture Earthquake Damage Estimation Survey (March 2004 Miyagi Prefecture Disaster Prevention Council Special Committee on Earthquake Countermeasures, [7]), a tsunami propagation simulation assuming a linked (M8) hypocenter model off the coast of Miyagi prefecture was performed and the estimated inundation area were plotted. Fig.9 shows the linked hypocenter model. However, in the first chapter of the

Fig.9 – Interlocked type fault model used by Miyagi prefecture, 2004

It should be noted here that the tsunami deposits in the Sendai plain and the Ishinomaki plain have been surveyed since about 2001, and that in 2007, Shishikura and seven others [8] were estimated to be due to the Jogan Tsunami (AD869). They reported that the Jogan tsunami might have reached the vicinity of the Sanriku Expressway in the Ishinomaki plain and the innermost part of the Watanoha lowland, that is, it reached area equivalent to the tsunami hit area of the 2011 Great East Japan Earthquake. In addition, Satake and two others [9], in 2008, analyzed the tsunami deposits area of the Jogan Tsunami in the Ishinomaki and Sendai plains using a tsunami simulation with many hypocenter models, and reported that the distribution of tsunami sediment could be well explained if the dislocation was more than 7m and Mw was 8.4. The location of the presented source fault extended the hypocenter model assumed by Miyagi Prefecture about 100km further south-southwest.
