PRODUCTION & USE OF HOLLOW CONCRETE BLOCKS IN RECONSTRUCTION AFTER GORKHA EARTHQUAKE

Abstract

Keywords: hollow concrete block; laboratory test; Gorkha earthquake; compressive strength; reconstruction

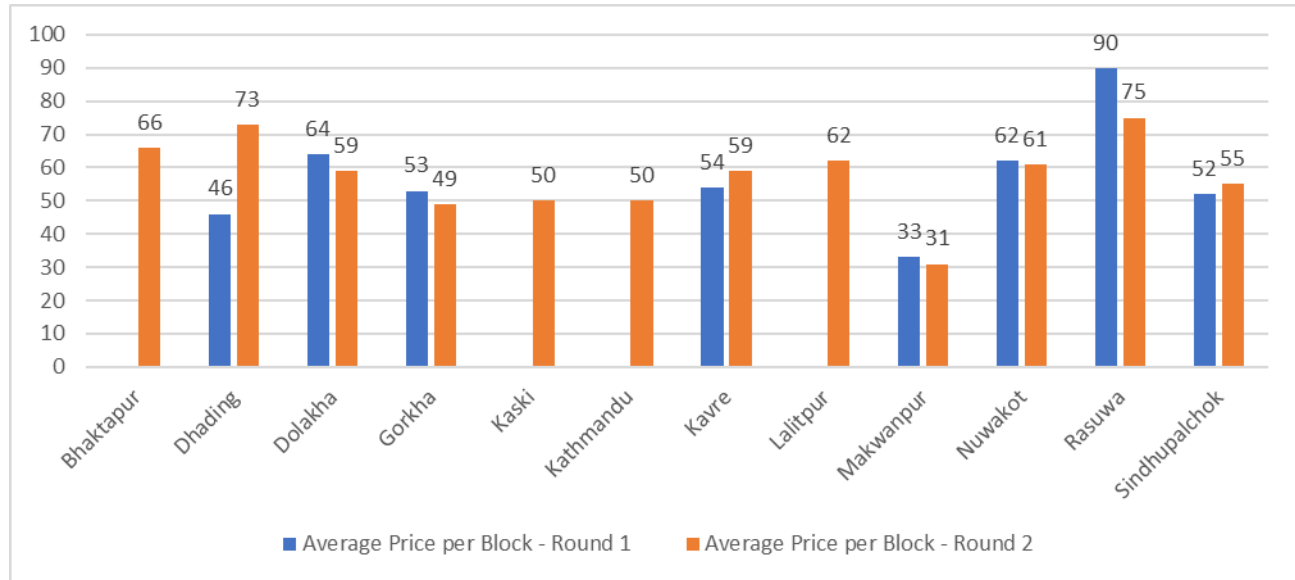
Fig. 2 – District wise average price per block

The price per block varies across producers and districts. The average price across all districts from the first and second round of sample collection was NPR 57 and NPR 58 per block respectively. It is interesting to note that quality seems to have limited impact on the cost of the block. The ten weakest blocks (with compressive strength ranging from 12.74 kg/cm² to 20.4 kg/cm²) have an average cost of NPR 56 per block.

The cost of blocks is highest in Dhading and Rasuwa, whereas the cost in Dhading has increased by more than 50% from round 1 data collection and the cost in Rasuwa has decreased by 20% since round 1 data

collection. The cheapest blocks are in Makwanpur where the average cost per block is NPR 33 which is below the overall average.

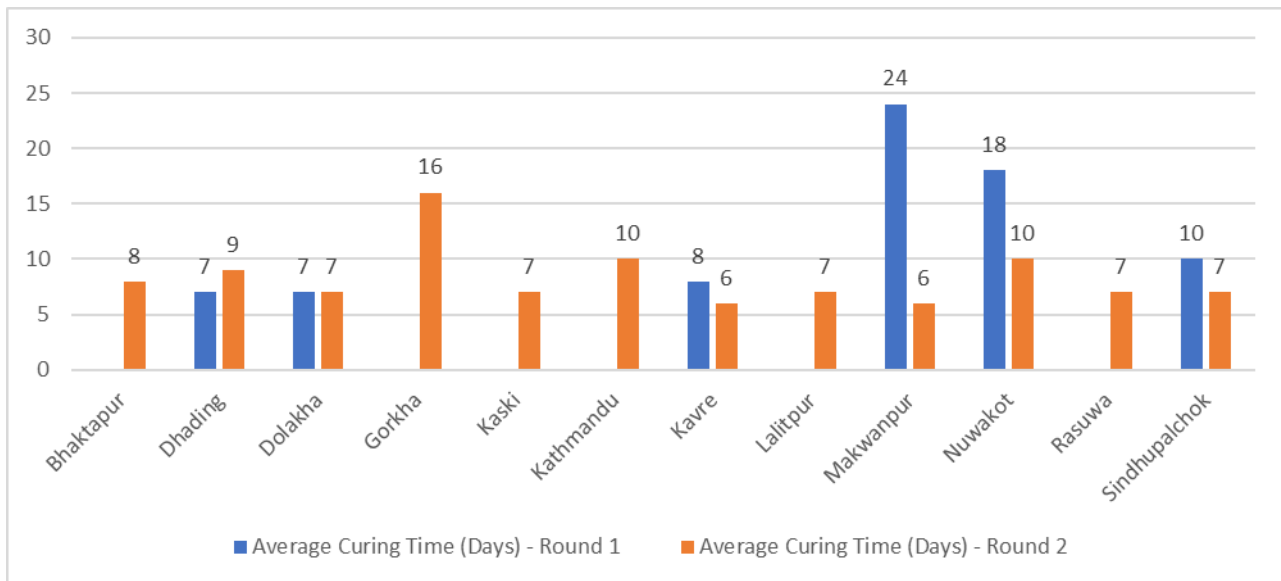
Fig. 3 – District wise average curing time in days

The Nepal Standard NS: 119/2042 does not specify required curing times but refers to the Indian Standard Specification for Concrete Masonry Units Part 1 Hollow and Solid Concrete Blocks IS 2185 (Part 1): 2005 [8]. As per the Indian Standard IS 2185 (Part 1): 2005 and IS 456: 2000 [9] HCBs should be cured for at least 14 days to permit a complete moisturization.

The average curing time across all producers is found to be 11 days and in the most recent set of data collected, Gorkha is the only district with an average curing time of greater than 14 days (16 days). It is perturbing that there seems to be a trend of reduction in curing times from the first round of data collection to the second. This trend was observed in Kavre, Makwanpur, Nuwakot, and Sindhupalchowk districts whereas only in Dhading district small increase in the average curing time was found. Most HCB producers cure the blocks for only seven days, but there are also producers curing blocks for as little as three days.

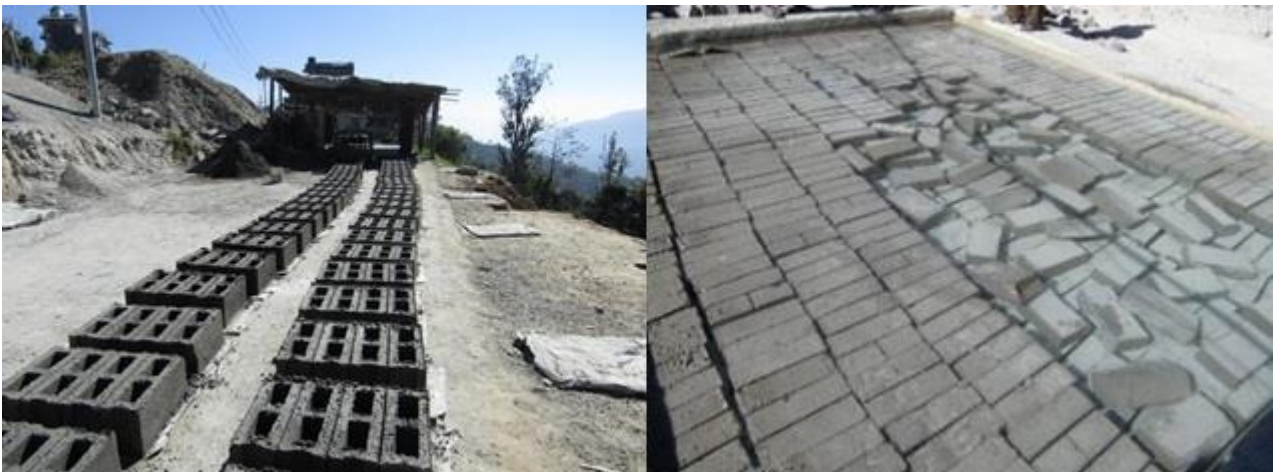
Fig. 4 – HCB laid in the sun after production in Dolakha (L) and blocks submerged in a pond in Dolakha (R).

The majority of producers use ‘sprinkle’ method for curing which involves either pouring or hosing water over the HCBs between two to four times per day, with other producers using a ‘ponding’ method where the blocks are submerged in water.

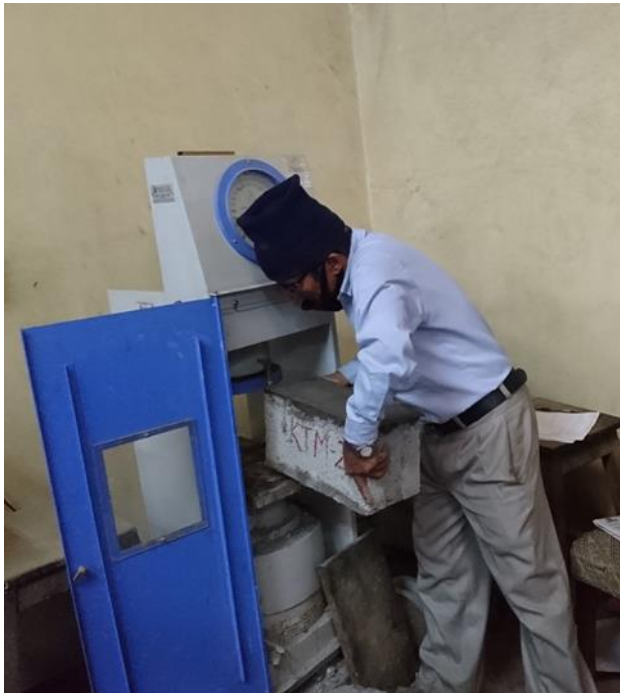
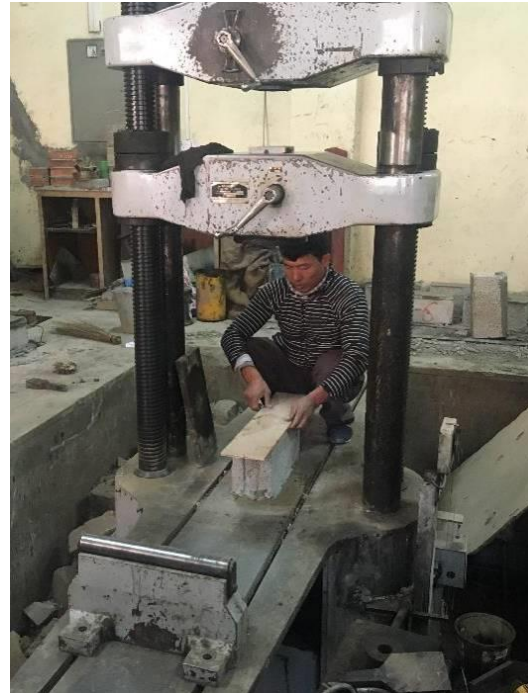
Fig. 7 – Block testing at central material testing laboratory, IoE, Tribhuvan University

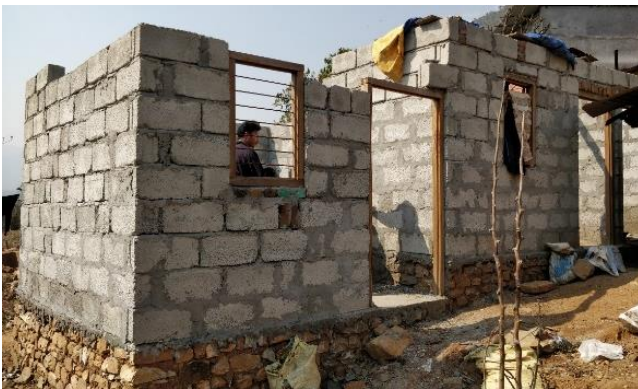
HCB house construction in Pokhara

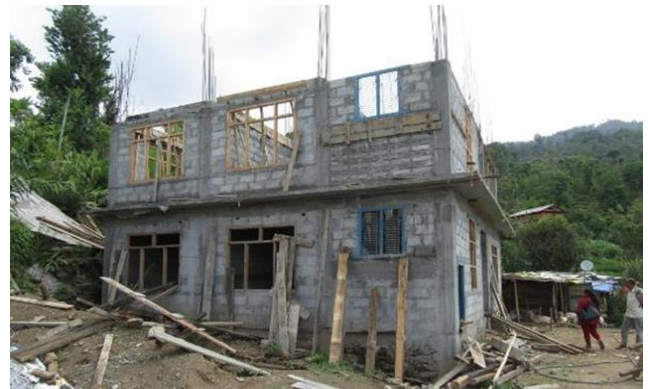
RC frame building with HCB infill in Dolakha

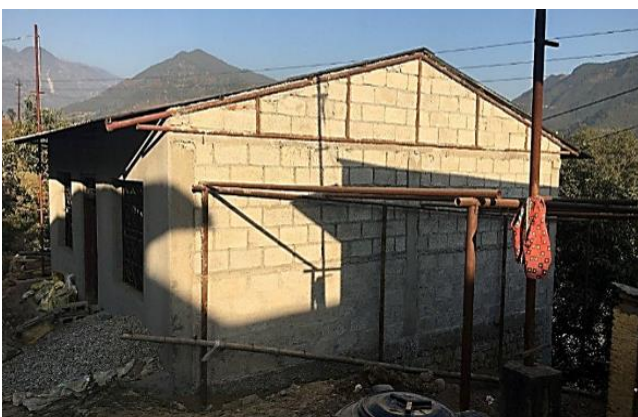
HCB house with steel truss for roof in Nuwakot

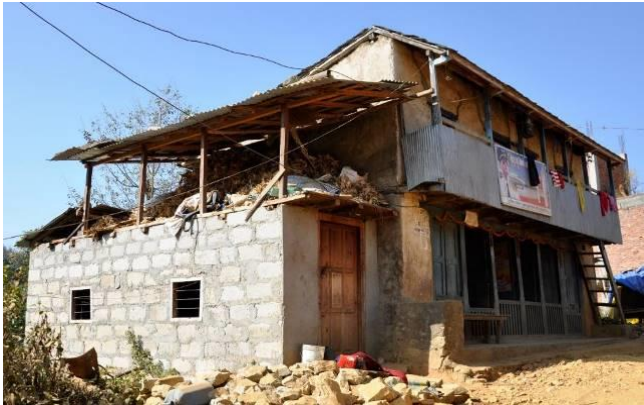
HCB extension to a stone masonry house in Dhading

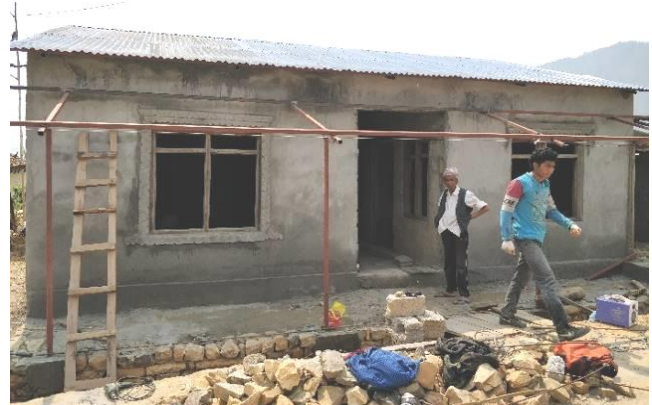
Steel frame structure with hollow concrete blocks infill walls in Parbat
