## EFFORTS AND IMPACTS OF SOCIO-TECHNICAL ASSISTANCE FOR RETROFITTING IN POST-EARTHQUAKE RECONSTRUCTION IN NEPAL

### Abstract

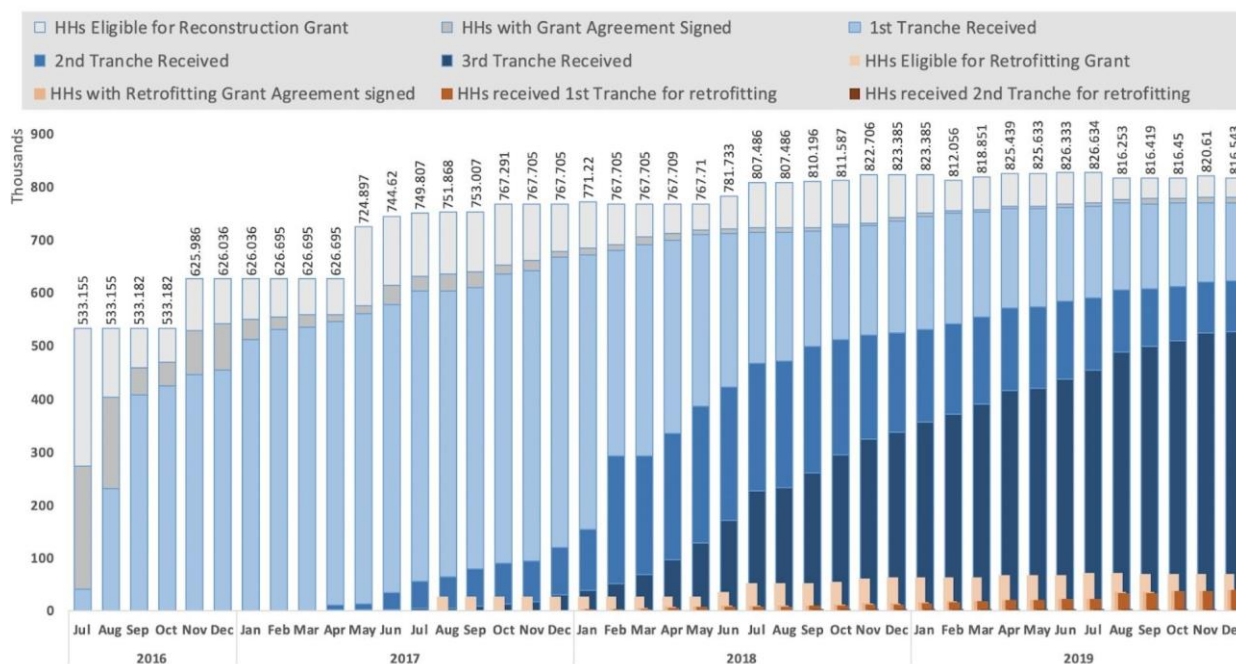
The Figure 3 shows the progress of reconstruction in Nepal in the aftermath of the Gorkha earthquake. The difference in progress between reconstruction and retrofitting is visibly evident in the chart. Although with a slow start, the progress of reconstruction has significantly increased over the last two years, with more than 62% of enrolled beneficiaries having completed their reconstruction [3], compliant to government standards. However, out of nearly 70,000 beneficiaries identified for retrofitting, less than 1% of the households have completed their required interventions and acquired the government grant. The data clearly shows the lack of public interest in retrofitting, despite the benefits that were discussed earlier.

Fig. 3 - Progress status of reconstruction in Nepal as of December 2019 [3]

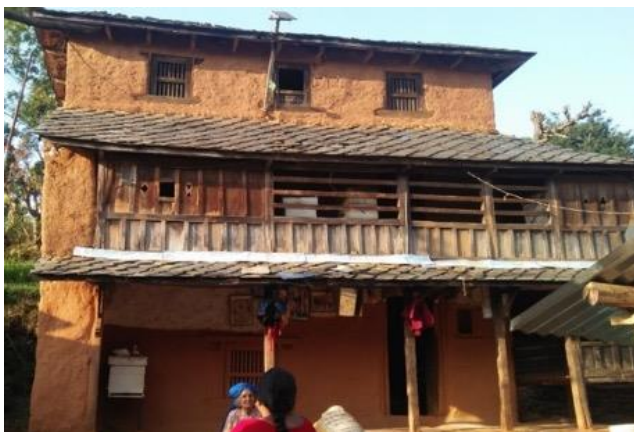
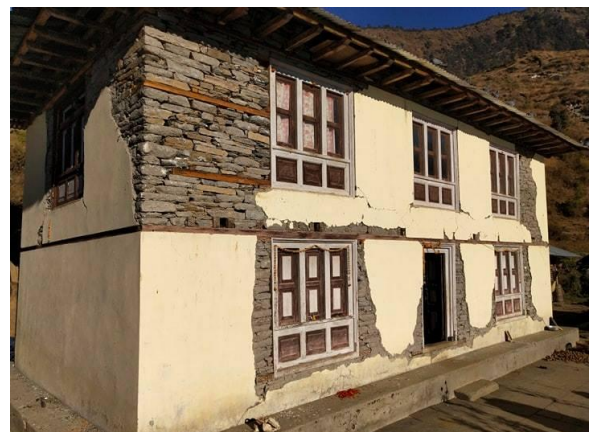
Fig. 5 – Typical stone masonry buildings in rural Nepal, categorized for retrofitting (left) and reconstruction (right) despite similar grades of damage. © NSET

- **Anomalies in damage assessments:** To ascertain the reconstruction requirements and ease the process of grant distribution, the government of Nepal conducted damage assessments of the earthquake affected houses by deploying huge number of technical personnel and social mobilizers. While this assessment was believed to provide accurate data of reconstruction needs, it has been seen that in some cases, the damage assessments are not free of anomalies. Houses that could be categorized as partially damaged and recommended for retrofitting were placed in the reconstruction category, owing to various reasons including human errors, lack of proper understanding and undue influence. This created confusion among the beneficiaries as in some communities, houses with similar grade of damage were placed in two different categories, with two levels of government support. This resulted in mistrust towards the government, as retrofitting beneficiaries demanded to be transferred to reconstruction for equal financial grant.

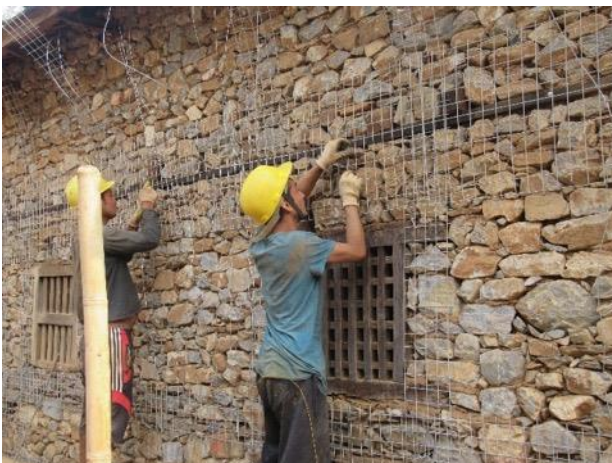
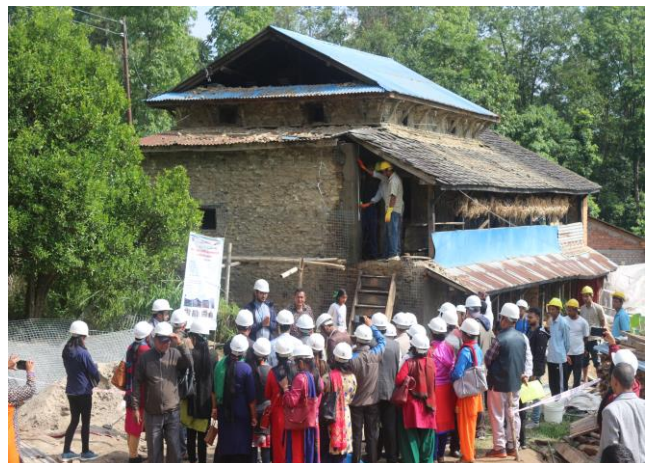
Fig. 7 – Masons receiving hands on training on retrofitting (left) and Representatives from a rural municipality observing the ongoing retrofitting of a typical rural stone masonry building. © NSET

Apart from information dissemination through theoretical media, NSET also focused on demonstrating the procedure of retrofitting by construction of actual scale demonstration models. For this, partially damaged houses which were enlisted for retrofitting were chosen in earthquake affected areas in collaboration with the local governments and assisted in retrofitting through hands-on training for masons. The demonstration house also served as a site for training local masons in the construction process of retrofitting, thus serving dual purpose of awareness as well as capacity enhancement for the local communities. NSET focused on retrofitting a wide range of houses based on size, socio-economic condition of households and geographical locations to portray the suitability of the technique in different aspects.

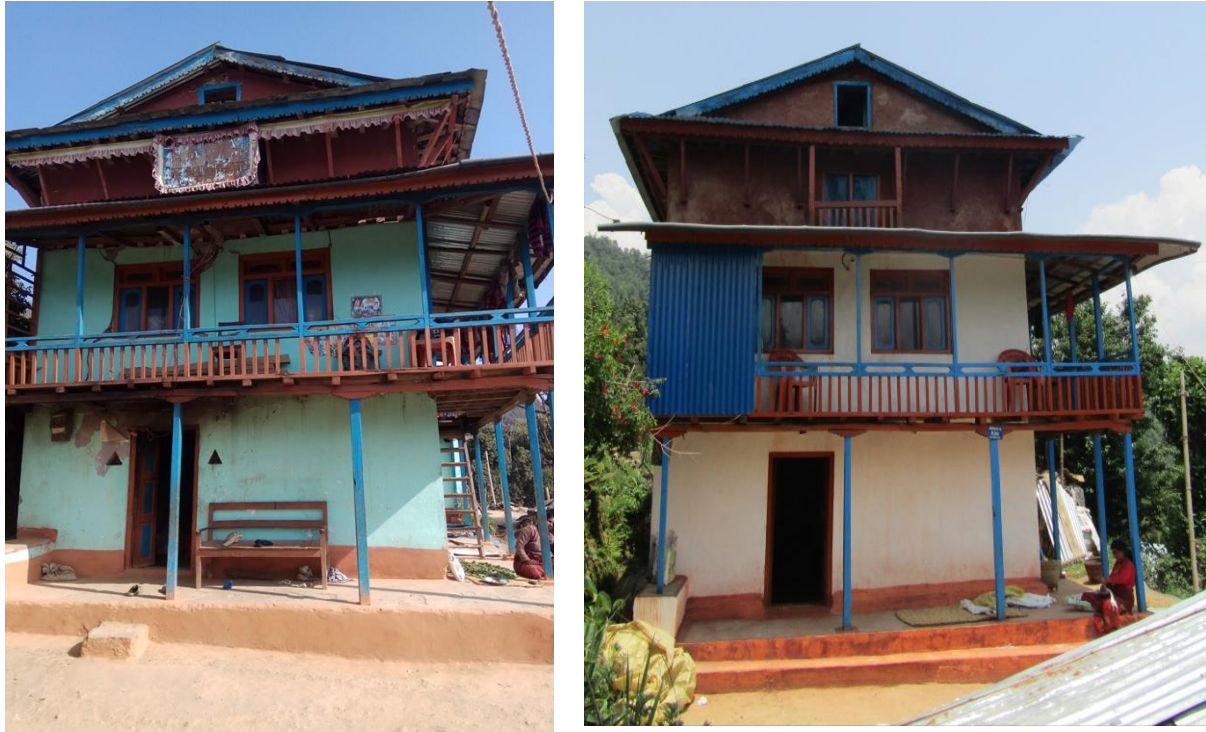
Fig. 8 – A typical 2 storey and attic stone masonry building before and after retrofitting. Beneficiaries are especially attracted to the low levels of architectural interventions thus ensuring adequate usable space.

With comprehensive socio-technical assistance activities conducted by NSET for retrofitting during the period of a year from October 2018 to September 2019, the program was able to convince house owners and retrofit 51 masonry buildings in four earthquake affected districts. Moreover, 316 local masons were trained during the construction of these demonstration houses and 488 engineers were trained on design, construction, supervision and inspection of retrofitting. Similarly, 1035 persons including local and central government officials, community people, beneficiaries visited the demonstration construction sites to witness retrofitting. As such, the demand for support for retrofitting has increased significantly, and most importantly, the misconception regarding retrofitting is gradually declining from the beneficiaries. With the
