## DAMAGE ASSESSMENT AND REPAIR COSTS OF RESIDENTIAL AND SCHOOL BUILDINGS AFTER RECENT ITALIAN EARTHQUAKES

*Keywords: loss-assessment; post-earthquake; RC buildings; school; vulnerability.*

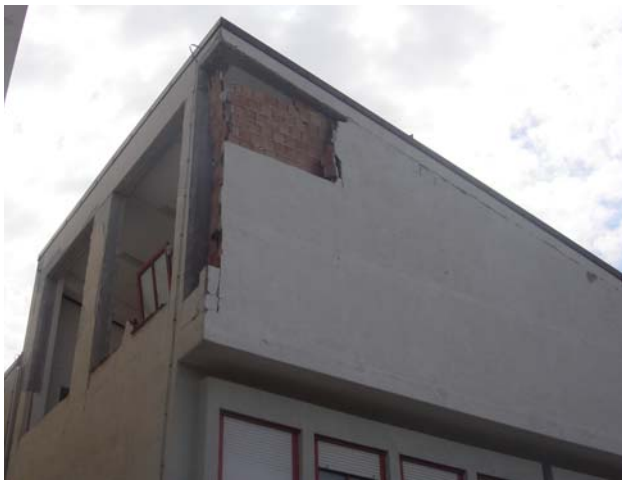
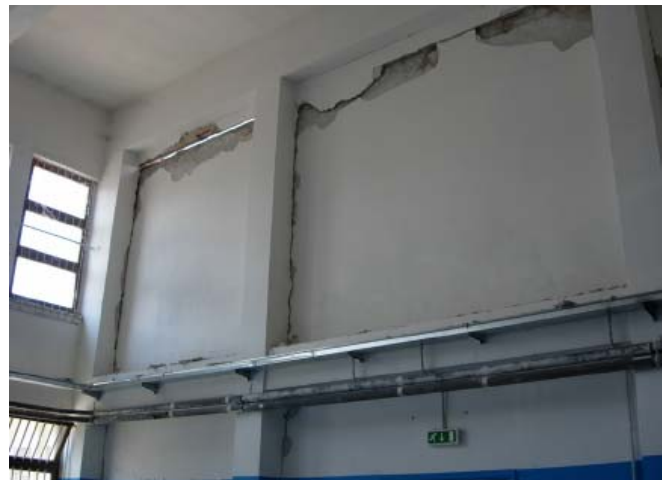
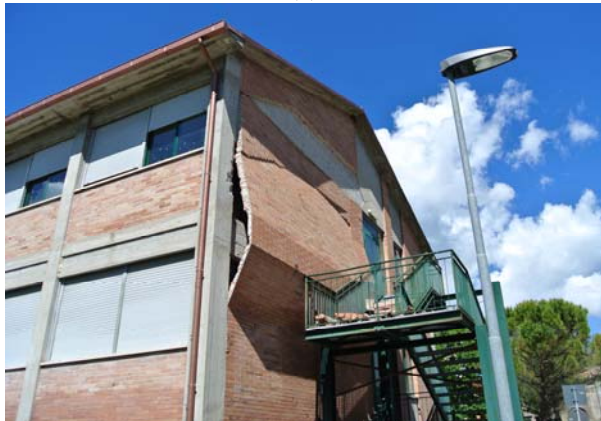
(a)

Fig. 1 – Damage to existing RC school building due to recent Italian earthquakes: out-of-plane damage and collapse of infills (a)(b) (c); damage to ceilings (d); damage to floor and partitions (e); collapsed school building during the 2016 Central Italy earthquake (f).

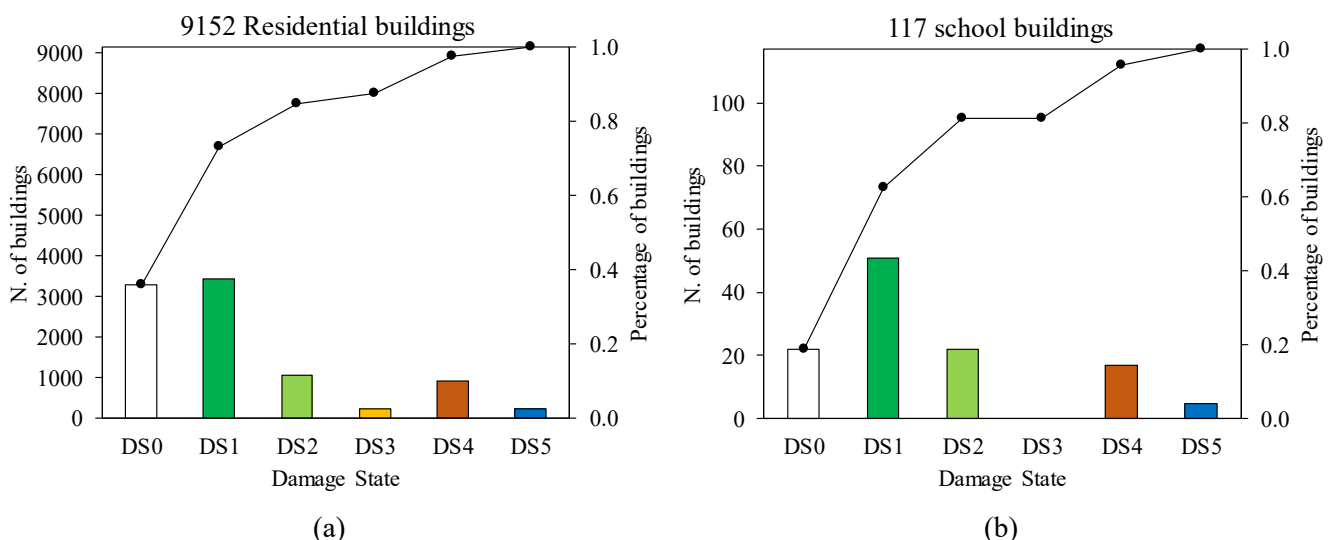
In order to compare the global performance of the RC buildings available in the database, the damage to the different building components should be converted into a damage state (DS). Different methodologies for the classification of the DS using the observed earthquake damage reported in the AeDES forms [13] are available. The classification proposed by Del Gaudio et al. [16] is used in this study. According to the widely recognized European Macroseismic Scale EMS-98 [18], this classification defines the damage state as a function of the maximum damage experienced by the vertical structures and IPs. Apart from DS0 (null damage), five DSs are identified: DS1 (Negligible-to-slight damage, consisting of fine cracking in the plaster or the IPs); DS2 (moderate damage, consisting of cracking in the structural members and IPs); DS3 (substantial-to-heavy damage, consisting of extensive cracking of structural members and large cracks or the failure of IPs); DS4 (very heavy damage, consisting of large cracks in structural members or collapse of a few members); and DS5 (destruction, consisting of the collapse of the ground floor or other portions of a building). A comparison of the damage state experienced by residential and school building of the selected database is reported in Fig. 6.

Fig. 6 – Comparison in terms of the achieved damage state between the RC residential buildings (a) and RC school buildings.

The comparison outlines a similar seismic response of the residential (Fig. 6a) and school buildings (Fig. 6b) and minor differences can be observed. In particular, based on this preliminary analysis, the residential buildings showed a rate of undamaged buildings (DS0) higher than schools. It is worth mentioning that, at this stage of the data collection, the completeness ratio of the surveys on residential building is higher than

the one on school buildings and further effort is needed to investigate this aspect. A similar trend can be observed for the other DSs where the school building shows a damage slightly higher than residential ones.
