## A SIMPLE PROPOSAL FOR THE SEISMIC RISK ASSESSMENT OF WOODEN PATRIMONIAL STRUCTURES IN CHILE

A simple proposal to evaluate the patrimonial seismic risk of wooden structures is presented, taking as study case the city of Valdivia, in southern Chile. The seismic risk is analyzed under three core aspects: vulnerability, hazard and architectural cost that considers the patrimonial variable.

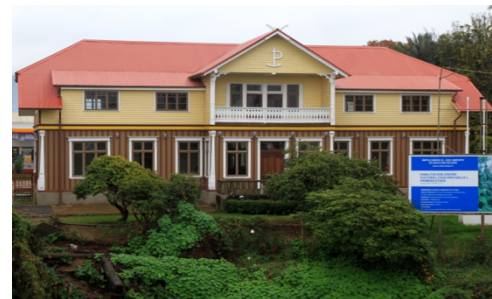
Fig. 2 – Typical study case: Prochelle I House

The Prochelle I House, despite its relatively high architectural heritage value and prevailing vulnerability, the structure does not present an imminent risk of collapse and its architectural elements do not present major or irreversible problems [13]. The result (RIPAT1.0) obtained after the analysis of the model and application of the methodology was 0.289 points (eq. 5); it may therefore be classified within condition B (orange colour), namely a building with average seismic vulnerability.

After 2014, as part of the restoration process, the building underwent mayor improvements in the form of structural reinforcement through the incorporation of metal elements or the replacement of deteriorated wood elements, coupled with the improvement and restoration of non-structural elements such as coatings, stairs and façades [16].
