DAMAGE ASSESSMENT ACTIVITIES OF SCHOOL BUILDINGS AFTER RECENT MAJOR EARTHQUAKES IN JAPAN

Y. Nakano

2. Typical Damage to School Buildings from Recent Four Major Earthquakes in Japan

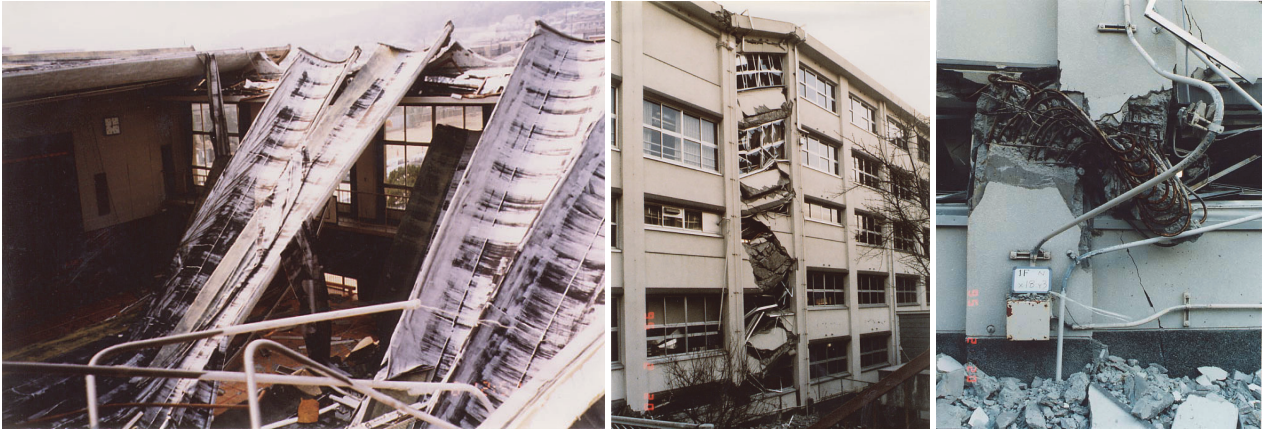
Photo 1: Serious damage to school buildings (1995 Kobe earthquake) [4]

The 1995 Kobe earthquake, which centered the urban area of Hanshin-Awaji district, caused extensive structural and/or non-structural damage to approximately 4,500 educational facilities. No fatalities fortunately resulted from damaged schools since the quake struck the area early in the morning. Some school buildings, however, sustained serious damage as shown in **Photo 1**, and 54 buildings were demolished and reconstructed following the event. The Government of Japan (GOJ) appropriated 94 billion JPY for fiscal years 1994 and 1995 to restore damaged educational facilities and subsidized 1,126 buildings [2, 3]. As will

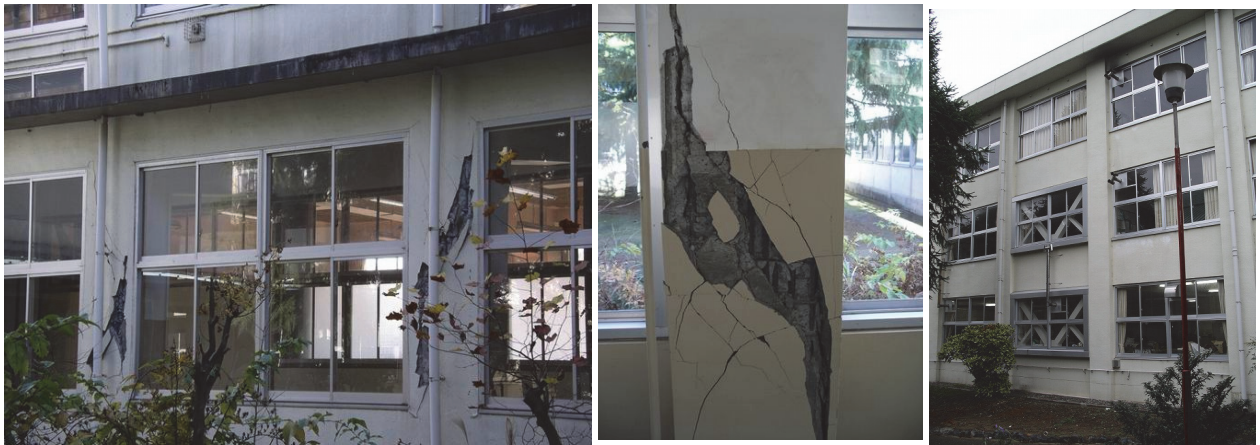
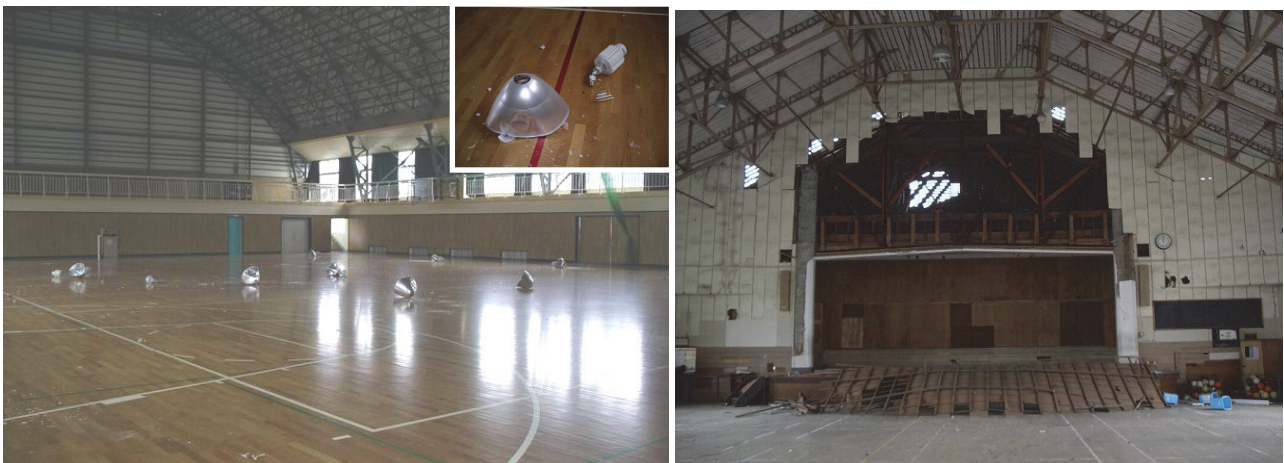
Photo 2: Structural and non-structural damage to school buildings (2004 Niigata-ken Chuetsu earthquake) [5]

This earthquake was a localized event but caused extensive damage to buildings as shown in **Photo 2**. After 1995 Kobe earthquake, the seismic rehabilitation program was implemented throughout Japan and this event was the first major earthquake to demonstrate the effectiveness of seismic rehabilitation under severe earthquake ground motions. The observed damage clearly demonstrated that the rehabilitated school buildings performed successfully and the effectiveness of seismic rehabilitation was re-recognized. This earthquake was followed by numbers of aftershocks, and they caused remarkable damage to non-structural elements such as light shades or interior walls, which might harm evacuees as shown in the photo, and the inspection of damaged buildings to rapidly evaluate their safety to aftershocks was highlighted.

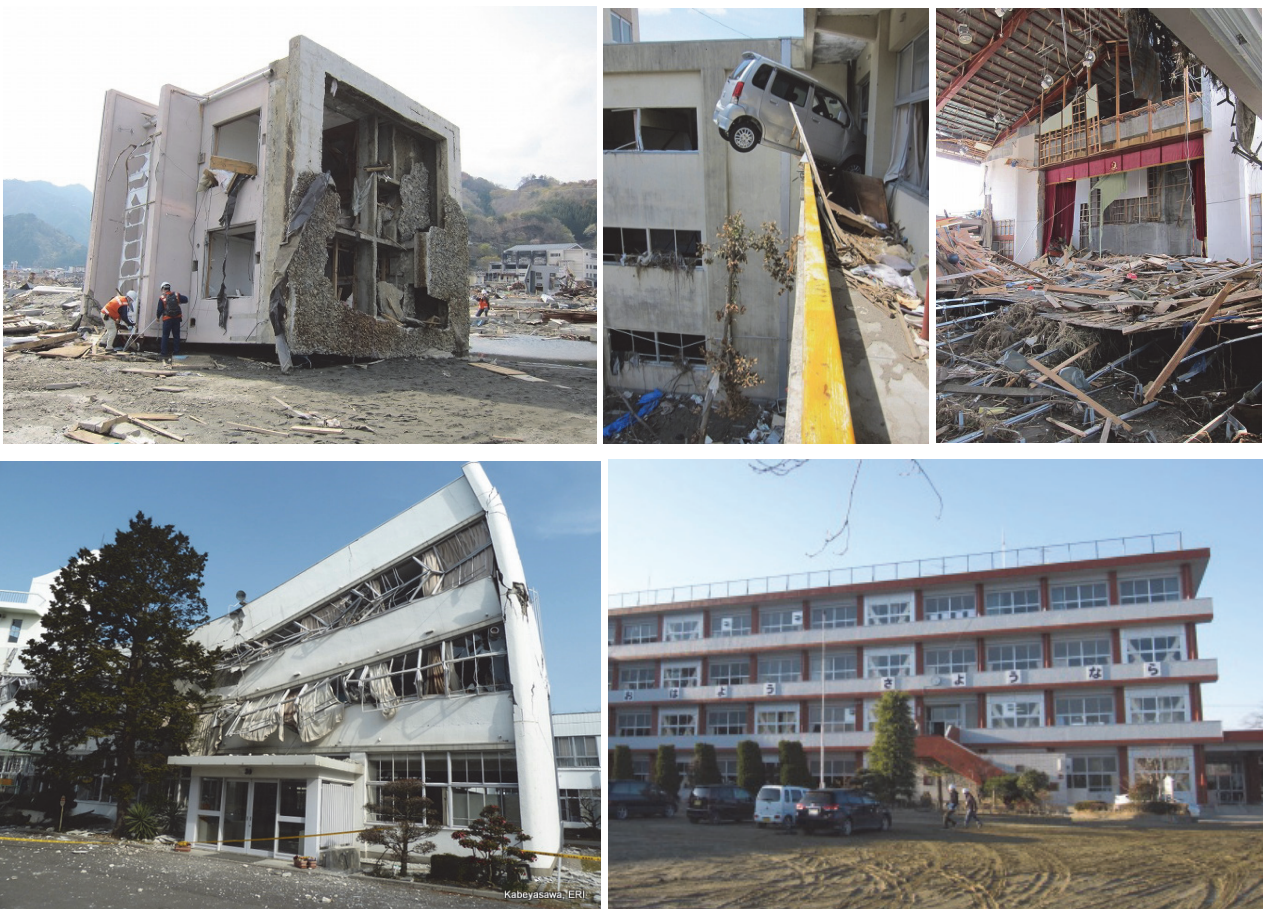
Photo 3: Ground shaking and tsunami damage to school buildings (2011 Great East Japan earthquake) [6]

The Great East Japan (Tohoku) earthquake was one of the most damaging earthquakes in the modern history of Japan. Massive and widespread damage was found in coastal areas due to devastating tsunamis, but as was found in Niigata-ken Chuetsu earthquake, seismically rehabilitated buildings generally performed well while old and vulnerable buildings left not upgraded had most serious damage, including total or partial collapse as shown in **Photo 3**. It should also be reminded that ceilings of theater/concert halls or gymnasiums which fell down to the audience area or indoor playground caused critical damage with fatalities. Due to such damage observed, the MEXT issued a notice to accelerate the countermeasures to eliminate falling hazard as well as further implementation of structural rehabilitation.

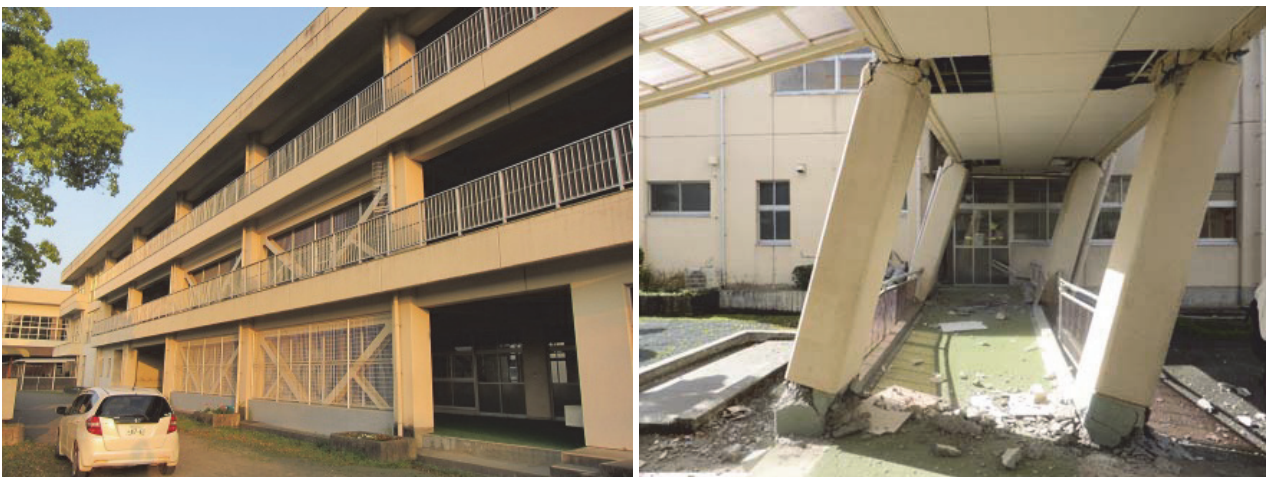
Photo 4: Survived and severely damaged school buildings (2016 Kumamoto earthquake) [7]

Two major shakings with the main shock following a foreshock that occurred 28 hours earlier consecutively hit Kumamoto and Oita areas, resulting in extensive damage to structures, especially to timber houses. As was found in the past major earthquakes, this event also caused remarkable damage to school buildings which were not seismically upgraded before the events, while those upgraded performed well. It should be noted, however, that some buildings designed highly dependent on ductility with lateral resistance reduction largely responded, causing large residual deformations. **Photo 4** shows a contrasting performance, one showing no damage after seismic rehabilitation and the other large residual deformations in columns.

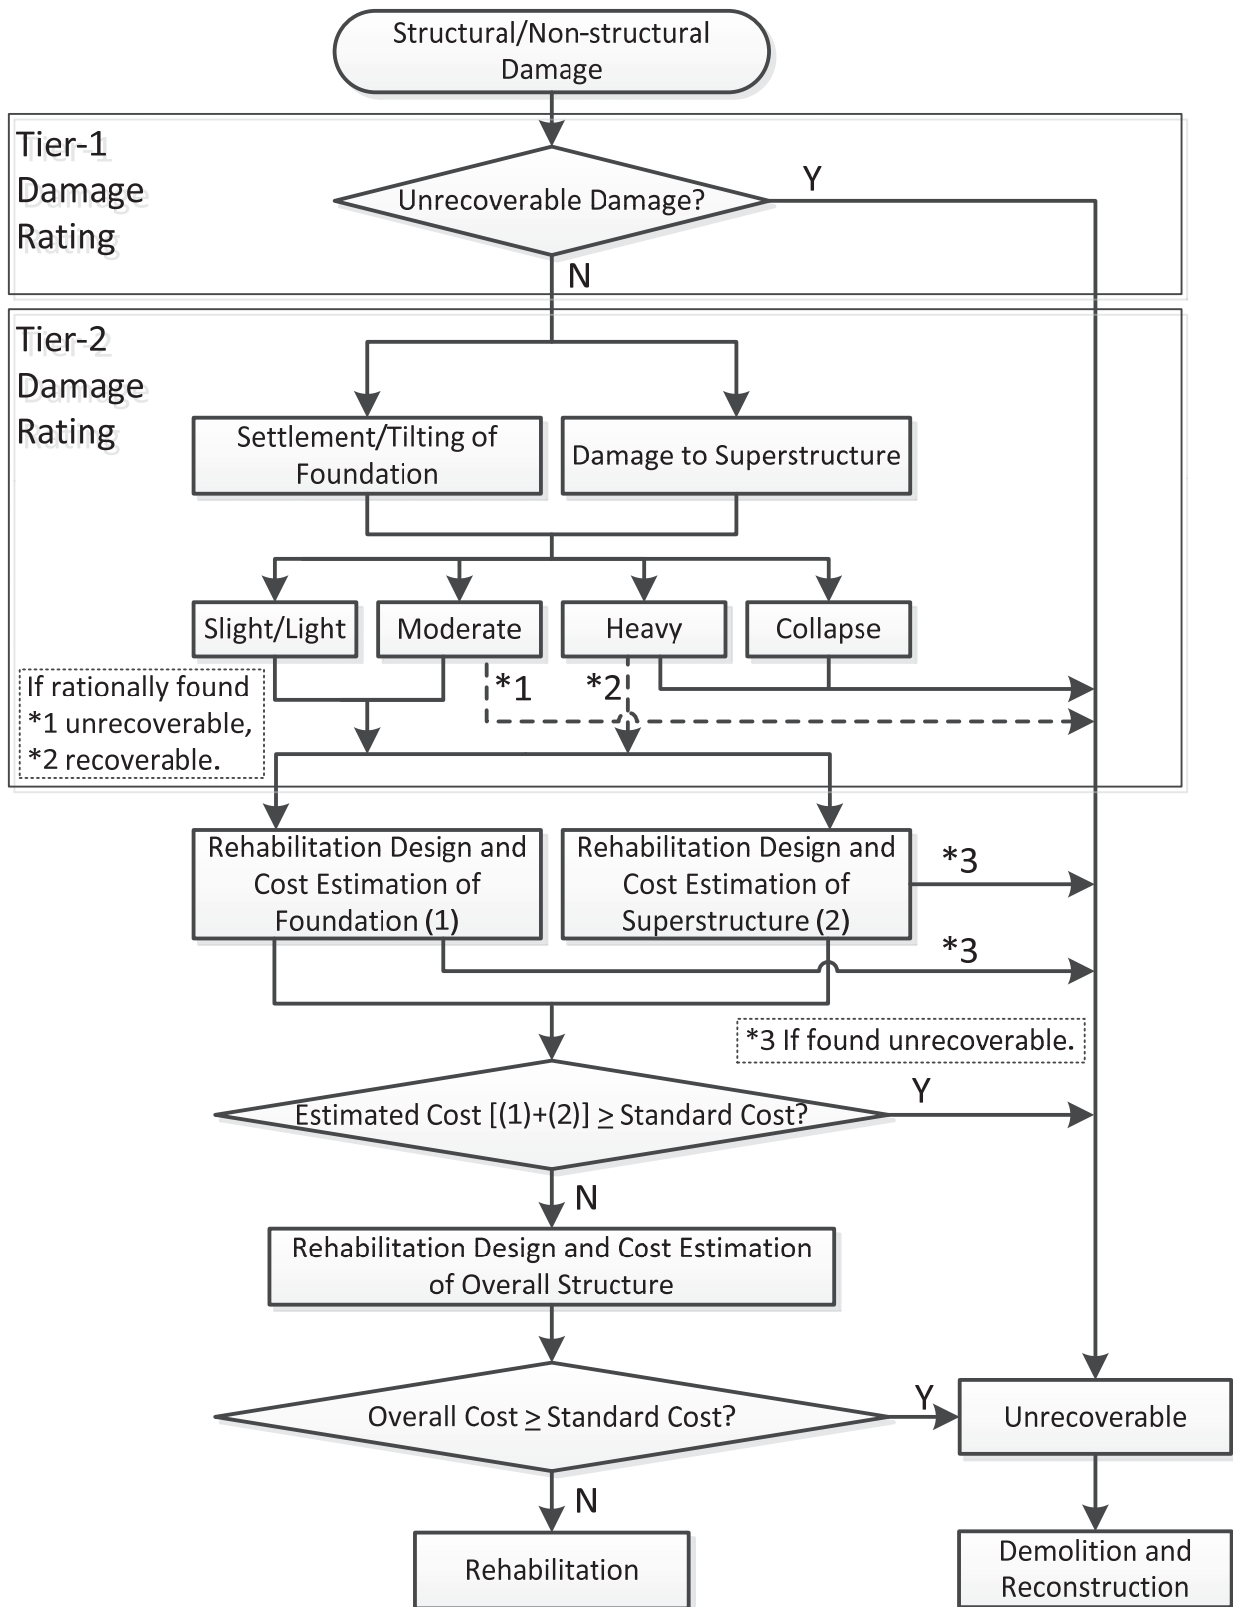
Fig. 2: Two-tiered damage rating procedure for RC school buildings [after 7]

In the past four events, the damage of extensive number of school building needed to be rated, and the two-tiered assessment procedure was employed. This procedure is provided respectively for reinforced concrete (RC), steel, timber school buildings. Although the detailed criteria for damage rating differ depending on the structural type, each structural type shares the basic policy for rating. **Fig. 2** shows the general flow of the damage rating procedure for RC school buildings [after 7].

The Tier-1 damage rating is designed to quickly identify obviously unrecoverable buildings through visual inspection and/or simple measurement. When the Tier-1 rates the building unrecoverable, it will be renewed after demolition and reconstruction. The criteria to find unrecoverable buildings are:

- 1) Obviously dangerous condition to enter due to extensive damage to major structural columns, walls, or beams, causing total or partial collapse,
- 2) Foundation settlement with more than 1m (0.2m for pile foundation),
- 3) Foundation tilting with more than 6/100 rad. (3/100 rad. for pile foundation), or
- 4) Class V¹ damage to more than 35% of surveyed columns and walls.

The Tier-2 damage rating then applies to those which are not obviously identified unrecoverable in Tier-1. In this rating, the Guidelines for Post-earthquake Damage Evaluation and Rehabilitation [8] applies, where damage rating of a building is performed on foundation system and superstructure system, respectively and the damage rating is made in a combination form for each system such as “no damage in foundation and moderate damage in superstructure.” The Guidelines also provides required actions depending on the damage, the estimated residual seismic capacity, and earthquake intensity at the building site. The general procedure can be briefly described as follows and the detailed procedure can be found in reference [9].

- (1) Damage rating of foundation and superstructure:
 - (a) The damage to foundation is rated from the matrix of tilting angle of overall structure and foundation settlement.
 - (b) The damage to each structural member is inspected and classified into one of the classes I through V. The residual seismic capacity ratio index R , which is defined as the ratio of capacity of post-damaged to that of pre-damaged condition (i.e., the ratio of the residual capacity to the original), is calculated and the overall damage rating of the building is performed base on the R -index.
- (2) Determination of rehabilitation actions:

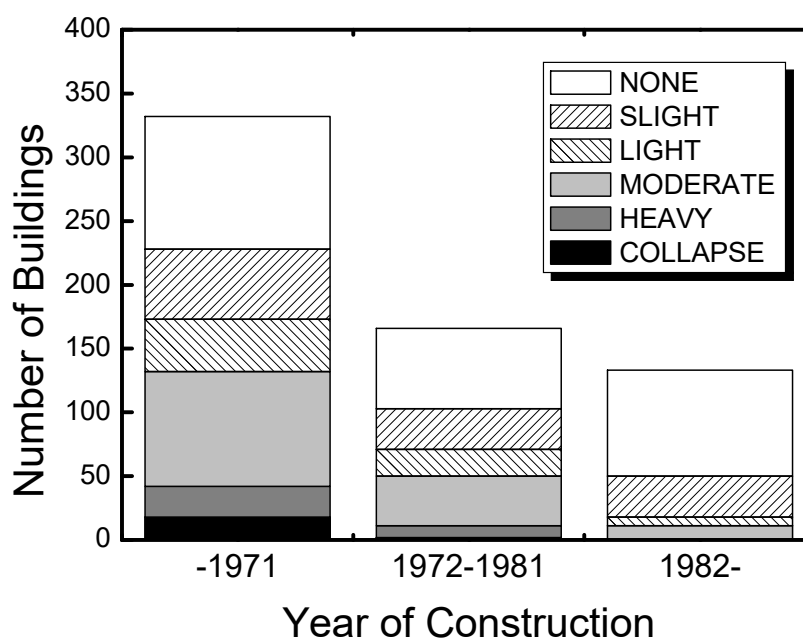
Fig. 3: Damage statistics of RC school buildings due to the 1995 Kobe earthquake [11]

In the last five decades, the seismic design code was revised in 1971 and 1981 in Japan. **Fig. 3** shows the damage statistics of RC school buildings due to the Kobe earthquake [11]. As can be found in the figure, the damage rate of buildings highly depends on the code generation, and those designed under the pre-1981 code had a higher possibility of more serious damage. This damage trends were widely found in other building use in the Hanshin-Awaji district, and various integrated efforts have been directed by the GOJ and engineering professionals toward upgrading seismic performance of vulnerable buildings and implementing learned and re-learned lessons for earthquake loss mitigation. Several new laws were promulgated soon after the event such as *Special Measures Law on Earthquake Disaster Prevention* and *Law to Promote Seismic Rehabilitation*. Along with these actions and recognizing the serious vulnerability of older buildings, especially of those designed under out-dated code, the MEXT launched a nationwide five-year project for seismic evaluation and rehabilitation of school buildings in 1996. It was extended several times until 2015, through enhancing a subsidy program to financially support the local government and publishing technical guides to help engineers determine technically and economically sound solutions of rehabilitation to upgrade their performance. **Fig. 4** shows the increasing trends of school buildings seismically upgraded in Japan. Due to these efforts to date, almost 100% of school buildings are provided with required structural capacity [12].

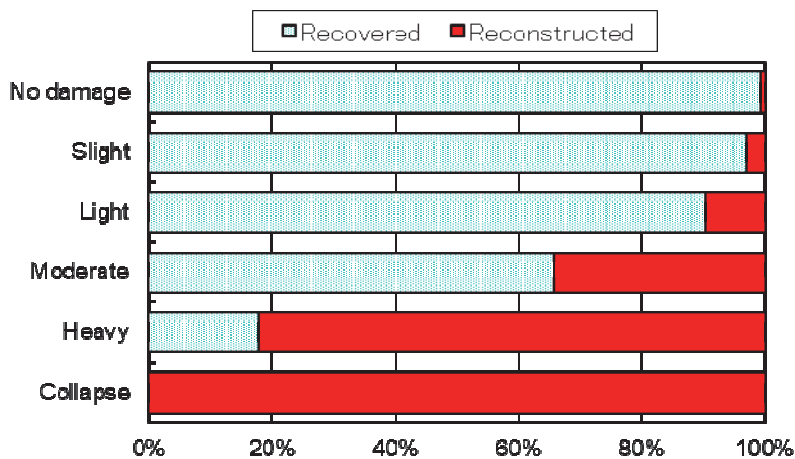
Fig. 6: Recovery ratio of damaged RC school buildings after 1995 Kobe earthquake (after [13])

Maeda made a follow-up study to investigate actions taken by the local government (i.e., building owner of public schools) after 1995 Kobe earthquake [13]. **Figs. 6 and 7** show the relationship between damage rating of RC school buildings and actions taken after the event, either “recovery” or “reconstruction after demolition.” As can be found in the figures, most of collapsed or severely damaged buildings were reconstructed after demolition, while those with or less than light damage and two-thirds of moderately damaged were recovered after repair and/or rehabilitation. Maeda also investigated the relation between the actions and the R -index described earlier, and pointed out that roughly 60% in R -index corresponded to the boundary between recovery and reconstruction, and R -index could serve as an index to define the limit state of recovery of RC buildings in Japan although the cost was undoubtedly a key factor for recovery decision.

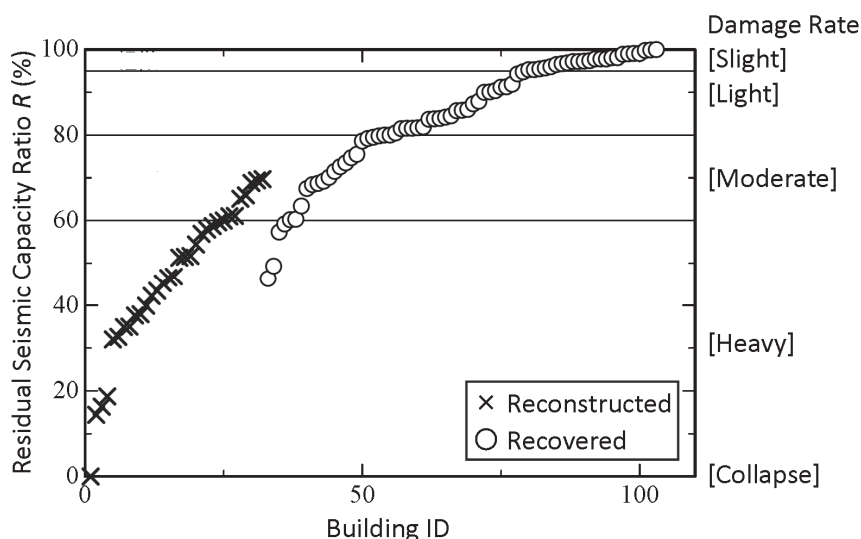
Fig. 7: Recovery criteria and damage rate (after [13])
