Drone Aided Machine-Learning Tool for Post-Earthquake Bridge Damage Reconnaissance

Z. Ma⁽¹⁾, E. Zhao⁽²⁾, G. Granello⁽³⁾ and G. Loporcaro⁽⁴⁾

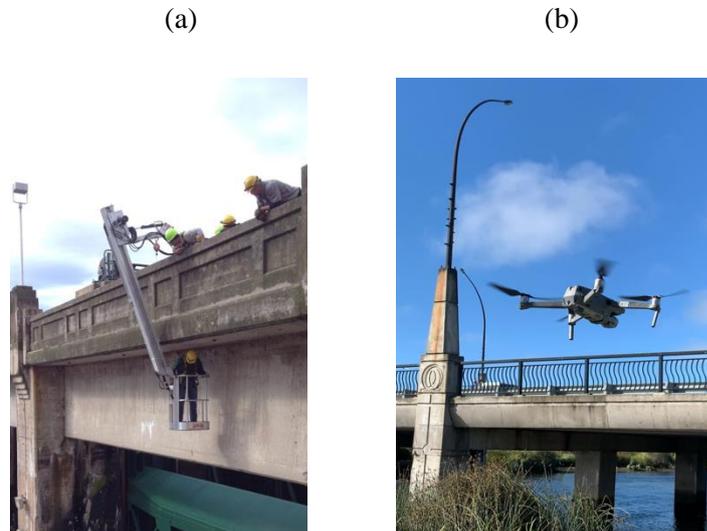
Fig. 1 – (a) Traditional bridge inspection with accessing difficulties by [1]; (b) Drone-aided inspection on the Anzac Drive Bridge

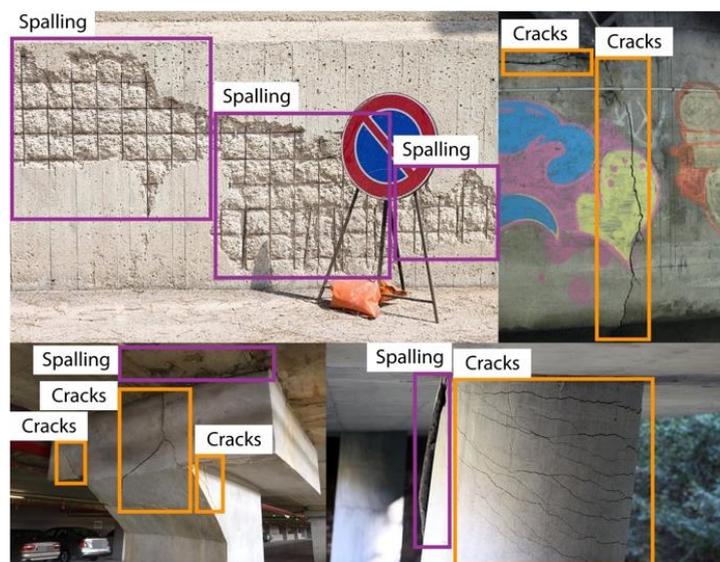
Fig. 3 – Demonstration of image database with labelled damages

A dataset was produced as part of the project work. It consisted of a total of 330 medium-high resolution images selected from the Canterbury Bridge Database (courtesy of Alessandro Palermo) and major search engines. Each image (Figure 3) contained either cracking or spalling damages on RC bridges. Damages were annotated within the bounding boxes and labelled according to their typologies.

The exclusion of corrosion in the damage class was due to its difficulty of being visually diagnosed. Without the help of scientific machinery, most corrosion damages were found due to the spalling of cover concrete. Figure 3 illustrates examples of each of these damage classes. The number of annotations for each damage type used for training and testing is summarised in Table 1.

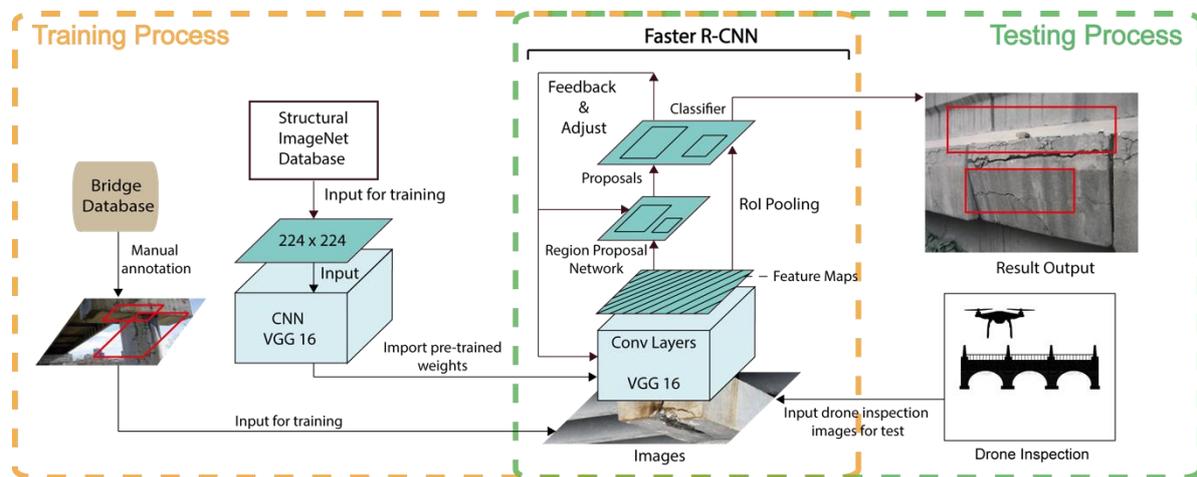
Fig. 4 – The flowchart of the training and testing process with faster R-CNN implemented

The proposed method has been composed of the training process and the damage detection process. The training process referred to the development of a machine-learning tool that can automatically detect the presence of damages on RC bridges. The damage detection process involved a proposed inspection method and the implementation of the developed ML tool. Figure 4 illustrates the flowchart of the proposed procedure from images collecting to results generation where VGG16 and faster R-CNN are applied.

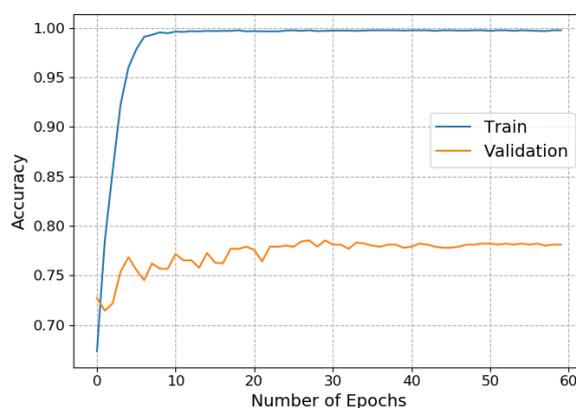
Fig. 5 – Training and validation accuracy changes responding to the increased number of epochs

After training the VGG16 network with 60 epochs the algorithm reached the accuracy of 78.5% base on the validation dataset. Figure 5 shows the change in training and validation accuracy against the number of epochs. It can be seen that accuracy rapidly increases within the first 10 epochs before becoming more stable. This indicates that the machine started to learn about the features and patterns of the input training set and started to reflect its performance optimization on the validation set. After 10 epochs of training, the training accuracy converges to the maximum, which is close to 1, as the machine has seen and recognise all images in the training set. On the contrary, the validation accuracy started to oscillate due to the potential of the loss function over-fitting the training set.

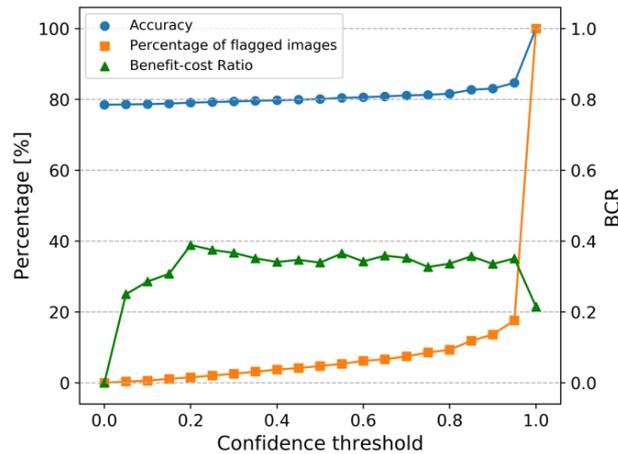
Fig. 6 – The increasing trend of accuracy (%) with the corresponding confidence threshold

Figure 6 indicates the change in accuracy and percentage of flagged images as the confidence threshold increases, assuming that the accuracy of manual classification is 100%. Both trendlines incline slowly along with the increasing in confidence threshold. It appears that the algorithm maintained a high confidence level regarding its decisions regardless of its correctness.

To find the optimal point between the increase in accuracy and the number of images flagged for manual classification, the benefit-cost ratio (BCR) has been used as the key measurement. The BCR was calculated as the gain in accuracy over the proportion of flagged images shown in Equation 1. The change in BCR was plotted against the change in confidence threshold, which is shown in Figure 6.

It is observed that the BCRs are less than 1.0 at all levels of confidence threshold, which indicates that the costs outweigh the benefits. In this specific case, it is acceptable to pay more labour to exchange for benefits as the consequences of missing potential damages could be much higher than the cost of labour. The trend indicates that the confidence threshold should be set to 20% as the benefit over cost is maximised. The accuracy can be improved up to approximately 84.6% with manually classifying 17.6% of images.

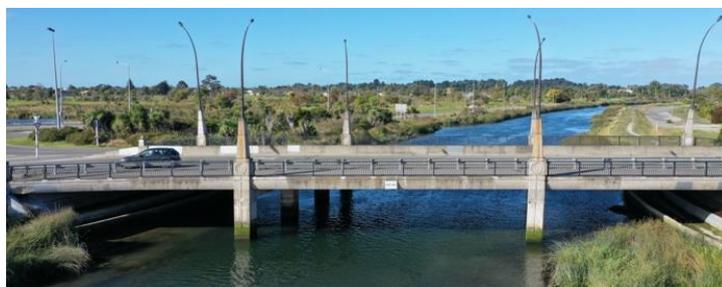
Fig. 7 – Elevation view drawings of the Anzac Drive Bridge

The Anzac Drive Bridge was initially constructed in 2000 (shown in Figure 7). It is a four-lane concrete beam bridge located about 6 km north-east of central Christchurch [14]. The bridge has three 18 m simply supported decks. The piers consist of four reinforced concrete columns, designed as portal frames. Inspections were conducted after both the 2010 Darfield Earthquake and the 2011 Christchurch Earthquake. According to the inspection log from the Canterbury Bridge Database, significant structural damages including cracks, concrete spalling and abutment rotation, were observed. The bridge has been repaired after the 2011 Christchurch Earthquake.

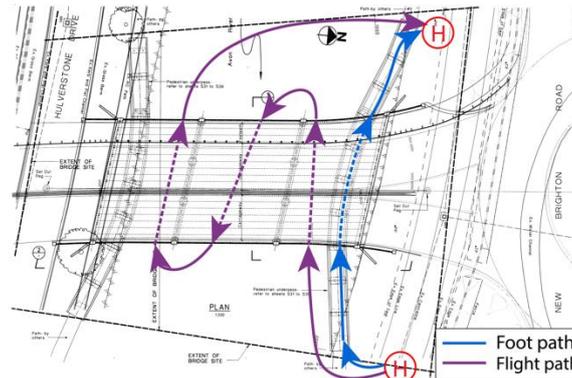
Fig. 8 – Drone inspection flight plan

As shown in Figure 8, the purple line indicates the flight path of the drone and the blue line represents the inspectors' walking path. By following the proposed inspection method, a drone was controlled to weave between the piers while the inspectors were walking through the pedestrian underpass. The elevation view of the deck and all faces of bridge columns were covered, and photos were obtained. The entire inspection was completed within 20 minutes.

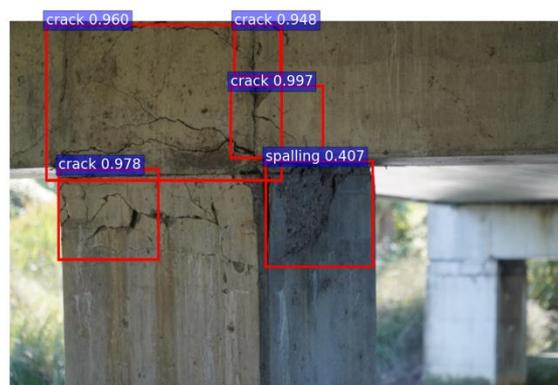
Fig. 9 – An example of effective damage detection

Figure 9 is one example of the algorithm output and the spotted damages at one connection of the portal frames were identified. The red bounding box indicates that a type of damage was detected inside the box. The corresponding damage type with its confidence level (CL) is shown in the blue box attached to the bound of the boxes. The cracks and concrete spalling were successfully identified except part of a long crack was observed outside the bounding box. This could be due to the RPN failing to propose precise regions or the

VGG net only recognising part of the cracking pattern. It is reasonable to expect that the algorithm is more confident about the identified cracks ($CL > 0.90$) and less confident about the identified spalling ($CL < 0.5$), as the number of annotated cracking damages used for training was twice as many as the spalling damages.

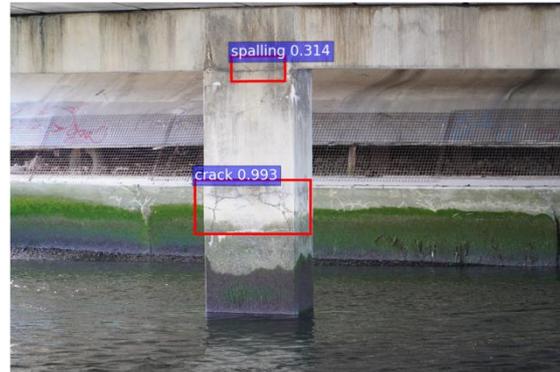
Fig. 10 – An example of an incorrect damage detection at the beam-column interface

Figure 10 is another example of the output results. The flexural cracks on the bridge column were identified with a high CL. However, the algorithm mistakenly classified the crack at the top of the column as spalling. This potentially indicates that the algorithm tended to categorise the spalling damage based on the colour variation inside of the texture variation within the region.

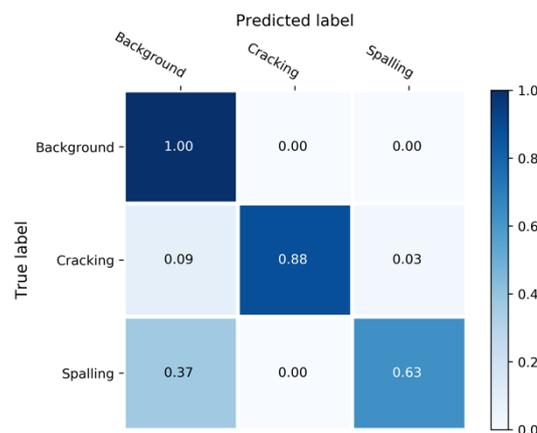
Fig. 11 – The normalised confusion matrix of the tested result generated by the algorithm

The accuracy of multiple object classification is hard to be quantified as the categorising correctness and bounding precision are both important contributing factors. To simplify the performance measurement, locations which contained identified damages within were counted. By inputting the 25 images obtained from the field, the algorithm identified 34 locations with the presence of damage. Twenty-eight cracking damages and five spalling damages were correctly identified. However, the algorithm failed to point out three cracking and three spalling locations. In addition, one cracking damage was mistaken as spalling damage. The results were summarised into a normalised confusion matrix in Figure 11 shown below.

In this normalised confusion matrix, a background category, which represents the regions without any damages was introduced. The value in the central box indicates that 88% of actual cracks were correctly predicted. Similarly, the value in the lower right corner indicates that 63% of spalling damages were identified.
