RATE OF LOADING EFFECTS ON UNCRACKED AND REPAIRED
REINFORCED CONCRETE MEMBERS

V. V. Bertero^I, D. Rea^{II}, S. Mahin^{III}, and M. B. Atalay^{III}

SYNOPSIS

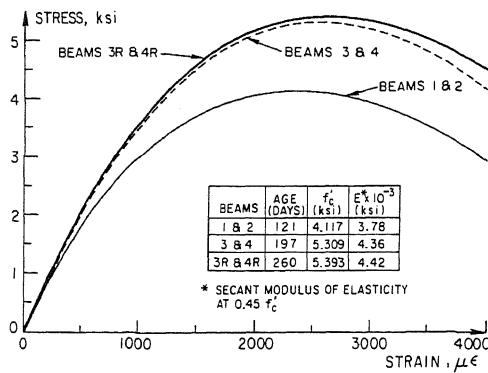
(a.) QUASI-STATIC, 35 PSI/SEC

FIG. 3 MECHANICAL CHARACTERISTICS OF CONCRETE

The specimen selected for this investigation was similar to that used in previous quasi-static tests, described in Reference 1 and shown in Fig. 1. Two beams were cast at a time from the same batch of concrete in order to obtain pairs of beams with similar concrete properties. The reinforcement consisted of deformed bars of intermediate grade steel conforming to ASTM designation A15. Stress-strain relationships were determined under tensile loads for samples of the longitudinal reinforcing bars at average strain rates of 50, 5,000, and 50,000 $\mu\text{in/in/sec}$. The standard main mechanical characteristics, determined at the slowest strain rate, are shown in Fig. 2(a). The main effect of higher strain rates was to increase the yield strength. The increases in yield strengths, above the quasi-static ones, were 16% and 28% for average strain rates of 5,000 and 50,000 $\mu\text{in/in/sec}$, respectively. As shown in Fig. 2(b), for a given strain rate, after the first excursion beyond yielding, the percentage increase in strength decreases for subsequent loading cycles even if these are in the plastic plateau range. The concrete mix was designed to achieve an ultimate strength of 4000 psi in 28 days. The properties of the concrete at the time each beam was tested were determined from the compressive stress-strain relationship for 12 in. control cylinders cast from the same batch of concrete as the beam. These relationships under quasi-static loading are shown in Fig. 3(a), where the main mechanical characteristics of the concrete are also tabulated. As shown in Fig. 3(b), the main effects of high strain rates were an increase in stiffness and compressive strength.

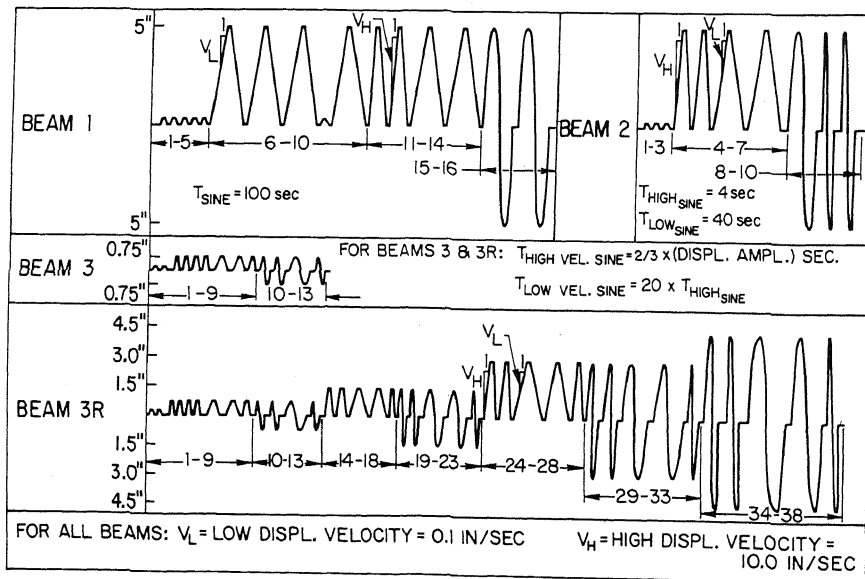
FIG. 4 DISPLACEMENT HISTORIES

SELECTION OF TEST PROGRAM: The loading program was selected specifically to evaluate strain rate effects, rather than to simulate response to any real dynamic excitation. Different strain rates were applied by moving the actuators with different displacement velocities. Two main velocities were used: one was the highest permitted by the system, 10 in/sec; and the other was to achieve a quasi-static rate, 0.1 in/sec. A pair of beams were subjected to similar displacement histories but with rates interchanged. Each beam was forced downward to a specified displacement at a constant velocity for several cycles until the behavior stabilized. These cycles were then repeated at a different velocity, and finally the original displacement rate was again imposed. To investigate displacement reversal, several cycles with sinusoidal displacement functions were applied. Typical displacement histories are shown in Fig. 4.

TEST PROGRAM FOR BEAMS 3R AND 4R: These beams were initially subjected to the same displacement time histories as beams 3 and 4. Then they were subjected to further loading cycles at displacement amplitudes of 1.5, 3.0, and 4.5 in. (Fig. 4). Cycles at high velocity and quasi-static rates were applied at each of these amplitude levels. Force-displacement relationships are shown in Figs. 7 and 8.

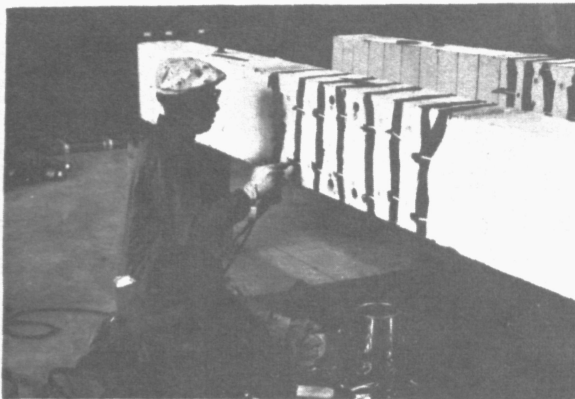
PHOTO 3 REPAIR OF BEAM

DAMAGE REPAIR OF BEAMS 3 AND 4: Cracks wider than 0.005 in. developed in the central third of these beams. These cracks were repaired by the injection of epoxy resins. The cracks were sealed except for ports at the beam surface with a fast drying epoxy. Epoxy resins were forced under pressure into the entry ports on one side of the beam until flow was detected through ports on the other side (Photo 3). After the epoxy cured, the temporary seal was removed. The repaired beams were designated as beams 3R and 4R.

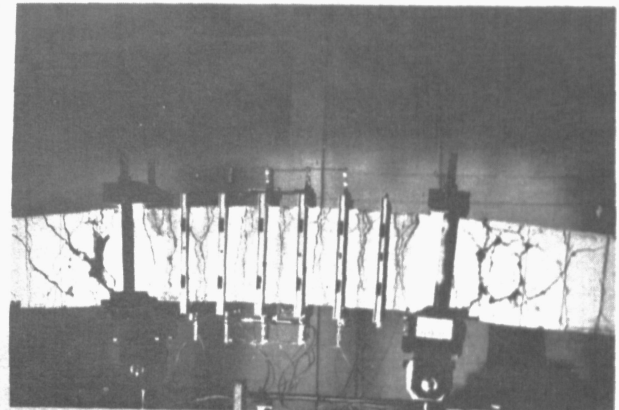
PHOTO 6 FAILURE MODE, BEAM 3R

Mode of Failure: The most significant differences between the behavior of repaired and non-repaired beams were the different modes of failure. While beams 1 and 2 failed due to the buckling of the main reinforcement, no spalling of concrete was observed in beams 3R and 4R. This particular difference was not a direct consequence of the repairing technique, but the result of the different load-displacement histories. Beams 3R and 4R failed in shear where damage accumulated in the unrepaired cracks outside the region of constant moment.
